EVALUATION OF OAK TREES AT
BUENA VISTA
19001 TONNER CANYON ROAD IN
BREA, CALIFORNIA

OCTOBER 13, 2002

**Re: Oak Tree Report
Buena Vista
LA54XC265C
19001 Tonner Canyon Road
Brea, California 92822
Los Angeles County**

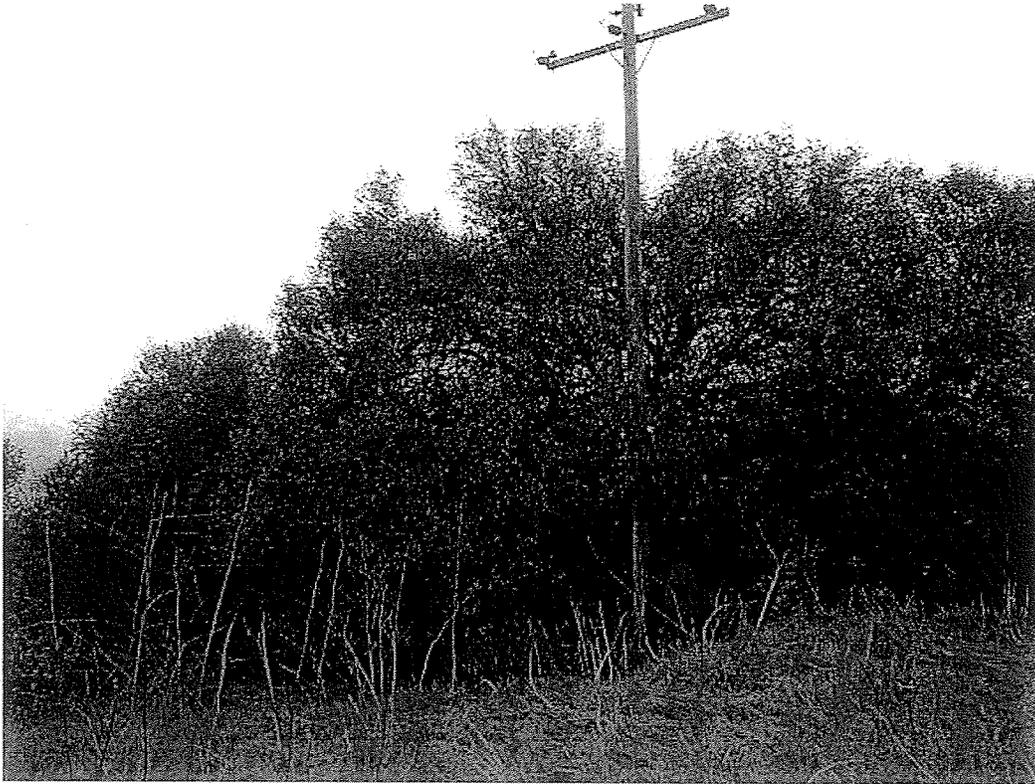
Individual tree information is provided on the attached field data sheets, and in summary, the two subject trees are in very good to excellent condition. Tree number '1' shows signs of previous fire damage in the trunk, but has compartmentalized the associated wood decay well.

Overall Vigor (see Explanation of Codes)	Very Good
Drought Stressed	No
Insect Damage	No
Exudation	Minimal bleeding in crown
Epicormic Growth	No
Twig/Branch Dieback (other than normal)	No

Trunk Cavity(s)	Yes; west side due to fire damage
Branch Cavity(s)	No
Exposed Roots	No
Leaning	No
Fire Damage (i.e., loss of strength, decay)	Yes
Weak Main Crotches	Yes
Dieback in Main Stem	No
Fruiting Bodies (i.e., decay, fungus)	No

Physiological Condition (Health)	Very Good
Structure	Very Good
Aesthetics and Conformity	Excellent
Balance/Symmetry	Excellent

Tree # 1, facing northwest. Power pole is in foreground.

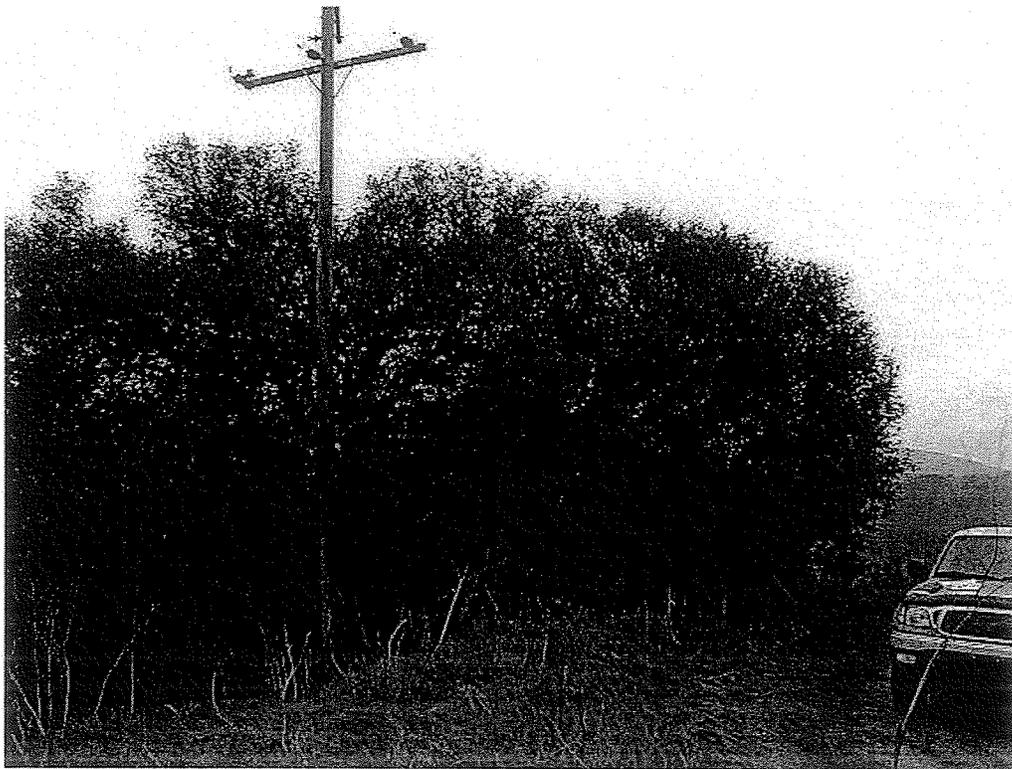
Tree number '2' has many small cankers on the three main trunks—the associated bleeding is fairly common on coast live oaks, and may be related to stress from root disturbance when the road was constructed many years ago. The trunks were not buried with soil, however, and besides infestation from insect pests common to coast live oaks, the tree appears to be healthy otherwise.

Overall Vigor (see Explanation of Codes)	Very Good
Drought Stressed	No
Insect Damage	Moderate infestation of oak twig girdler
Exudation	Yes, on all three trunks
Epicormic Growth	No
Twig/Branch Dieback (other than normal)	No

Physiological Condition (Health)	Good
Structure	Very Good
Aesthetics and Conformity	Very Good
Balance/Symmetry	Good—shaded by Tree # 1

Tree # 2, facing north. Power pole is in foreground.

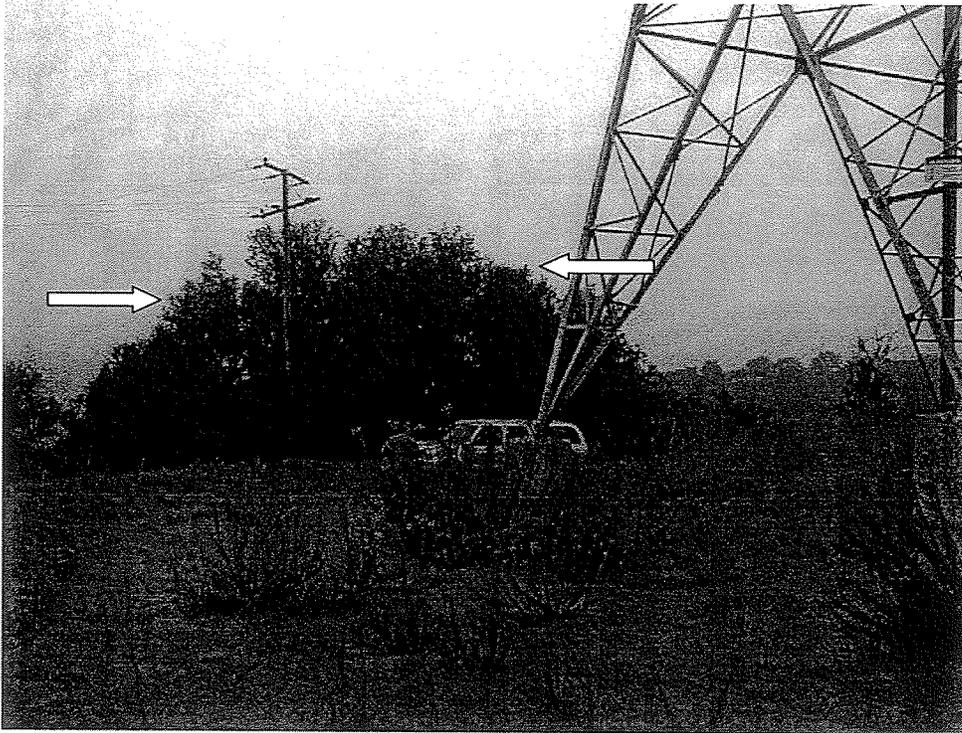
Facing northwest, showing Trees # 1 (left-pointing arrow) and # 2 (right-pointing arrow).
