**MILLS ACT EXEMPTION FROM DISQUALIFICATION ANDERSON HOUSE  
PROJECT NO. 2020-000311-(3) CASE NO. RPPL2020004010  
(THIRD SUPERVISORIAL DISTRICT) (3-VOTES)**

This Historic Structures Report (HSR) was completed by Architectural Resources Group (ARG) at the request and of Beatrice Faverjon, owner of the Anderson House at 19974 Sischo Drive in Topanga Canyon, Los Angeles County. The purpose of the HSR is to document the subject building's history, significance, and existing conditions, and to appropriately guide its rehabilitation and maintenance. This HSR is associated with a Mills Act Property Tax Abatement Program contract application that is being submitted for the subject building and is a required component of the application.

# Structural Evaluation Report

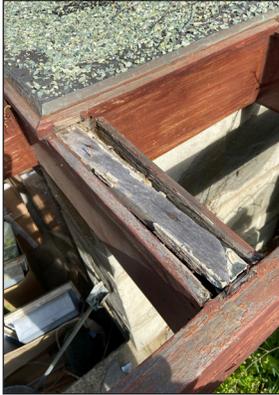
Wood decay/rot at the carport trellis (Beatrice Faverjon, 2020)

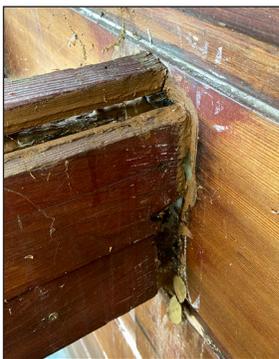
Carport roof beams pulling away from the house exterior wall (Beatrice Faverjon, 2020)

In general, the residence structural systems are intact and remain in fair condition overall, with some areas in need of repair. The carport structural system is in poor condition overall, and in need of significant repair.

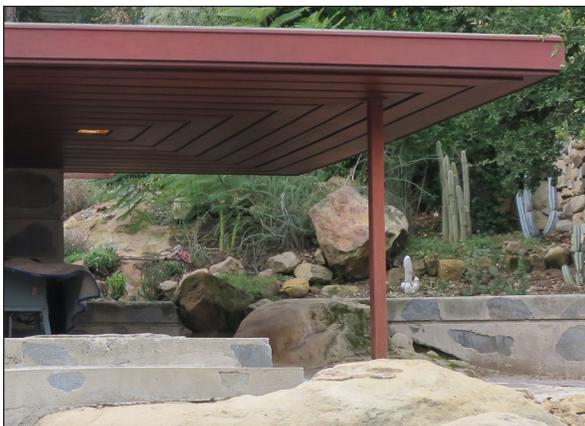
Wood post added at the northeast corner to support the carport (ARG, 2019)

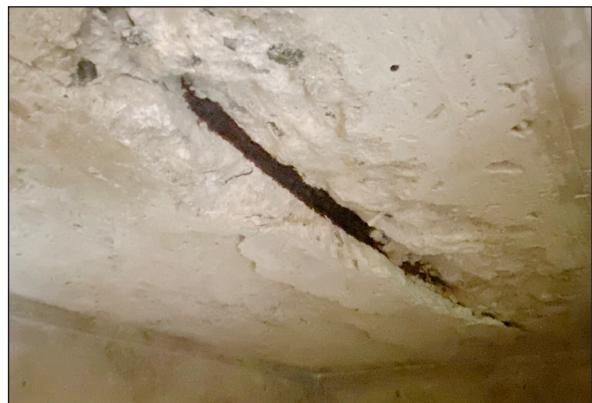
Concrete spalling and exposed/corroded steel reinforcement inside the utility shop (Beatrice Faverjon, 2020)

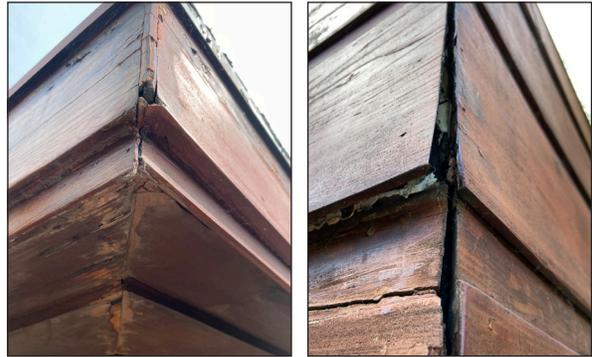
Wood decay/rot at mitered siding (left) and building corner (right) (Beatrice Faverjon, 2020)

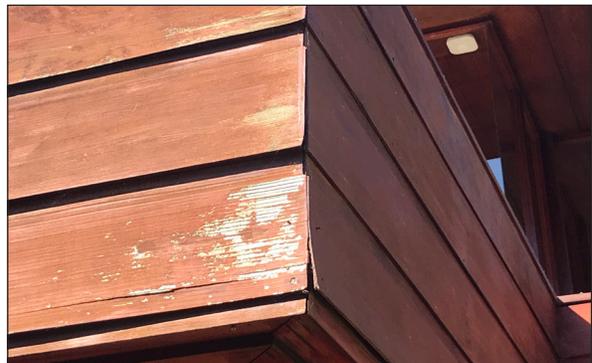
Deteriorated non-compatible siding (ARG, 2019)

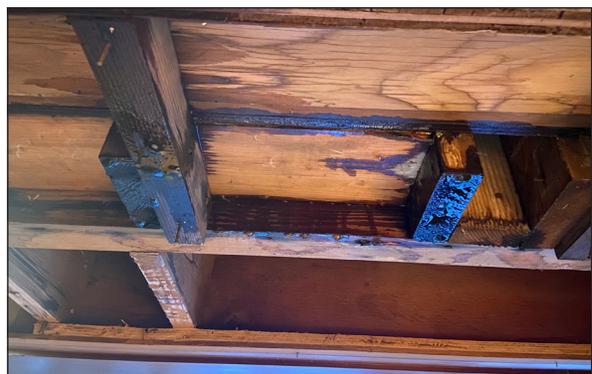
Water infiltration at ceiling of dining room, most likely associated with leaks at master bathroom/roof above (Beatrice Faverjon, 2020)

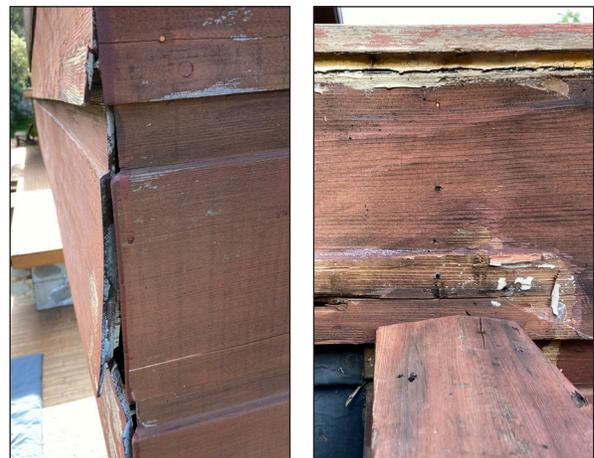
Damaged/split siding at balcony (left) and wood rot/decay at built-in planter (right) (Beatrice Faverjon, 2020)

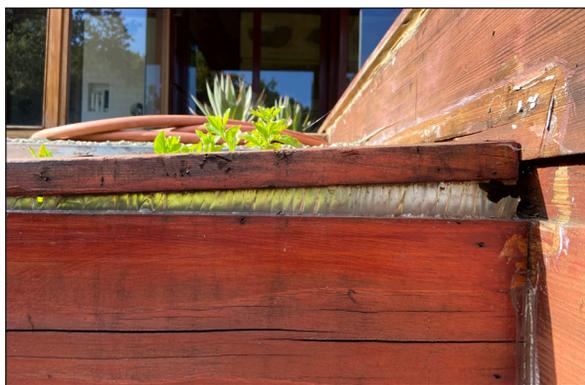
Wood rot/decay at built-in planter (Beatrice Faverjon, 2020)

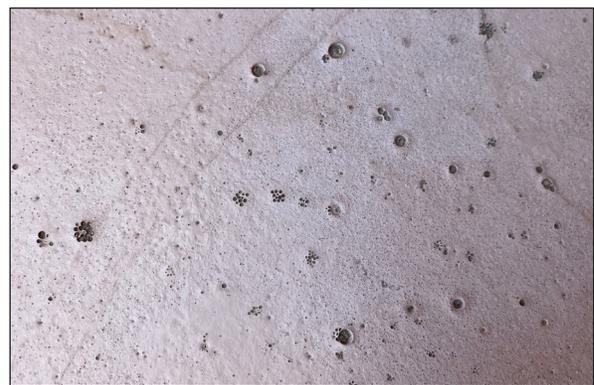
The traffic coating membrane at the balconies are in poor condition. The membrane is deteriorated, with tears and perforations in several locations, allowing for water infiltration. The small drains are in tact and appear operational.

Deteriorated membrane at balcony (Beatrice Faverjon, 2020)

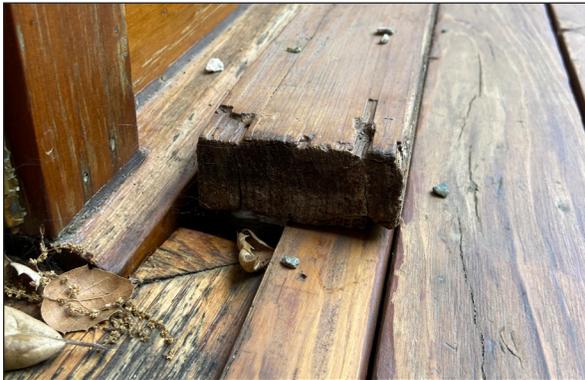
Localized area of wood decay at deck (Beatrice Faverjon, 2020)

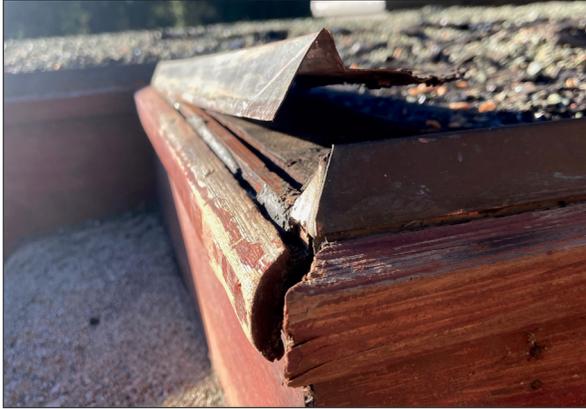
Close-up of damaged gravel stop flashing and deteriorated wood (Beatrice Faverjon, 2020)

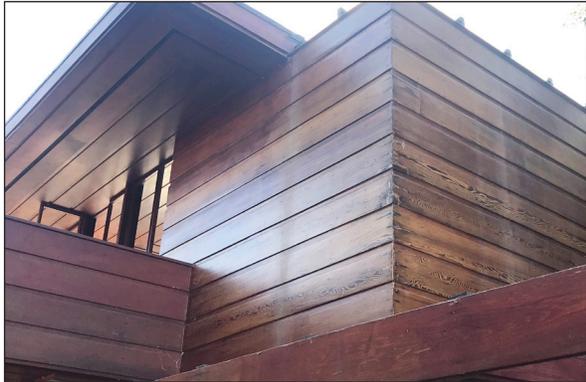
Drip stains on redwood siding (ARG, 2019)

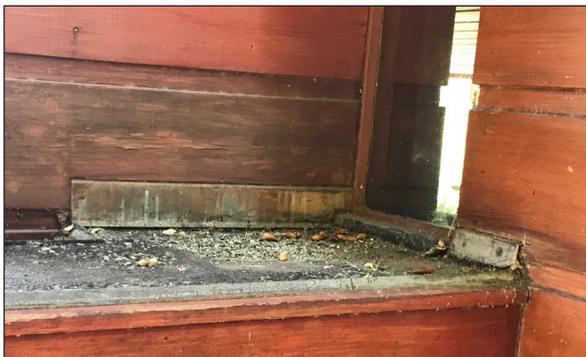
Deteriorated roof membrane and surviving remnant of original copper base flashing at low roof (ARG, 2019)

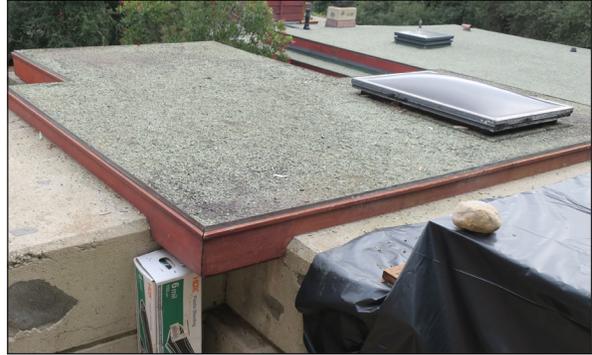
Currently, the utility shop roof is in poor condition. The roof surfaces are deteriorated and near the end of their useful service life. The gravel is eroded or missing in several areas, with a desiccated and cracked asphalt/tar layer visible. The concrete portion of the roof is leaking, with cracking and stains visible at the interior ceiling below.

Gravel roof at the utility shop; note areas of wear and skylight (skylight beyond is at the residence roof) (ARG, 2019)

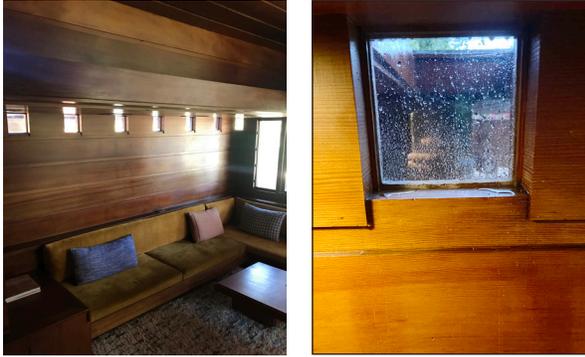
Small fixed windows at living room north wall; note water infiltration at sill (Beatrice Faverjon, 2020)

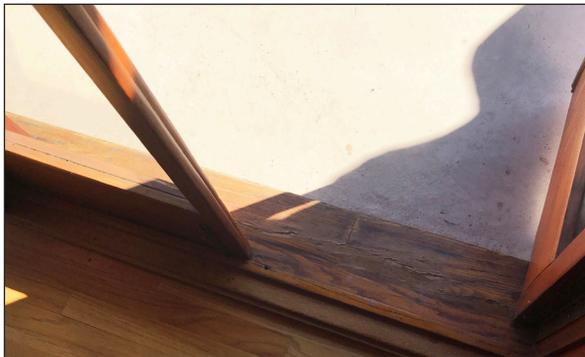
Water damage and wear at sills at exterior doors (ARG, 2019)

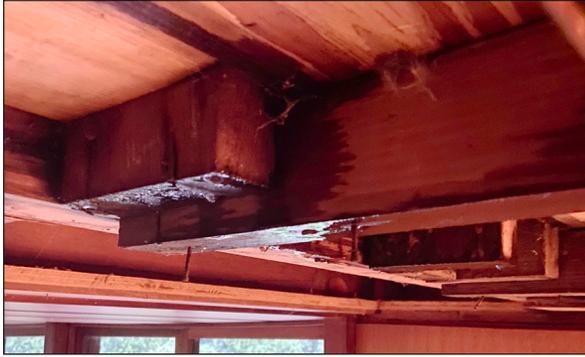
Kitchen interior wood ceiling finishes have been removed due to water damage (Beatrice Faverjon, 2020)

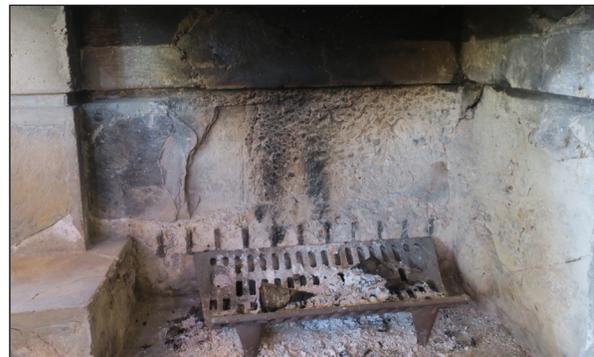
Soiled concrete and missing andirons in the main living room (ARG, 2019)

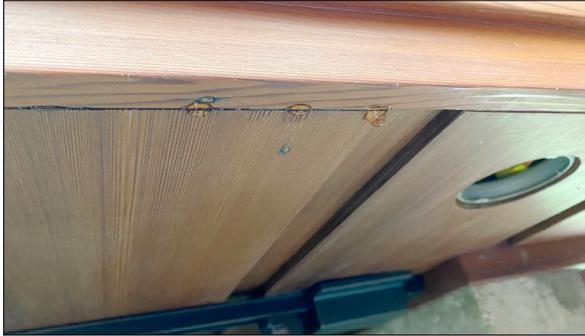
Leaking at the wood ceiling in the utility shop (Beatrice Faverjon, 2020)

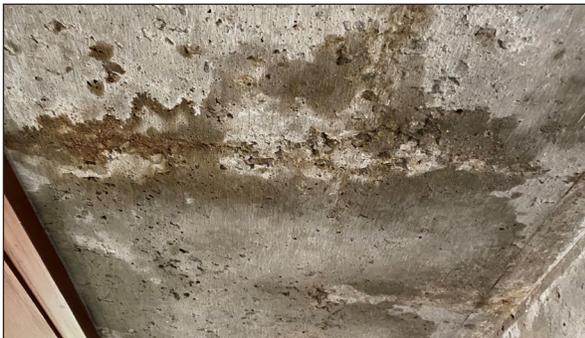
Localized concrete cracking and water damage at the utility shop ceiling (Beatrice Faverjon, 2020)

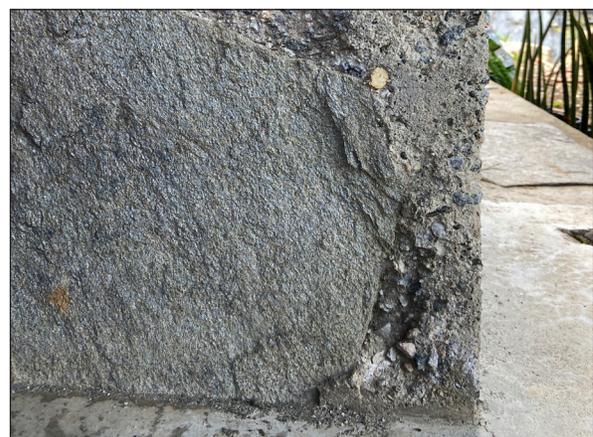
Spalling at concrete planter (Beatrice Faverjon, 2020)

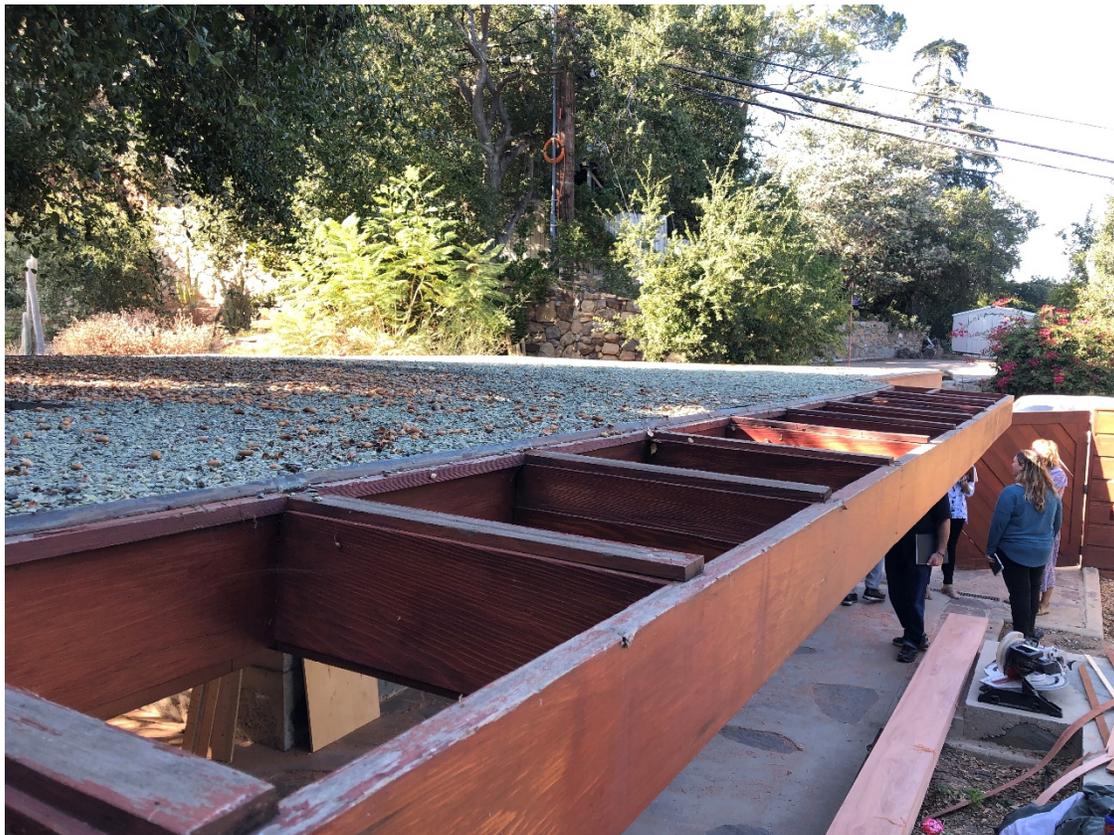
Figure 2: Deflection at carport framing

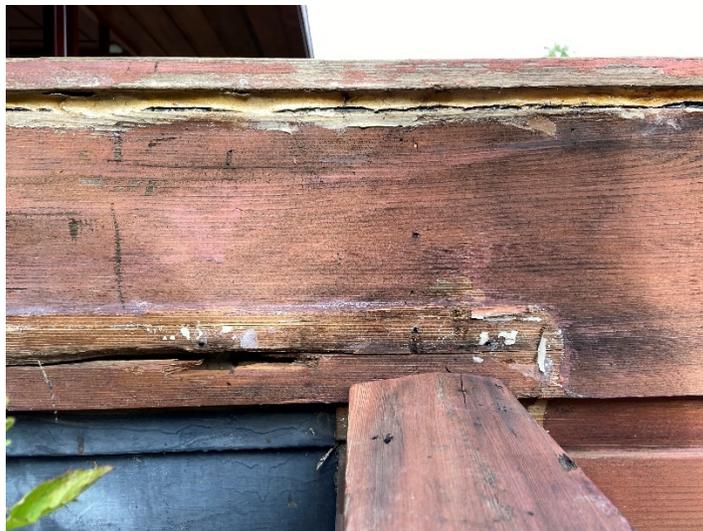
Figure 4: Water damage at master bedroom balcony.

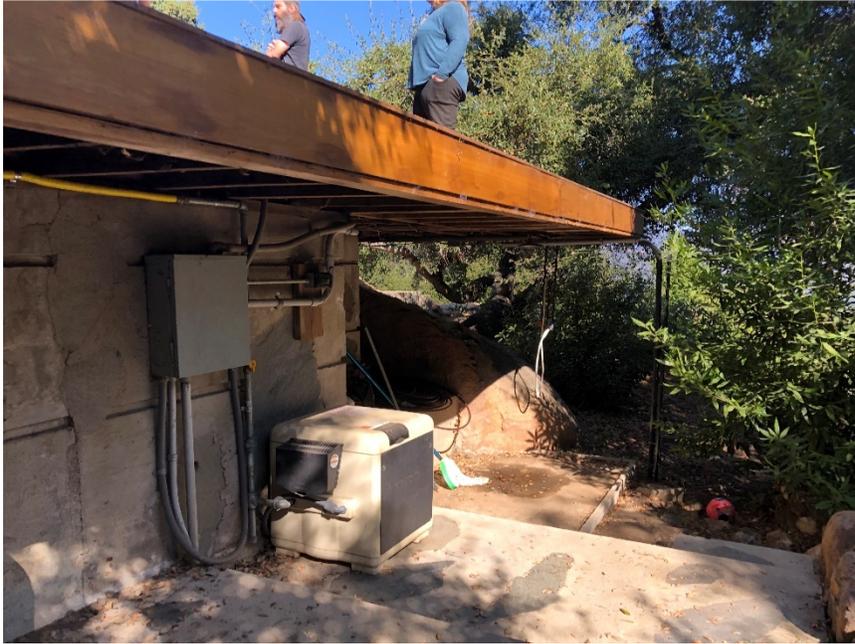
Figure 5: Jacuzzi deck deflection.

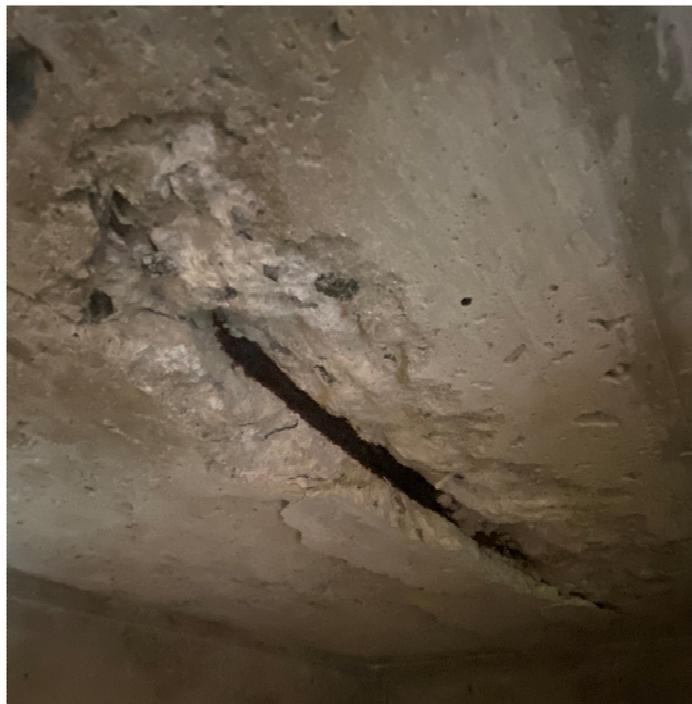
- The concrete walls/roof in the workshop show spalling and cracking indicative of water damage. The reinforcing has been exposed in several areas due to concrete spalling.

Figure 6: Concrete spalling and exposed reinforcing at workshop.
