COMMUNITY STANDARDS DISTRICT – COMPLAINT LOG SECOND QUARTER 2022

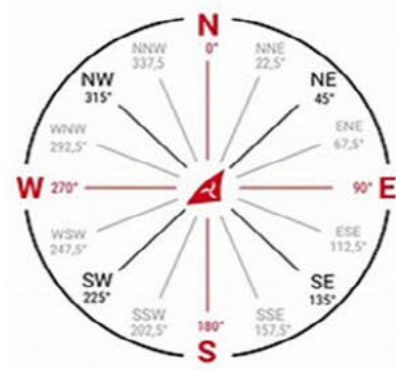
Complaint Reference # Q2-22-08

Reference #	Date & Time	Reporting Party (R/P) Name (Last, First)	Phone #	Location	Complaint	CSD Reporting (EMAIL - Date/Time)
<u>Q2-22-08</u>	5/25/22 @1:05 PM	SCAQMD - Louie, Mathew	[REDACTED]	Hauser and Obama Blvd. NE Edge of IOF	Odor	Delatorre Email - 5/25/22 @1:26 PM
Comments/ Sentinel Peak Resources actions:	<ul style="list-style-type: none">● Complaint: On 5/25/22 @1:05 PM, SCAQMD inspector contacted EHS on-call and indicated that they had received an odor complaint between 3:30 AM and 4:00 AM. The area was near Hauser Blvd. and Obama Blvd., approx. 0.78 miles NE of the IOF. The odor was described as a "foul, sour natural gas odor".● SPR Response: SCAQMD did not provide the callers information, therefore no return calls were conducted by SPR.● SCAQMD Assessment: On 5/25/2022 @1:05 PM, the SCAQMD inspector contacted SPR's Senior Environmental Scientist indicating that he was about 10 minutes away from the site and was responding to an odor complaint described above. <p>At 1:18 PM the SCAQMD inspector arrived on site at the IOF. The inspector was equipped with a FLIR camera and escorted by a SPR Field Operator. The areas as described in the SPR Operator Assessment below were checked. No odors were identified or observed. The inspector indicated that he would be checking the area near the complainants location after leaving the site.</p> <p>The SCAQMD inspector was offsite at 2:12 PM.</p> <ul style="list-style-type: none">● SPR Operator Assessment: On 5/25/2022 @1:10 PM, EHS contacted SPR Field Operations to assist with escorting the inspector and assess possible odors based on the subject odor complaint. <p>At 1:18 PM, the AQMD inspector arrived at the primary guard shack and was escorted by a SPR Field Operator to the most northern part of the lease, i.e., the old Shell tank setting and across the La Cienega bridge down Rubel road all the way to Dabney Lloyd (the most northeastern point). The inspector wanted to check some wells below the Cone setting; the following production wells were assessed: VRU 278, VRU 257 Idle well and VRU 139 Idle well. The inspector scanned the wells with a FLIR camera and had no observable emissions. Thereafter, the inspector was escorted back to the guard shack to meet EHS personnel and then left the site at approximately 2:12 PM.</p> <ul style="list-style-type: none">● On-site MET Station: Hourly wind direction and wind speed were provided from 2 AM to 6 AM on 5/25/2022 via the SPR MET Station. At the estimated time of the complaint (3:30 to 4:00 AM), the wind direction and speed were 81.6° (out of the [E] and blowing to the [W]) at 2.0 mph, respectively. The overall average wind direction for the 2 AM to 6 AM timeframe was out of the E, 97.3° at an average rate of 2.0 mph.● Conclusion: Based on the site assessment and Met Station data it was determined that the odor was not from SPR.

Time	WS_ Vector [mph]	WD_ Vector [°]	WD [General]
5/25/2022 2:00	1.8	22.0	NNE
5/25/2022 3:00	2.0	81.6	E
5/25/2022 4:00	1.4	67.8	ENE
5/25/2022 5:00	2.1	15.9	NNE
5/25/2022 6:00	2.7	299.2	WNW
AVERAGE	2.0	97.3	E

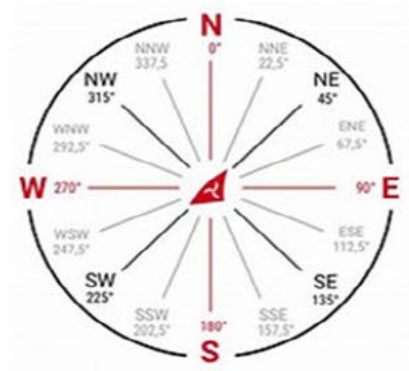
Complaint Reference # Q2-22-09

Reference #	Date & Time	Reporting Party (R/P) Name (Last, First)	Phone #	Location	Complaint	CSD Reporting (EMAIL - Date/Time)
<u>Q2-22-09</u>	6/13/22 @5:44 PM	[REDACTED]	[REDACTED]	[REDACTED] Onacrest Dr., Windsor Hills	Odor	Delatorre Email - 6/14/22 @7:04 AM
Comments/ Sentinel Peak Resources actions:	<ul style="list-style-type: none">● Complaint: On 6/13/22 @5:55 PM, LACDRP reported that they received an odor complaint via email @5:44 PM from a resident in the Windsor Hills area. The R/P indicated the odor occurred 1 hour earlier @4:44 PM. The odor was described as a "very strong rotten egg or burning rubber smell".● SPR Response: On 6/14/2022 @6:48 AM., EHS rep. sent an email response to the R/P indicating that SPR operations staff were in the process of investigating the odor complaint, and provided the MET Station data table (below). The R/P was asked to please call Joe Walters on his mobile to further discuss and to assist with assessing the odor further. <p>At 9:36 AM., The R/P responded via email and indicated that the odor was not as strong as the other day, but noticed the smell this AM as well. The R/P indicated that on average, the smell is strong enough to notice about once per month.</p> <p>At 10:06 AM., SPR EHS responded via email. Indicated that SPR Operations staff focused their inspection on the SE portion of the IOF, nearest SPR offices, and they did not find any issues, odors, or equipment malfunctions. EHS rep. suggested there's a possibility that the odor could have been from other commercial or traffic sources as well – particularly along Slauson to the west southwest of the resident.</p> <ul style="list-style-type: none">● SPR Operator Assessment: On 6/14/2022 @6:28 AM, EHS contacted SPR Field Operations to assess possible odors based on the subject odor complaint. <p>~7:00 AM, SPR operators inspected the entire side of the Stocker Lease, i.e., the SE quadrant of the oil field, and no odors were encountered in or around the field including no equipment malfunctions that could potentially cause a "burning rubber" odor as referenced above.</p> <ul style="list-style-type: none">● On-site MET Station: Hourly wind direction and wind speed were provided from 2 PM to 7 PM on 6/13/2022 via the SPR MET Station. At the estimated time of the complaint (4:44 PM), the wind direction and speed were 251° (out of the [WSW] and blowing to the [ENE]) at 12 mph, respectively. The overall average wind direction for the 2 PM to 7 PM timeframe was out of the west southwest (WSW, 249°) at an average rate of 12 mph.● Conclusion: Based on the site assessment and Met Station data the odor was not from SPR operations.

Time	WS_ Vector [mph]	WD_ Vector [°]	WD [General]
6/13/2022 14:00	12.0	244.6	WSW
6/13/2022 15:00	12.6	249.3	WSW
6/13/2022 16:00	12.3	250.8	WSW
6/13/2022 17:00	12.0	250.6	WSW
6/13/2022 18:00	10.3	248.5	WSW
AVERAGE	11.8	248.8	WSW

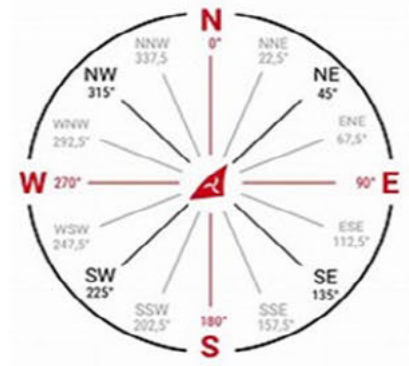
Complaint Reference # Q2-22-10

Reference #	Date & Time	Reporting Party (R/P) Name (Last, First)	Phone #	Location	Complaint	CSD Reporting (EMAIL - Date/Time)
<u>Q2-22-10</u>	6/28/2022 @10:14 AM	SCAQMD - Louie, Mathew	[REDACTED]	West MLK Jr. Blvd / Hillcrest Dr.	Odor	Delatorre Email - 6/28/22 @2:38 PM
Comments/ Sentinel Peak Resources actions:	<ul style="list-style-type: none">● Complaint: On 6/28/22 @10:14 AM, SCAQMD inspector contacted EHS on-call and indicated that they had received an odor complaint on 6/27/2022 at approx. 5:00 AM. Based on the information received from the SCAQMD inspector, the approximate timeframe was from the evening of 6/23/22 (Thursday) to 6/24/22 early morning (Friday). The complainant was near West Martin Luther King Jr Blvd and Hillcrest Dr; approx. (1.65) miles NE of the IOF. The odor was described as a "natural gas and/or sour smelling gas".● SPR Response: SCAQMD did not provided the callers Information, therefore no return calls were conducted by SPR.● SCAQMD Assessment: On 6/28/2022 @10:14 AM, the SCAQMD inspector contacted Mr. Walters, SPR Senior Environmental Scientist, indicating that he was enroute to the IOF and was responding to the odor complaint described above. At 10:30 AM, The AQMD inspector arrived at the primary guard shack. The inspector informed Mr. Walters that SCAQMD received an odor complaint on Monday, 6/27/2022 at approximately 5 AM. The inspector reported that the resident location was approximately two (2) miles northeast of the IOF; he was equipped with a FLIR camera; and was escorted onsite by Mr. Walters. The inspector reported that the residential area was assessed; however, no definitive odors were identified and he further indicated that there did not appear to be any likely sources between the IOF and the residential location. The inspector was escorted by Mr. Walters to the most northern part of the lease, i.e., the old Shell Tank Setting, as well as the Packard Tank Setting. The inspector scanned the Packard Tank Setting area with a FLIR camera and had no observable emissions or odors. Thereafter, the inspector was escorted back to the guard shack and then left the site at approximately 11:00 AM.● SPR Operator Assessment: On 6/28/2022 @10:16 AM, EHS contacted SPR Field Operations to assess possible odors based on the subject odor complaint. Perimeter areas of the Baldwin Cienega and the Shell Rindge Leases, i.e., the eastern most leases, and no equipment malfunctions or identifiable odors were detected.● On-site MET Station: Hourly wind direction and wind speed are provided from 8 PM on 6/23/2022 to 8 AM on 6/24/2022 via the SPR MET Station. Wind direction and speed throughout this timeframe ranged from the southwest (SW, 214°) to the west (W, 261°) from 2.81 to 10.3 mph. The overall average wind direction for this timeframe was out of the west southwest (WSW, 242.1°) at an average rate of 5.2 mph.● Conclusion: Based on the site assessment and Met Station data it was determined that the odor was not from SPR.

Time	WS_ Vector [mph]	WD_ Vector [°]	WD [General]
6/23/2022 20:00	10.3	248.0	WSW
6/23/2022 21:00	6.5	235.0	SW
6/23/2022 22:00	5.9	218.0	SW
6/23/2022 23:00	3.1	214.0	SW
6/24/2022 0:00	3.1	244.0	WSW
6/24/2022 1:00	4.5	261.0	W
6/24/2022 2:00	4.6	244.0	WSW
6/24/2022 3:00	2.8	223.0	SW
6/24/2022 4:00	3.6	234.0	SW
6/24/2022 5:00	4.7	259.0	W
6/24/2022 6:00	6.1	252.0	WSW
6/24/2022 7:00	5.1	250.0	WSW
6/24/2022 8:00	6.1	254.0	WSW
6/24/2022 9:00	6.3	254.0	WSW
AVERAGE	5.2	242.1	WSW
