## COMMUNITY STANDARDS DISTRICT – COMPLAINT LOG THIRD QUARTER 2022

COMMUNITY STANDARDS DISTRICT – COMPLAINT LOG  
THIRD QUARTER 2022

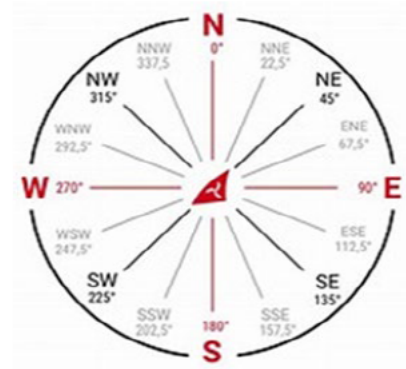
Complaint Reference # Q3-22-12

**Q3-22-12:** On 8/26/22 @11:27 AM, SPR's EHS Rep. received a call from a SCAQMD inspector regarding an odor complaint that was reported earlier that morning. The location was near Ladera Park., approximately 1.0 mile southeast of the IOF. The odor was described as a "petroleum-type smell". The SCAQMD inspector arrived on-site @11:44 AM, and was escorted by SPR Field Operations through sections of the field, south of Stocker St. and east/west of South Fairfax Ave. The inspector conducted a thorough inspection of the IOF, no odors or emissions were identified. Based on the site assessment, SPR's Meteorological (MET) Station data, and distance from the IOF, it was determined that the odor was not from SPR Operations.

Reference #	Date & Time	Reporting Party (R/P) Name (Last, First)	Phone #	Location	Complaint	CSD Reporting (EMAIL - Date/Time)
<u>Q3-22-12</u>	8/26/22 @11:27 AM	SCAQMD - Louie, Matthew		Near Ladera Park, 1 Mile SE of the IOF	Odor	Delatorre Email - 8/26/22 @11:44 AM
Comments/ Sentinel Peak Resources actions:	<ul style="list-style-type: none"><li>● Complaint: On 8/26/22 @11:27 AM, SCAQMD inspector contacted SPR's Sr. Environmental Scientist and indicated that they had received an odor complaint earlier that morning. The area was near Ladera Park, approx. 1 mile SE of the IOF. The odor was described as a "petroleum-type smell".</li><li>● SPR Response: SCAQMD did not provide the callers Information, therefore no return calls were conducted by SPR.</li><li>● SCAQMD Assessment: At 11:27 AM on 8/26/2022, the SCAQMD inspector contacted SPR Sr. Environmental Scientist, indicating that he was near the area of the odor complaint as described above and enroute to the IOF.</li><li>At 11:44 AM, The AQMD inspector arrived at the primary guard shack. The inspector met with SPR field operations staff. Although a follow up report was not received from the inspector, the SPR Operator Assessment below provides a summary of the inspection.</li><li>● SPR Operator Assessment: At 11:44 AM on 8/26/22, the SCAQMD inspector was onsite to investigate the odor complaint. The inspector said the complaint originated from the southeast portion of the field near Ladera Park. The person filing the complaint indicated that it was a petroleum odor that they have been smelling early in the morning for the past several weeks. SPR Operation's staff drove the inspector through sections of the field that are south of Stocker St. and east/west of South Fairfax Ave. (Stocker Side and 62-Setting Side). The inspector assessed the header system, the Stocker screw compressor, and the LAI tank setting along La Cienega Blvd. While at the Stocker header, the inspector thought he smelled an odor and scanned with a FLIR camera. The inspector also scanned the maintenance rig at injector well Stocker 6971 and indicated there was no visible sign of gas using the FLIR. The SPR Field Operator informed the inspector that maintenance rig work doesn't normally begin until after 8:00 AM in that area of the field. The inspection was completed with no issues discovered by the inspector and the inspector left the site at 12:33 PM.</li><li>● On-site MET Station: Hourly wind direction and wind speed are provided from 12 AM to 12 PM on 8/26/2022 via the SPR MET Station. Wind direction and speed throughout this timeframe ranged from the west southwest (WSW, 246.8°) to the west (W, 268.4°) from 3.0 to 9.3 mph. The overall average wind direction for this timeframe was out of the west southwest (WSW), 254.5°) at an average rate of 5.4 mph.</li><li>● Conclusion: Based on the site assessment, distance from the IOF, and MET Station data it was determined that the odor was not from SPR.</li></ul>

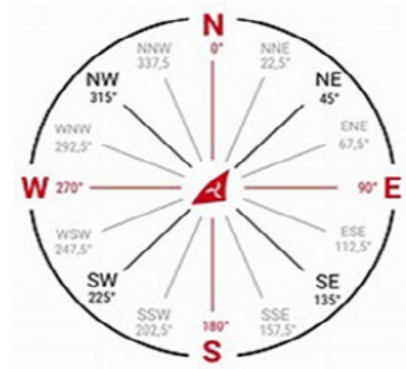
Complaint Reference # Q3-22-13

**Q3-22-13:** On 8/30/22 @11:00 AM, SPR's EHS Manager notified SPR's EHS Team that he had received a call from the R/P. The R/P was smelling a strong petroleum odor at her house, located at [REDACTED]. SPR's EHS staff assessed the offsite area between the IOF and the resident's address, possible other sources such as an asphalt road improvement operation by others were identified. SPR Operations conducted a thorough inspection of the IOF, no odors were found. Based on the site assessments, SPR's Meteorological (MET) Station data, and distance from the IOF, it was determined that the odor was not from SPR Operations.

Reference #	Date & Time	Reporting Party (R/P) Name (Last, First)	Phone #	Location	Complaint	CSD Reporting (EMAIL - Date/Time)
<u>Q3-22-13</u>	8/30/22 @11:00 AM	[REDACTED]	[REDACTED]	[REDACTED] 60th Street, Los Angeles	Odor	Delatorre Email - 8/30/22 @12:11 PM
Comments/ Sentinel Peak Resources actions:	<ul style="list-style-type: none"><li>● Complaint: On 8/30/22 @11:00 AM, [REDACTED] and The R/P contacted SPR's EHS Manager regarding an odor complaint. The R/P stated that she can smell a strong petroleum odor at her house, located at [REDACTED] 60th Street. It was also mentioned that 83 people had posted a similar experience on Next Door.</li><li>● SPR Response: On 8/30/2022 at 11:17 AM, SPR EHS Manager contacted SPR EHS staff and informed them of the odor complaint. He asked them to investigate and to call the R/P with their findings. At ~11:30 AM, EHS staff assessed the offsite area between the IOF and the R/P resident address, possible other sources such as an asphalt road improvement operation by others were identified. Again, there was no indication that the petroleum smell was coming from the IOF. SPR Sr. Environmental Scientist contacted the R/P and spoke to her at length. He indicated that SPR Operations were currently checking all of the equipment/operations in the IOF. However, SPR has not found anything emanating from the site. He also informed the R/P that in instances like this she should call the fire dept. (hazmat division) and provided her with the number [REDACTED]; The R/P asked SPR Sr. ES to also call [REDACTED] to inform him of SPR's findings.</li><li>At ~1:25 PM, SPR Sr. ES contacted [REDACTED] and provided him with an update, and a summary of his conversation with the R/P. He appreciated the follow-up and liked the suggestion of calling the fire dept. to have their hazmat division address the issue.</li><li>Follow-up: On 9/7/2022 at ~10:30 AM, SPR Sr. ES visited the R/P at her residence. The R/P stated that the odor was coming from her floor vent. SPR Sr. ES monitored her floor vent with a methane and VOC meter, there were zero readings from both meters. He informed the R/P that based on several phone calls he had with the fire Dept, and their hazmat division, the best thing to do in this situation is to call 911. The R/P stated that she did not want to take that approach.</li><li>● SPR Operator Assessment: SPR Operation's inspected the IOF and no odors were identified.</li><li>● On-site MET Station: Hourly wind direction and wind speed are provided from 4 AM to 12 PM on 8/30/2022 via the SPR MET Station. The overall average wind direction for this timeframe was out of the west southwest (WSW), 248.2° at an average rate of 5.2 mph.</li><li>● Conclusion: Based on the site assessments, distance from the IOF, and MET Station data it was determined that the odor was not from SPR.</li></ul>
