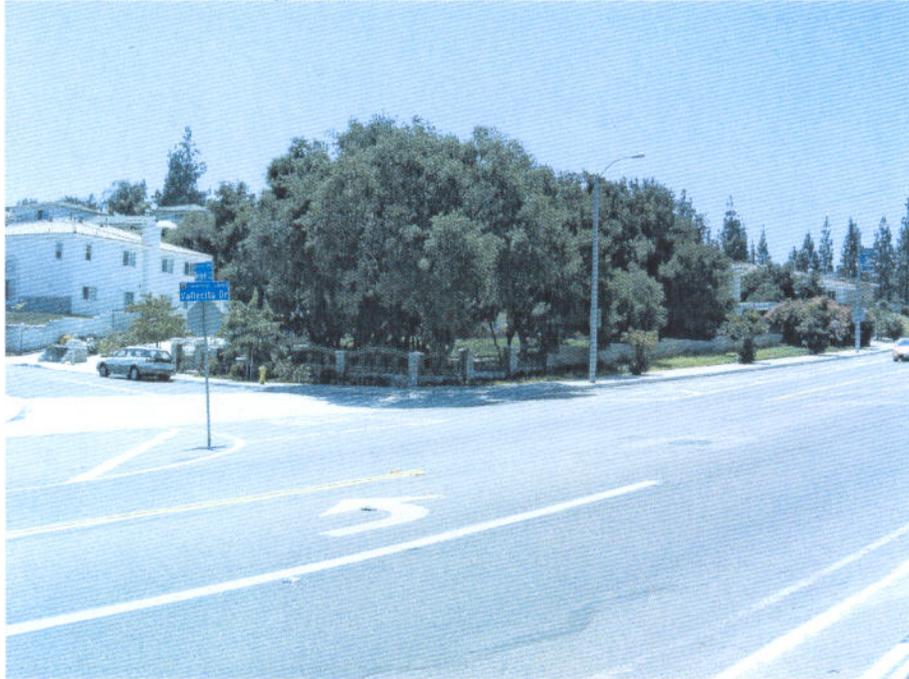
Photo A looks south to the grove of Coast Live Oak trees.

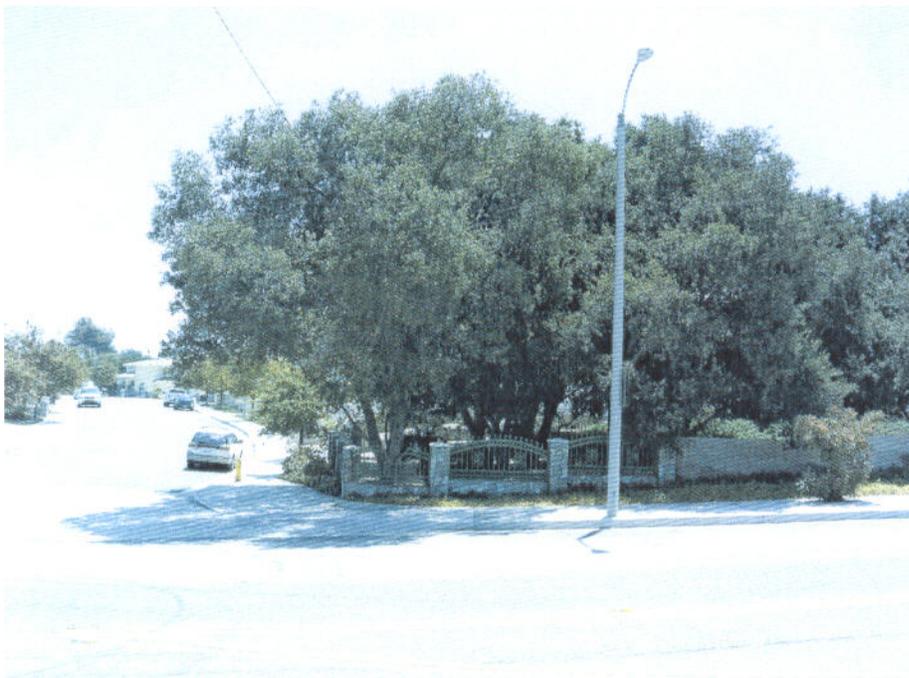
Photo B looks east to the grove of Coast Live Oak trees. These trees form a continuous canopy. Four trees were heavily cut back.

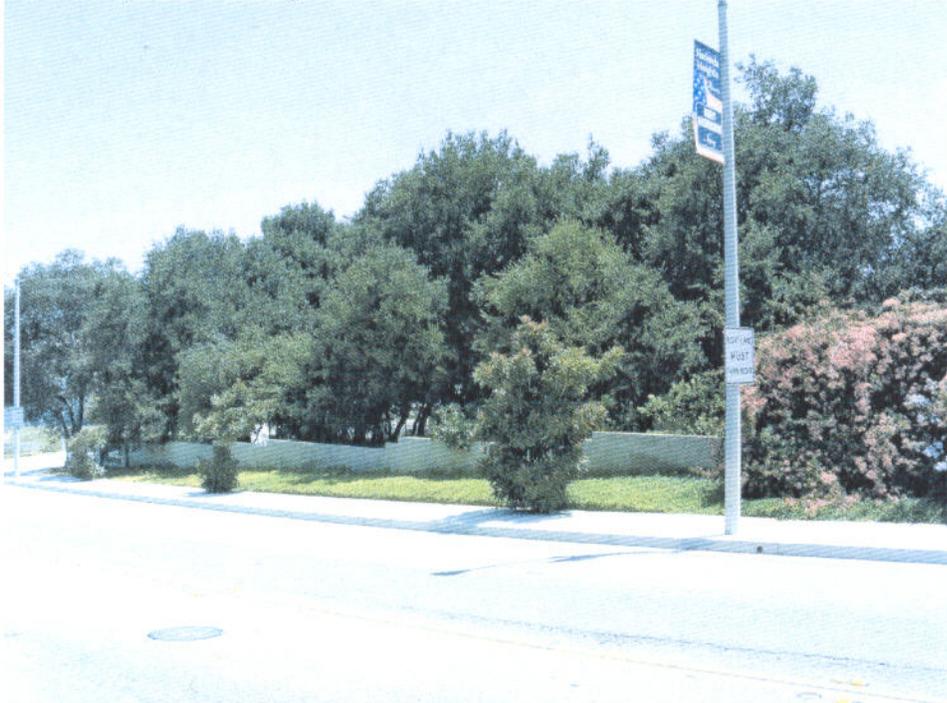
Photo C looks north east and shows the area where four west facing trees were apparently cut back to provide more sunlight to landscape trees and plants beneath.

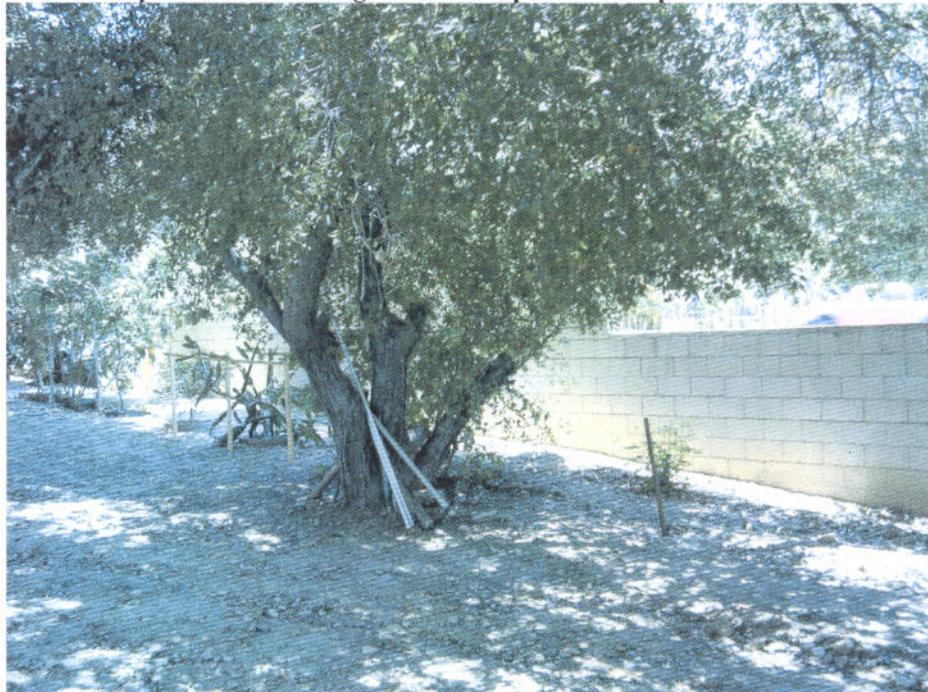
Photo D shows Oak #12 cut back on the right side.

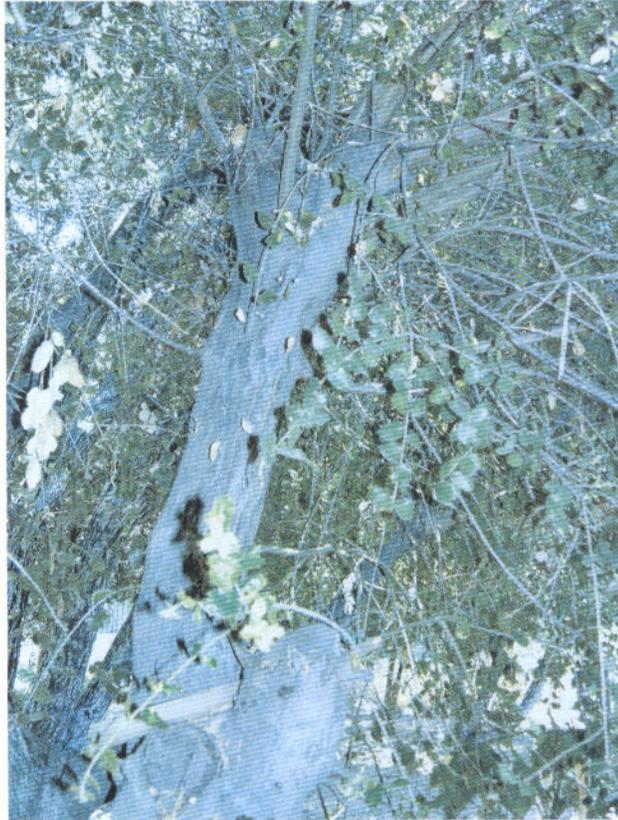
Photo E shows poor cuts on Oak #12. Branches of 7, 6, 6, 6 and 5 inches estimated diameter are removed. Restoration pruning is recommended.

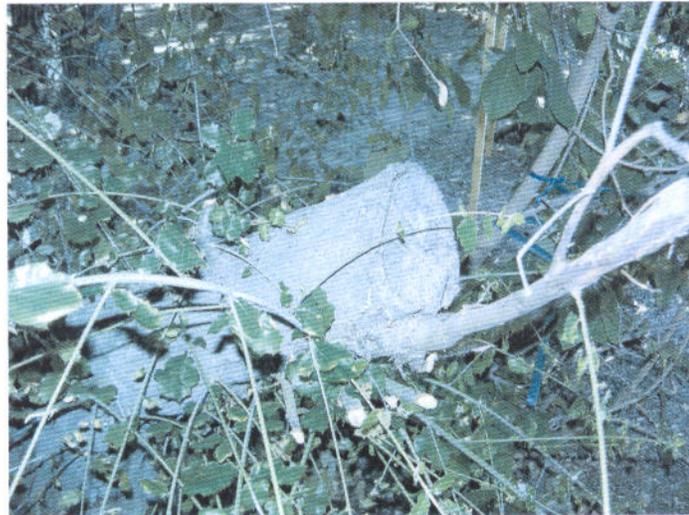
Photo F shows re-growth at one of the Oak #12 branch cuts and continued cutting of sprout growth.

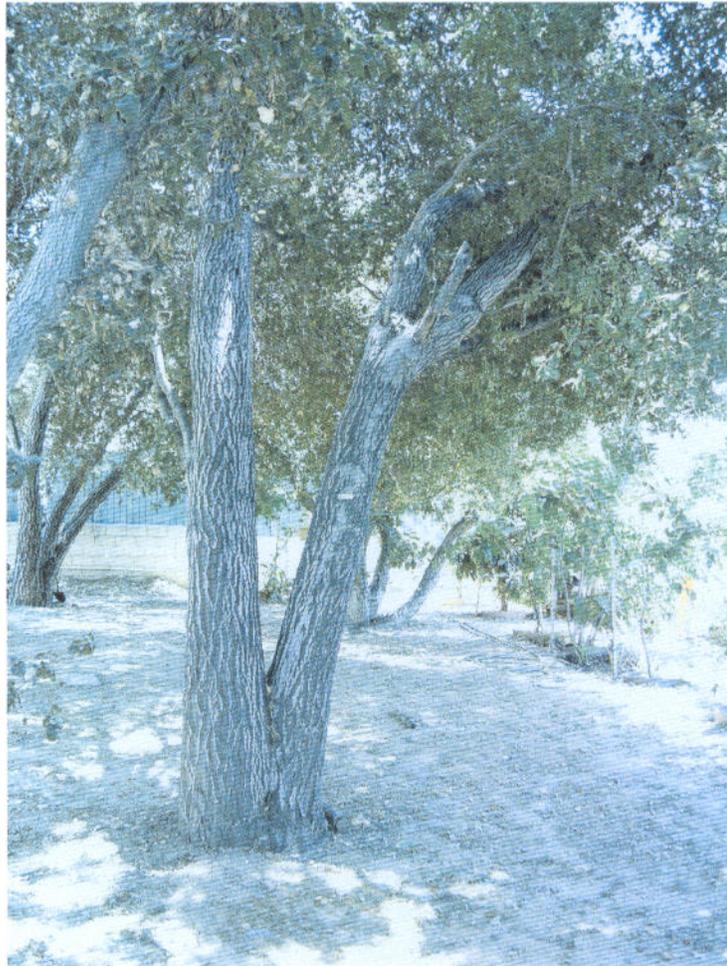
Photo G shows Oak #13. One 6 inch diameter branch and two 2 inch diameter branches are removed.

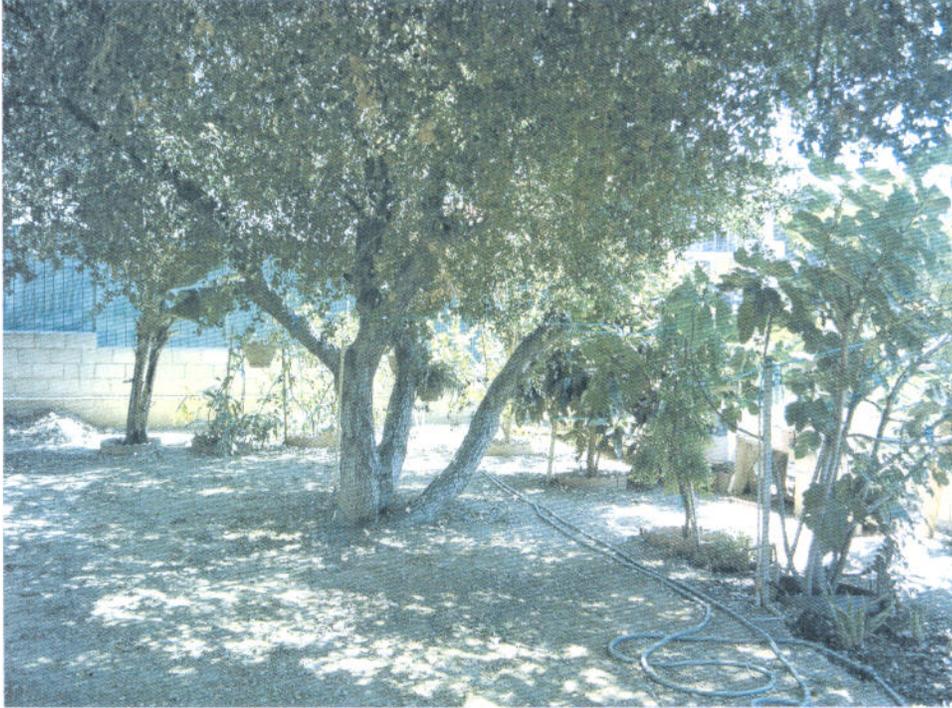
Photo H shows Oak #16 with 7, 6, 4, 4, 4 & 3 inch branches removed.

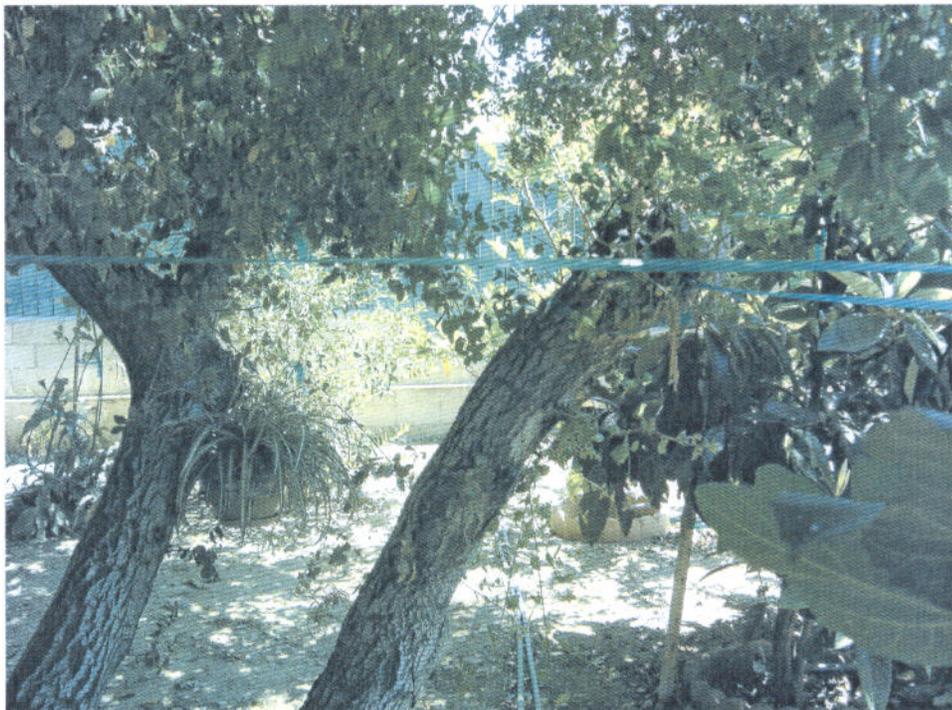
Photo I shows a closer view of a stubbed branch on Oak #16.
This branch may never regain its full size again.

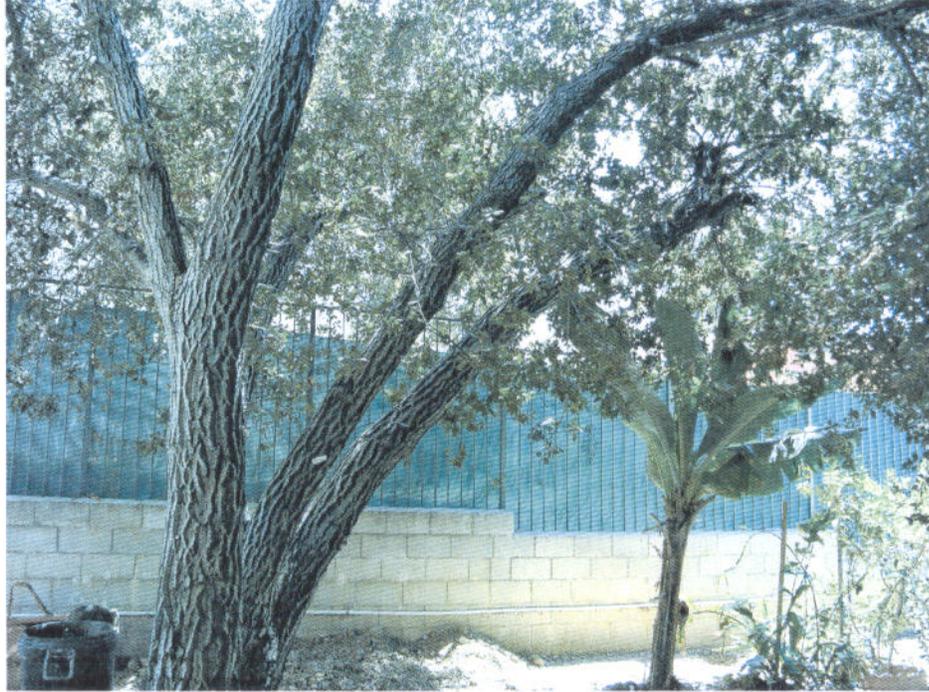
Photo J shows Oak #18. The lowest branch was cut back.

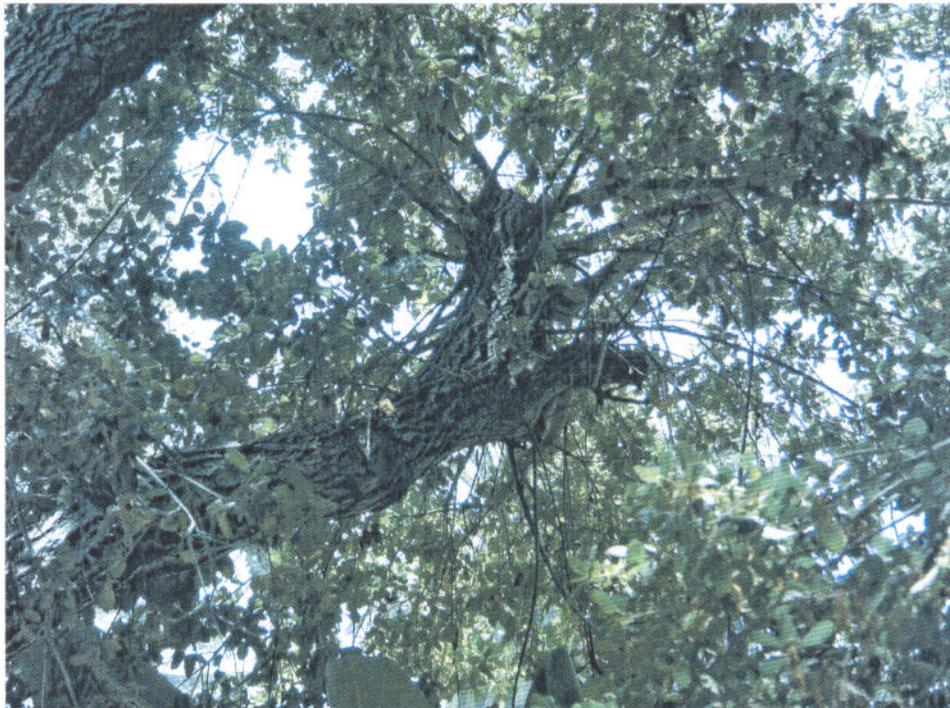
Photo K shows removed branches of 7, 3, and 2 inches estimated on Oak #18.
