# SUNSHINE CANYON LANDFILL

Subject: Report to the Joint Sunshine Canyon Landfill Technical Advisory Committee

Subject: Report of Geologic Observations  
Ground Movement of Temporary Construction Slope  
Sunshine Canyon City/County Landfill,  
Sylmar, California

RE: Earthwork and Drainage Repairs  
March 20, 2011 Rainfall Event

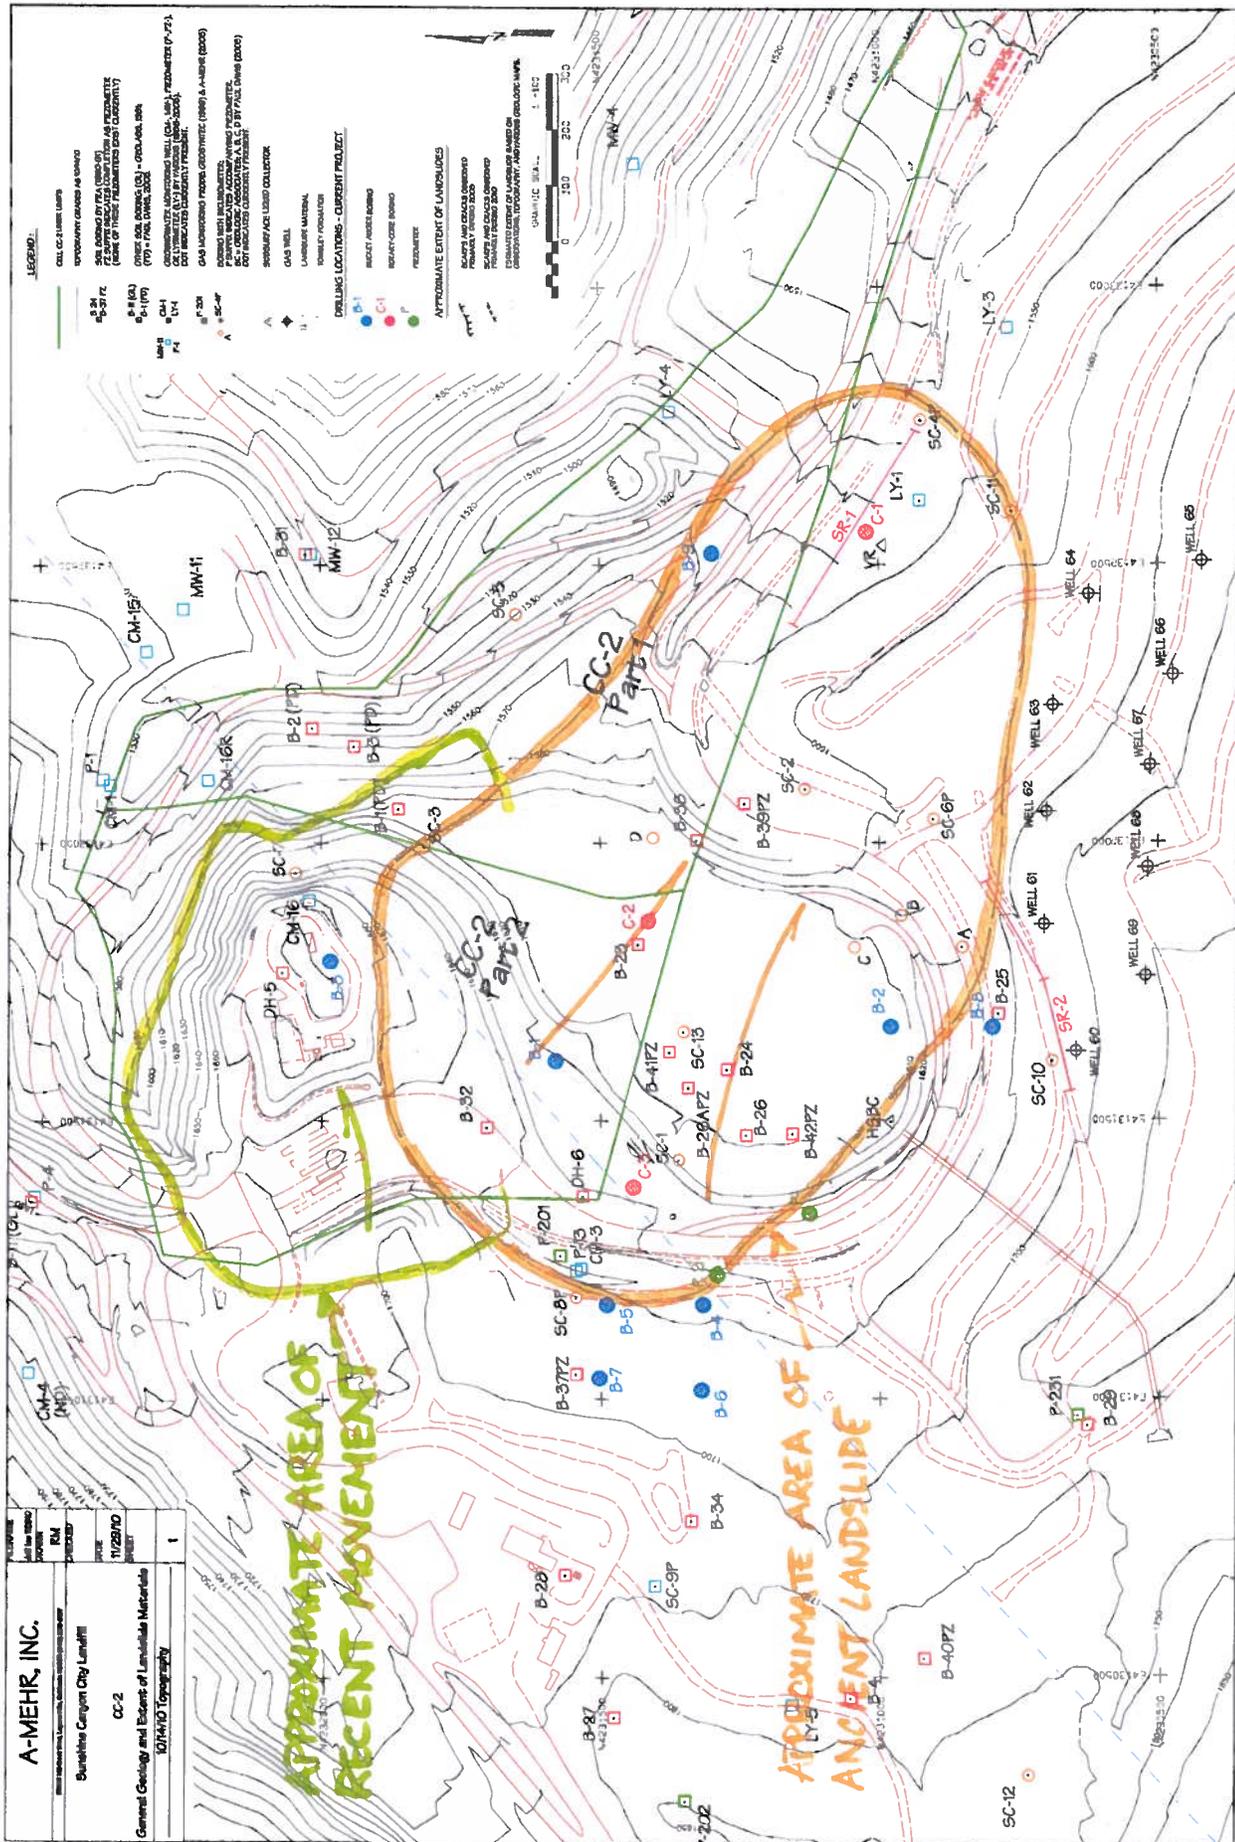
At about 2:30 pm on January 11, 2011, the A-Mehr geologist noted movement near the northern end of the excavation area floor. Movement was primarily to the east and continued overnight. The attached Figure 1 shows the approximate extent of the movement. As shown in the figure, the area of movement covers approximately seven acres. Based on the character of the graben structure along the head scarp, and observations of offset surface features at the toe of the movement, we tentatively estimate that horizontal (easterly-directed) movement was on the order of 20 feet. Vertical offset is estimated to be on the order of 5 to 10 feet.

<b>A-MEHR, INC.</b>	
Project Name	RM
Client	11/28/10
Scale	AS SHOWN
Drawn by	RM
Checked by	RM
General Geology and Extent of Laminated Materials	CC-2
10/11/10 Topography

A-Mehr will prepare a report summarizing the results of the above investigative activities. The report will provide recommendations regarding procedures for completing the planned permanent removal of the affected movement area including maintenance of 2:1 grades in all remaining temporary construction slopes.

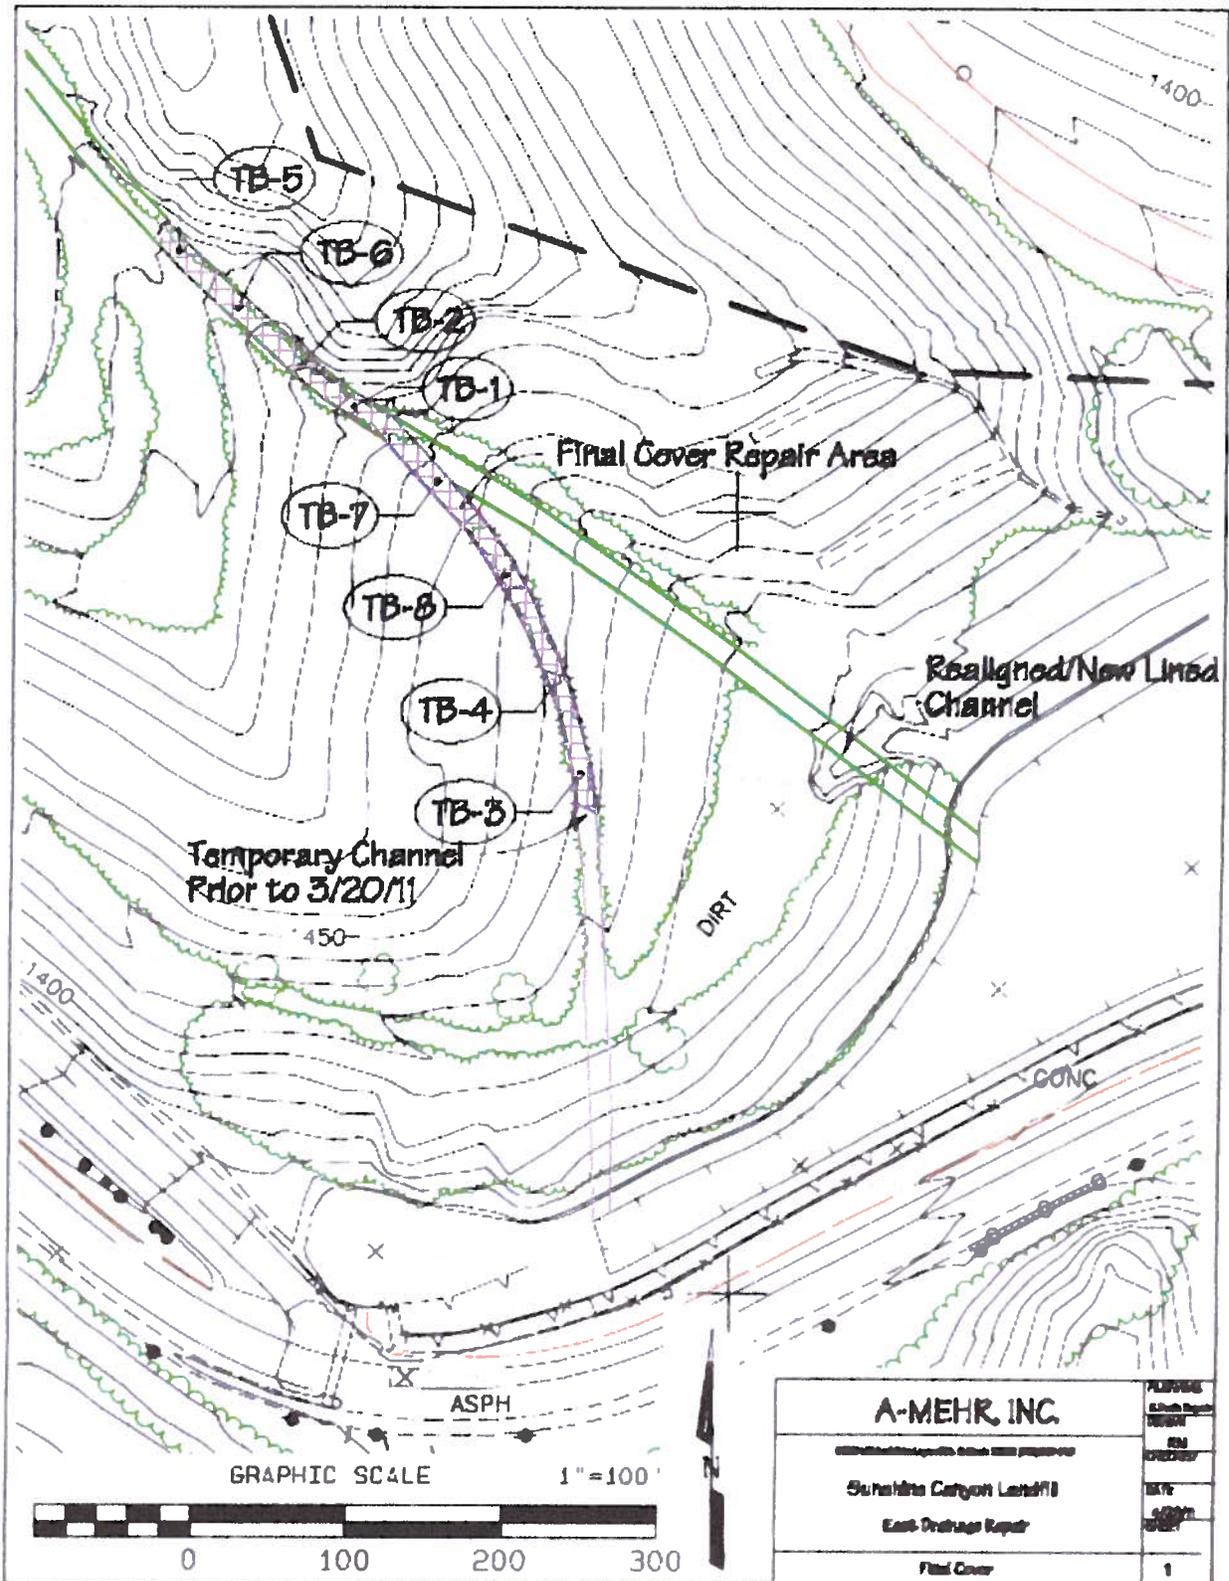
- A section of the temporary east drainage channel extending from the terminal sedimentation basin to approximately 500 feet up the slope of the closed City Landfill was damaged. The HDPE liner had been blown away and the underlying soil was eroded, exposing some refuse. We estimate the area of erosion averaged about 10 feet wide, with the area of refuse exposure averaging approximately 2 feet wide. Figure 1 shows the general area of the temporary channel and location of the damaged section.
- Mud, and apparently some refuse from the eroded area, was washed into the area above the terminal sedimentation basin.

<b>A-MEHR, INC.</b>		<small>PROJECT</small> <small>Client Name</small> <small>NO. 12345</small>
Sunahita Canyon Landfill		<small>DATE</small> <small>1/20/11</small>
East Drainage Repair		<small>SCALE</small> <small>1" = 100'</small>
Final Cover		<small>NO.</small> <small>1</small>

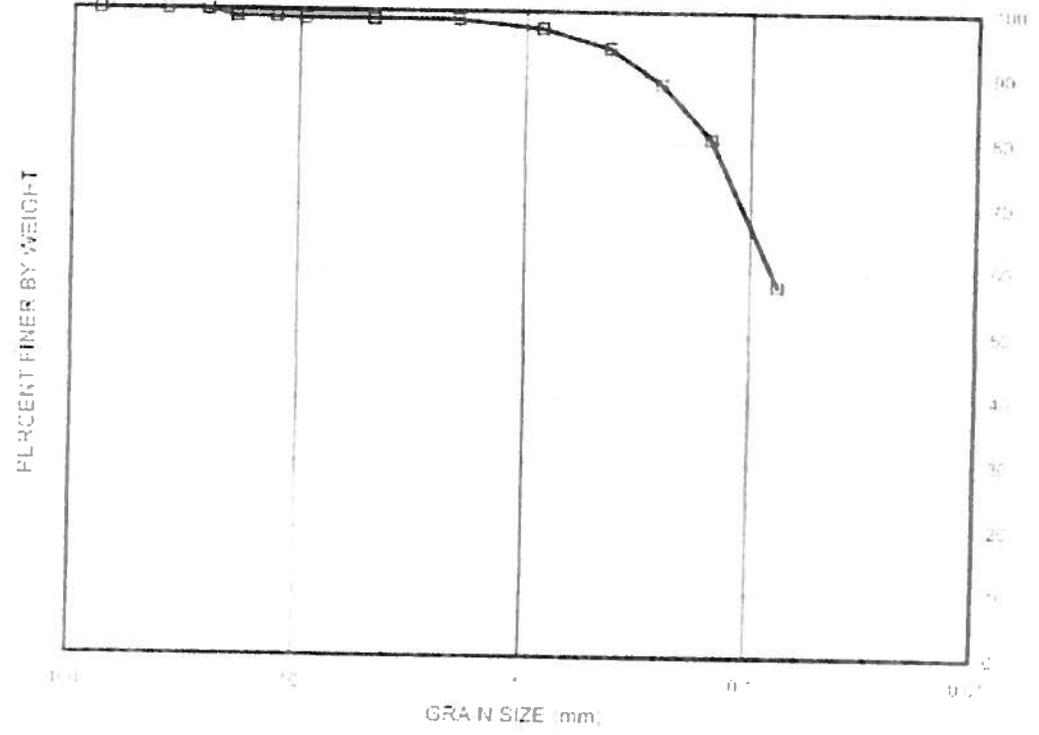
GRAVEL		SAND		SILT OR CLAY
75 μm	4.75 mm	75 μm	4.75 mm	75 μm

3" 1" 1/2" 3/4" #4 #10 #20 #40 #60 #100 #200

SYMBOL	BORING NO	SAMPLE NO	DEPTH (FT)	SAMPLE TYPE	SOIL TYPE	LIQUID LIMIT	PLASTICITY INDEX
U	N/A	TB-1	N/A	Full	Cl	30	10

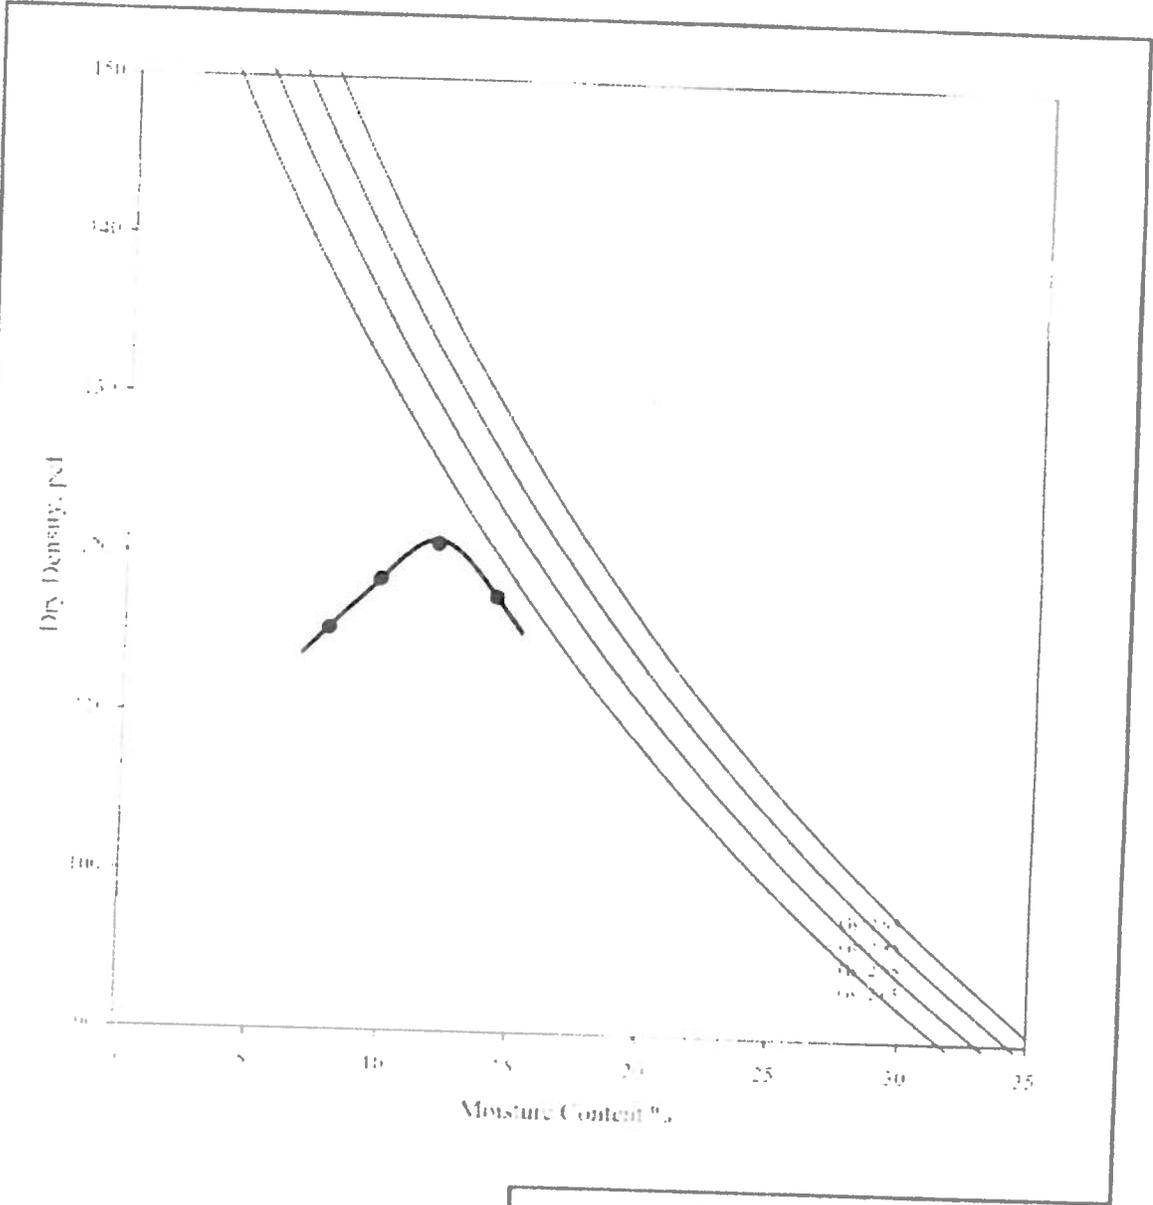
Maximum Dry Density = 121 pcf		Boring No: N/A	
Optimum Moisture Content = 12 %		Sample: 1B-1
