**Subject: Results of 2011 Focused Least Bell's Vireo Survey**

**JURISDICTIONAL DELINEATION  
(EXISTING CONDITIONS)  
FOR  
GRAND AVENUE/SR-60 CONFLUENCE PROJECT  
CITY OF INDUSTRY, LOS ANGELES COUNTY, CALIFORNIA**

# State Route 57/State Route 60 Confluence at Grand Avenue Project Grand Avenue Interchange and Confluence Improvements

## Natural Environment Study

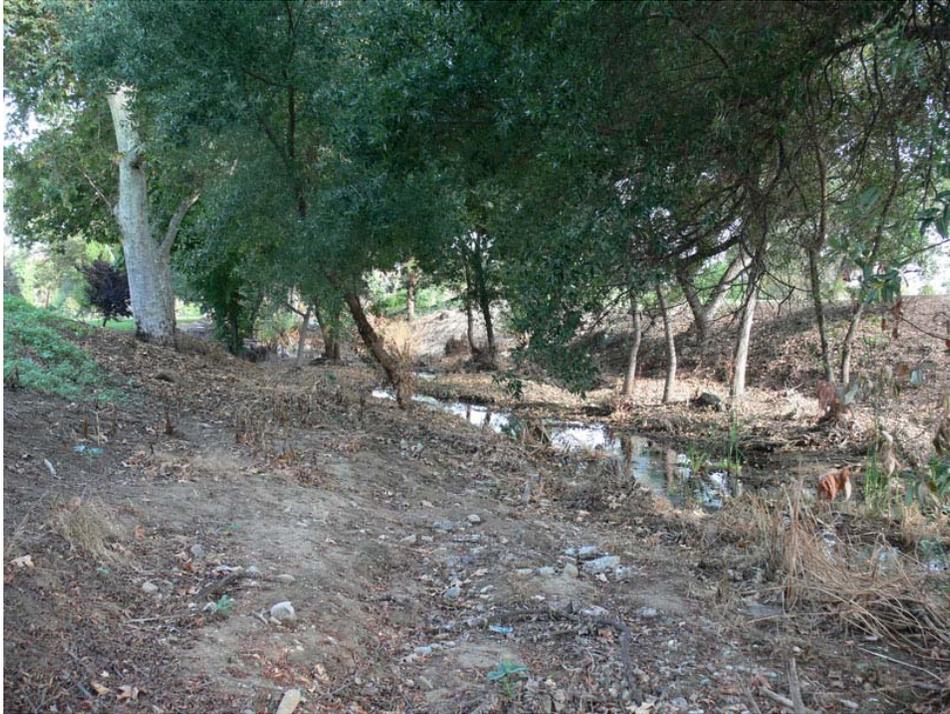
This view shows typical habitat within the western golf course survey area.

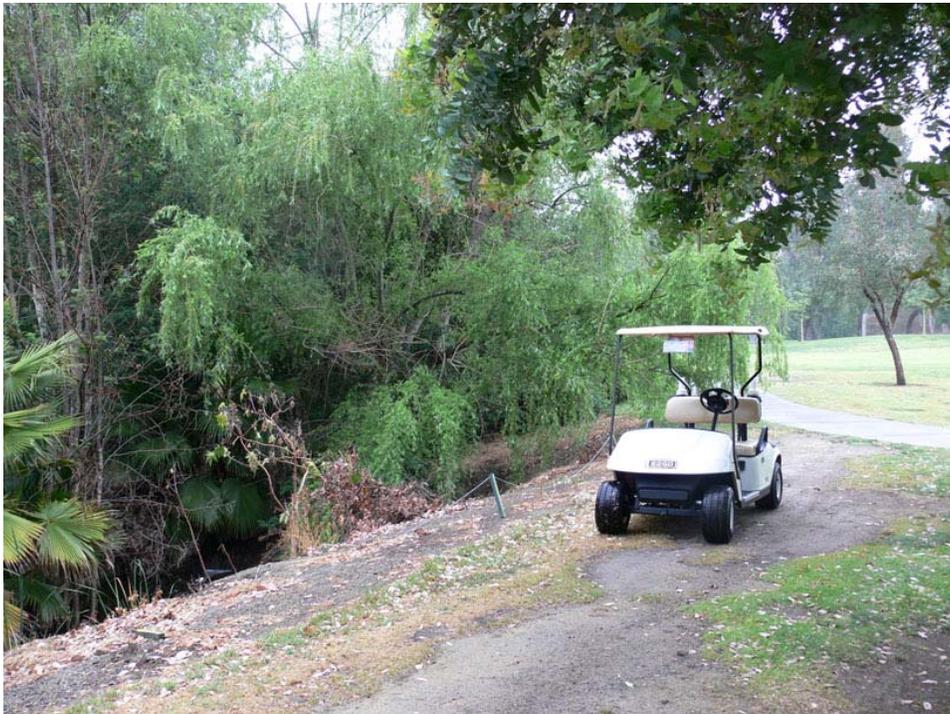
This view shows the central golf course survey area

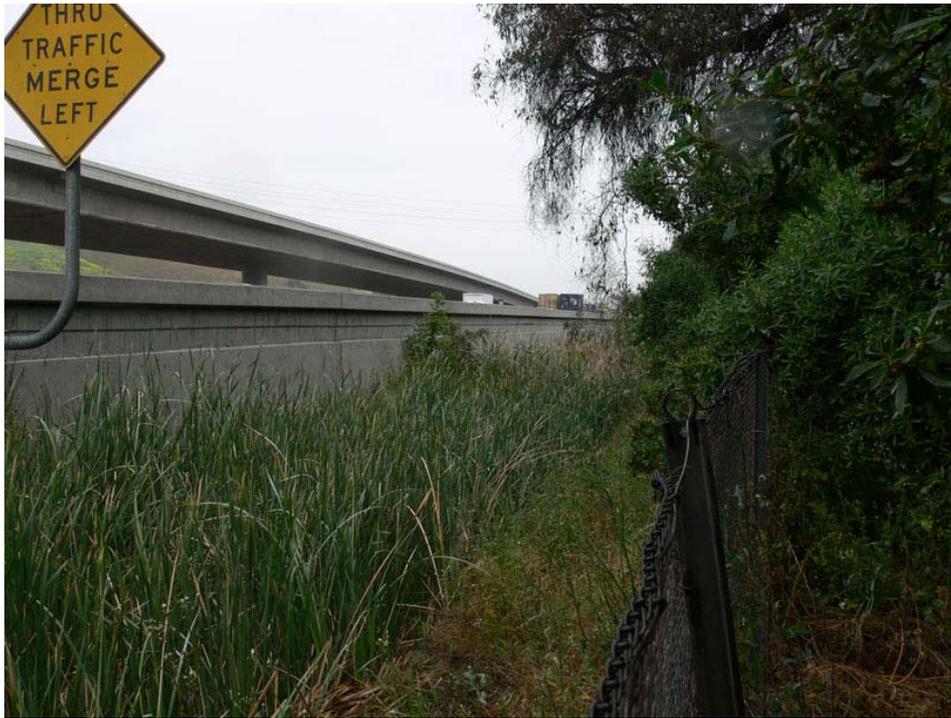
This view shows the dominant vegetation in the eastern half of the western golf course survey area adjacent to the freeway.

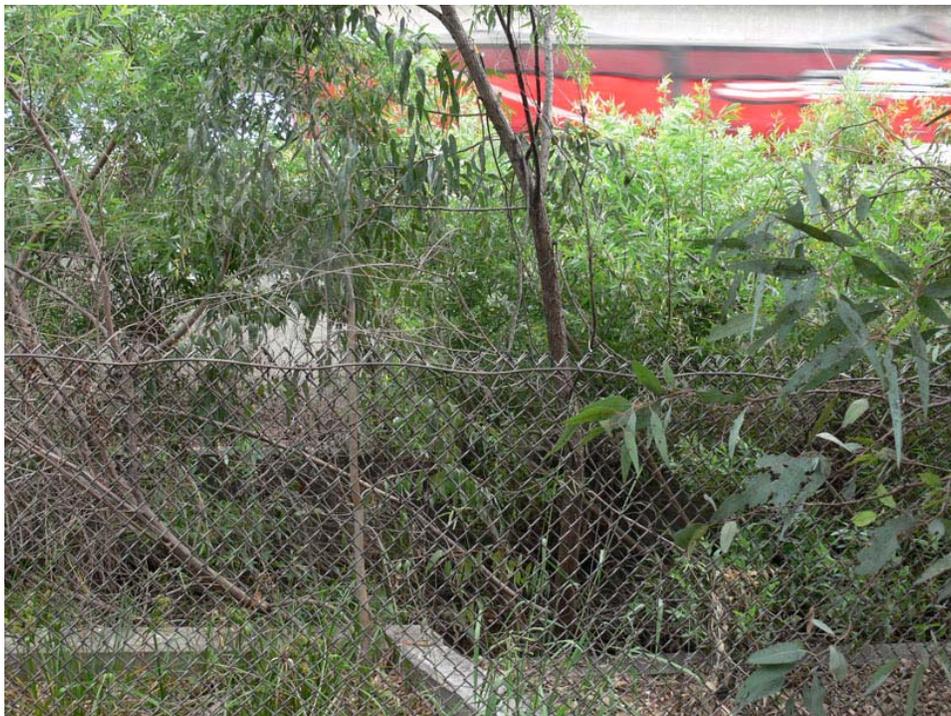
This view shows vegetation more typical of the western half of the golf course western survey area.

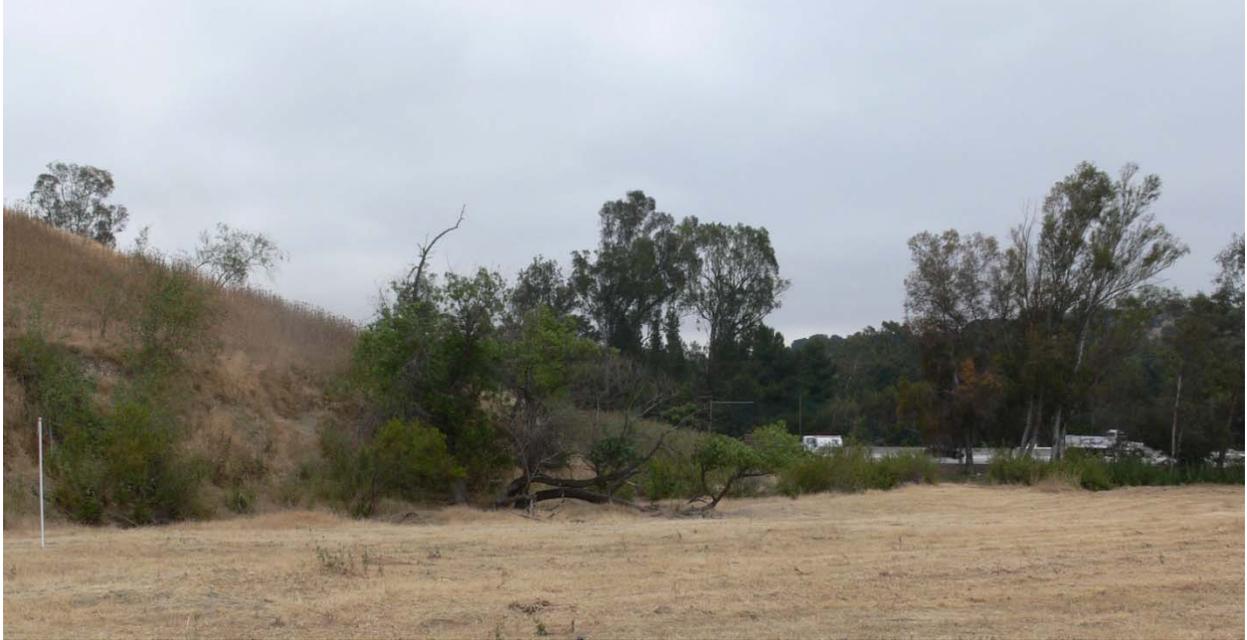
This view shows the eastern half of the ramp survey area as seen looking to the south with the freeway behind.

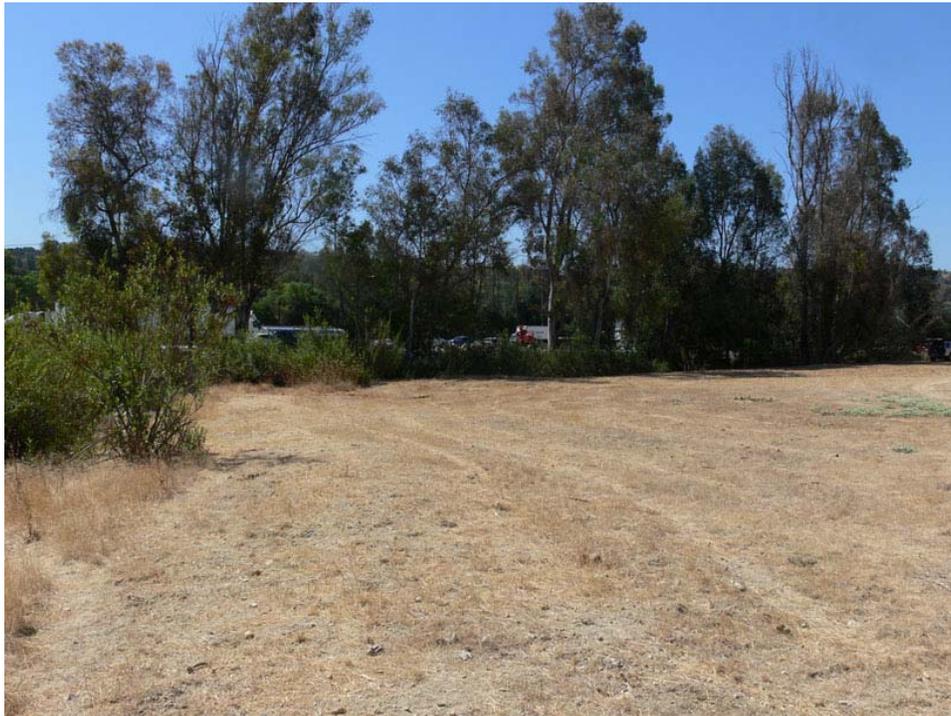
This view shows the eastern portion of the ramp survey area with its canopy of eucalyptus trees.

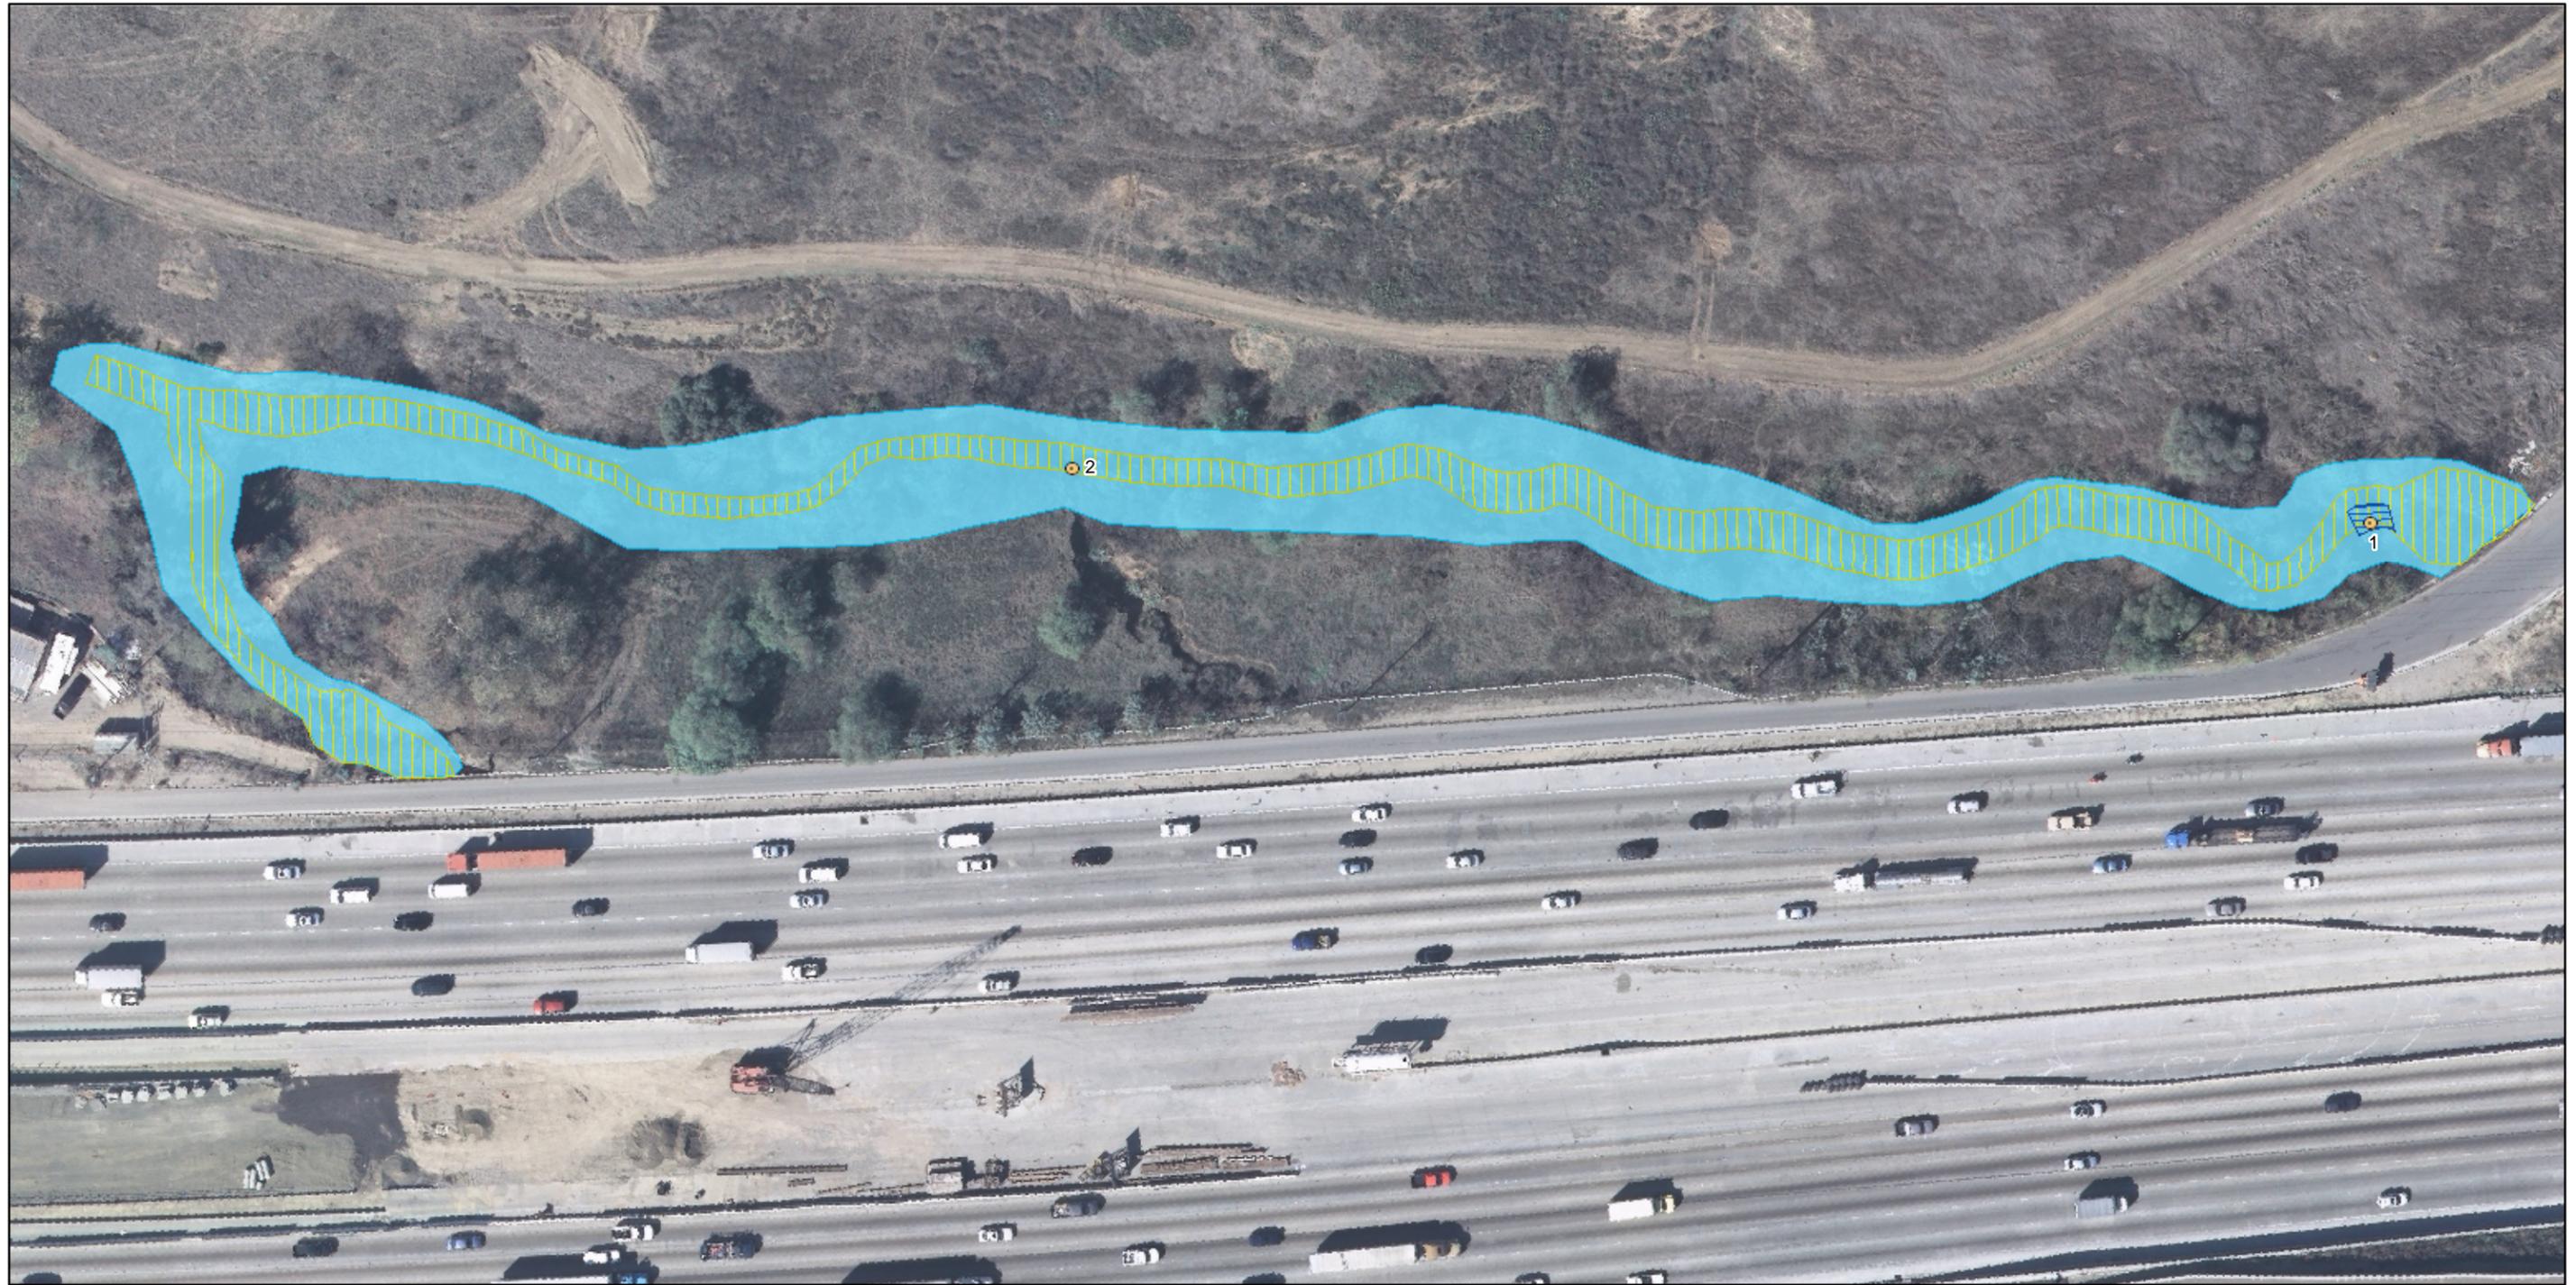
**Exhibit 2**  
**Diamond Bar Creek**  
**Jurisdictional Delineation**

| <b>Authority</b> | <b>Wetland</b> | <b>Dripline/Bank to Bank</b> | <b>OHWM</b> | <b>Total</b> |
|---|---|---|---|---|
| CDFG | 0.661 | 3.597 | 0 | 4.258 acres |

- There are **0.661** acres (**1519.56** linear feet) of wetlands within the survey area. All wetlands are under the joint jurisdiction of the CDFG, USACE, and the RWQCB. Wetlands were found in five separate locations in the survey area within the Relatively Permanent Water of Diamond Bar Creek and its tributaries.

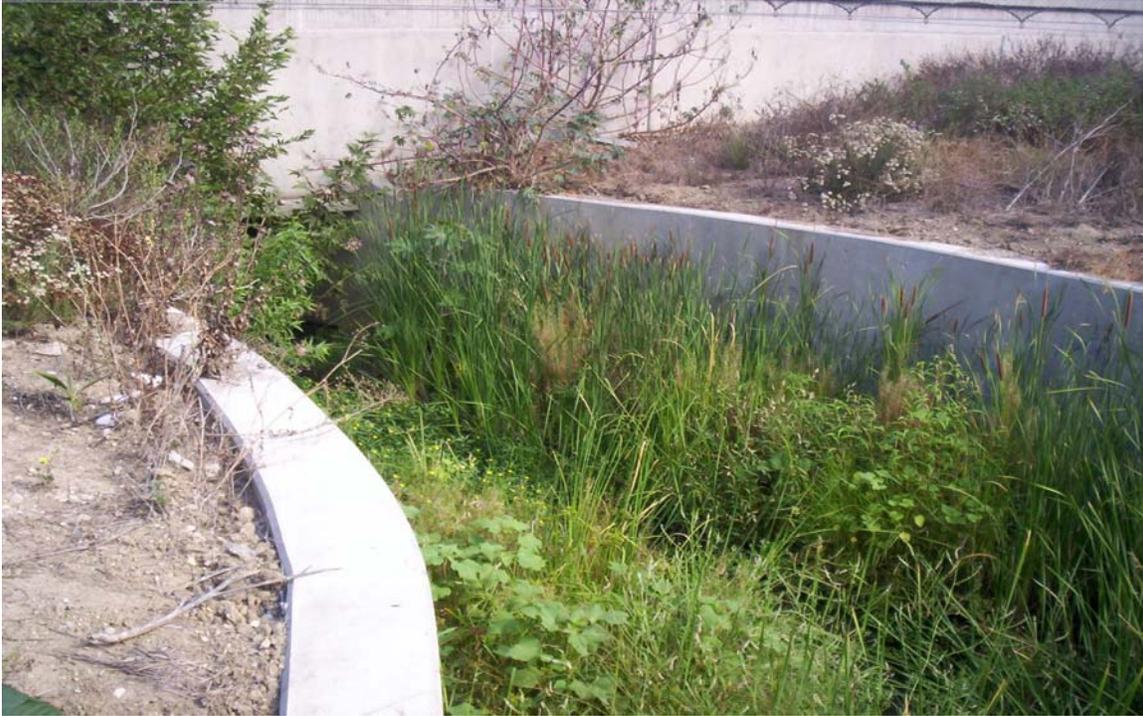
**Photo 1:** Wetland vegetation confined within concrete walls on Diamond Bar Creek at the underpass of SR-57/60 on Diamond Bar Golf Course (Exhibit3).

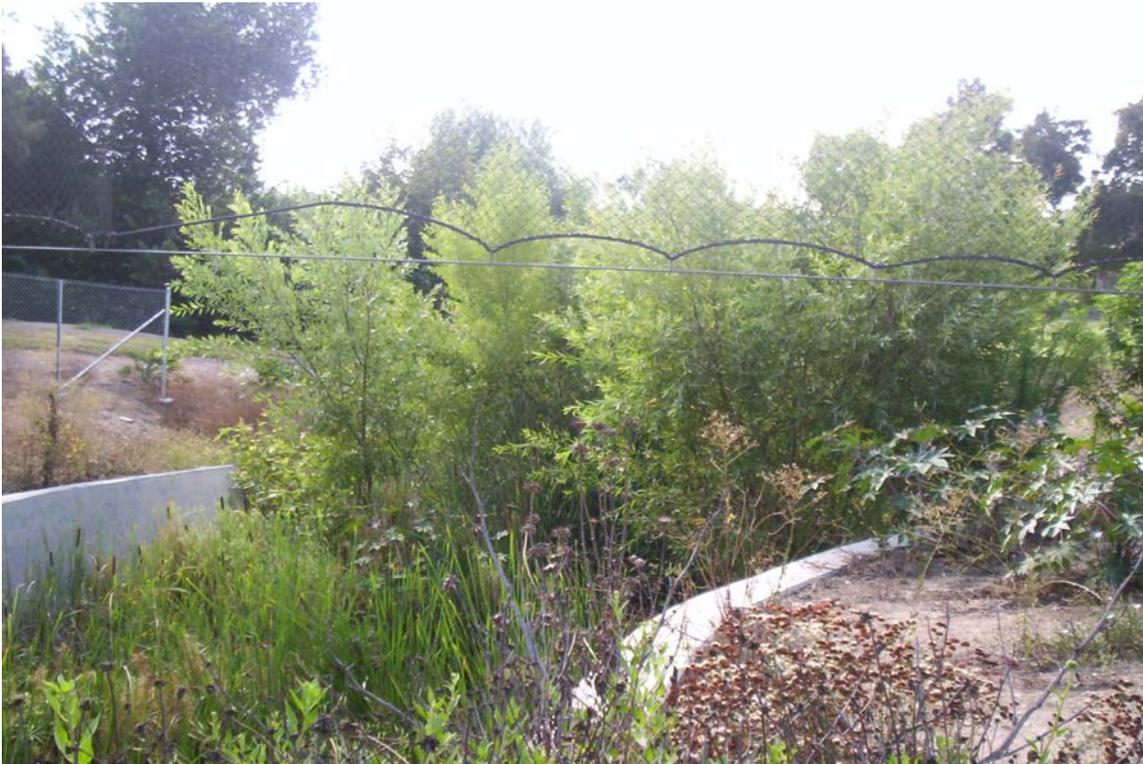
**Photo 2:** View upstream from the SR-57/60 underpass along Diamond Bar Creek into Diamond Bar Golf Course. Note prominence of wetland and young woody riparian growth (Exhibit 3).

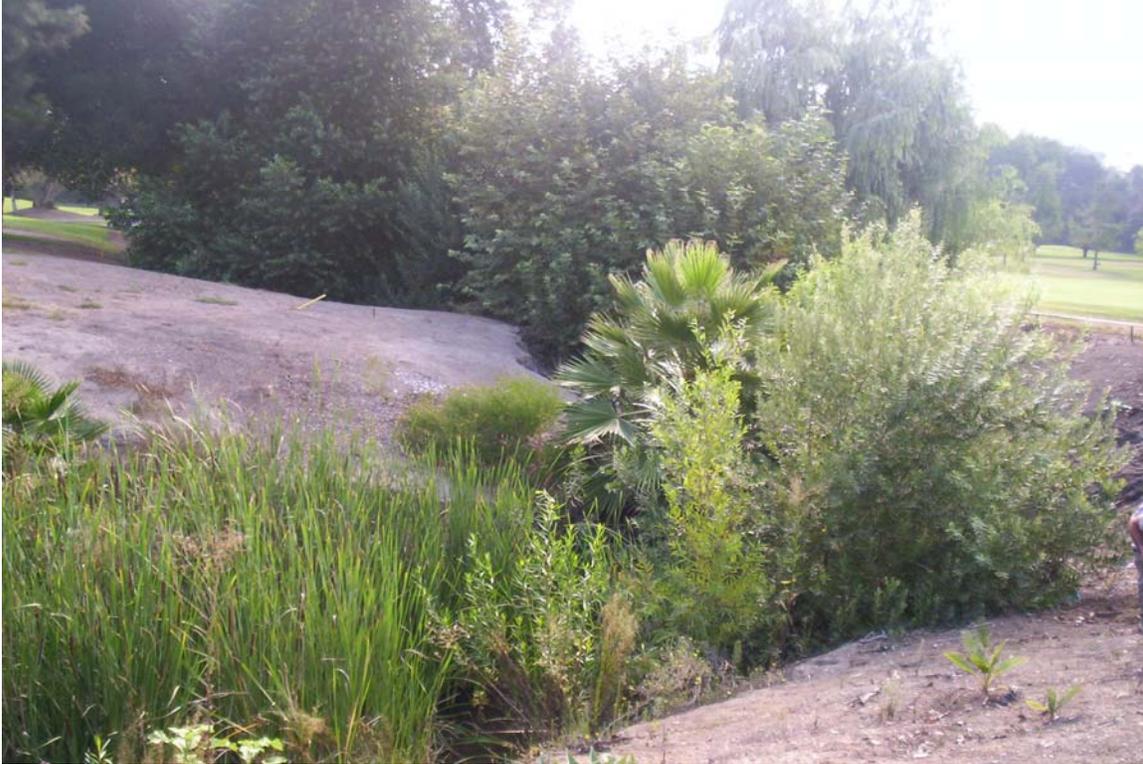
**Photo 3:** View upstream along Diamond Bar Creek from fill slope of Diamond Bar Golf Course (Exhibit 3). Note young woody riparian growth and cattails in foreground and the older, more mature riparian growth in the background.

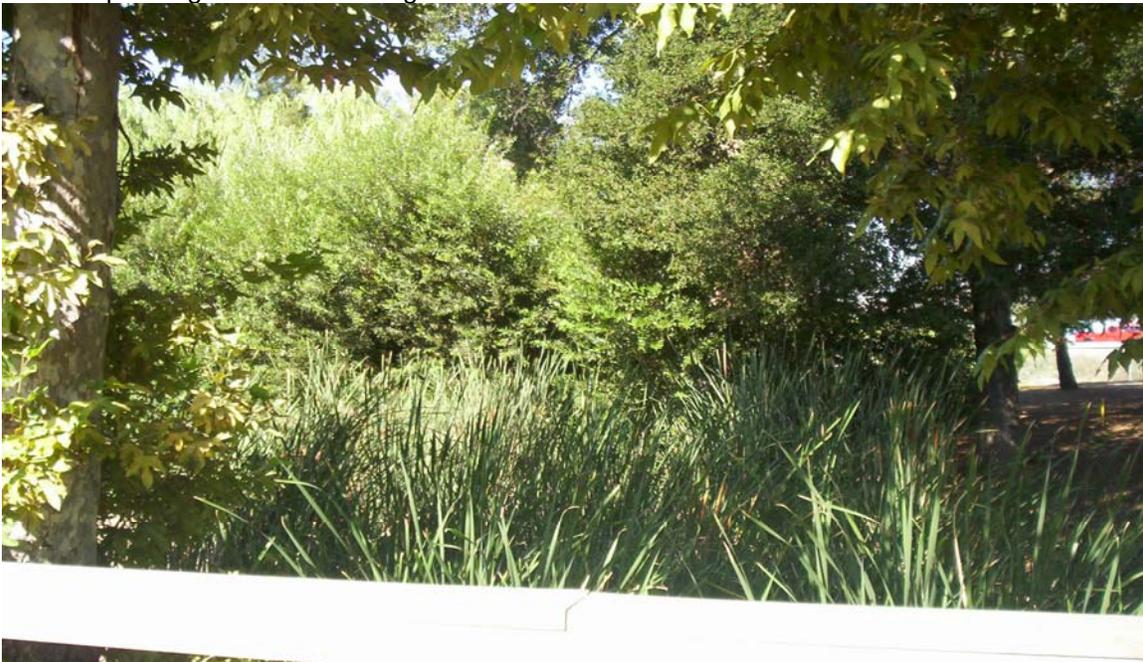
**Photo 4:** View downstream along Diamond Bar Creek from golf cart bridge. Note continuous coast live oak canopy with the streamside riparian vegetation (Exhibit 3).

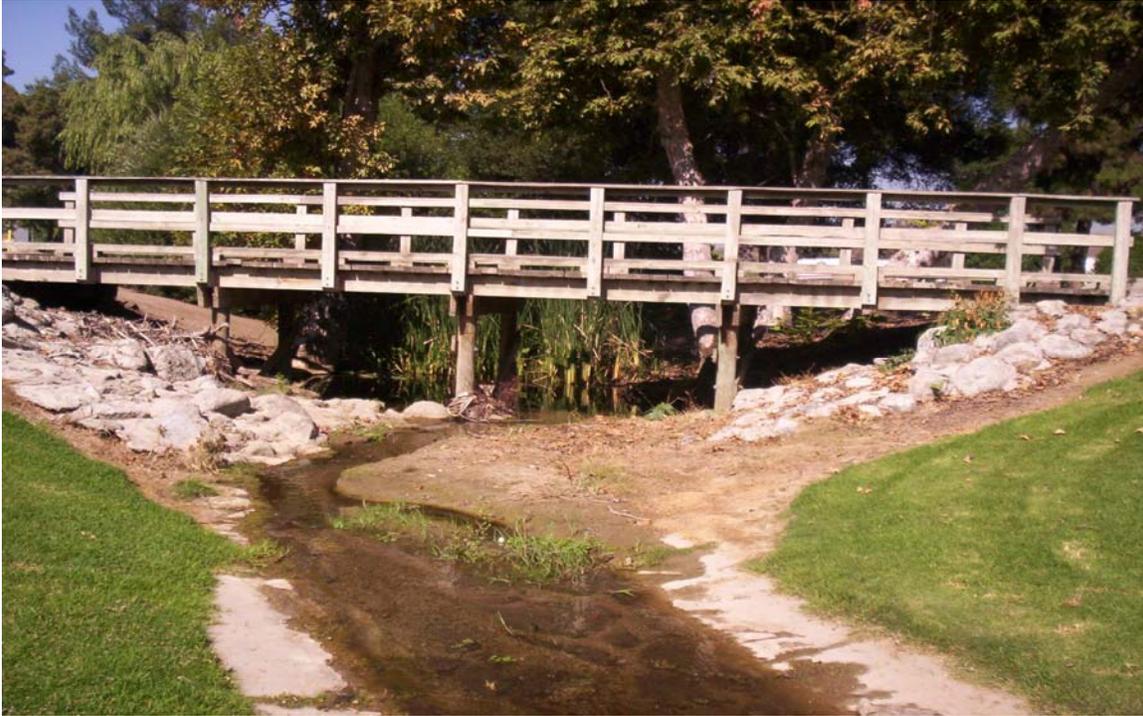
**Photo 5:** View downstream from RWQCB jurisdictional concrete ditch showing golf cart bridge and downstream wetland vegetation in Diamond Bar Creek (Exhibit 3).

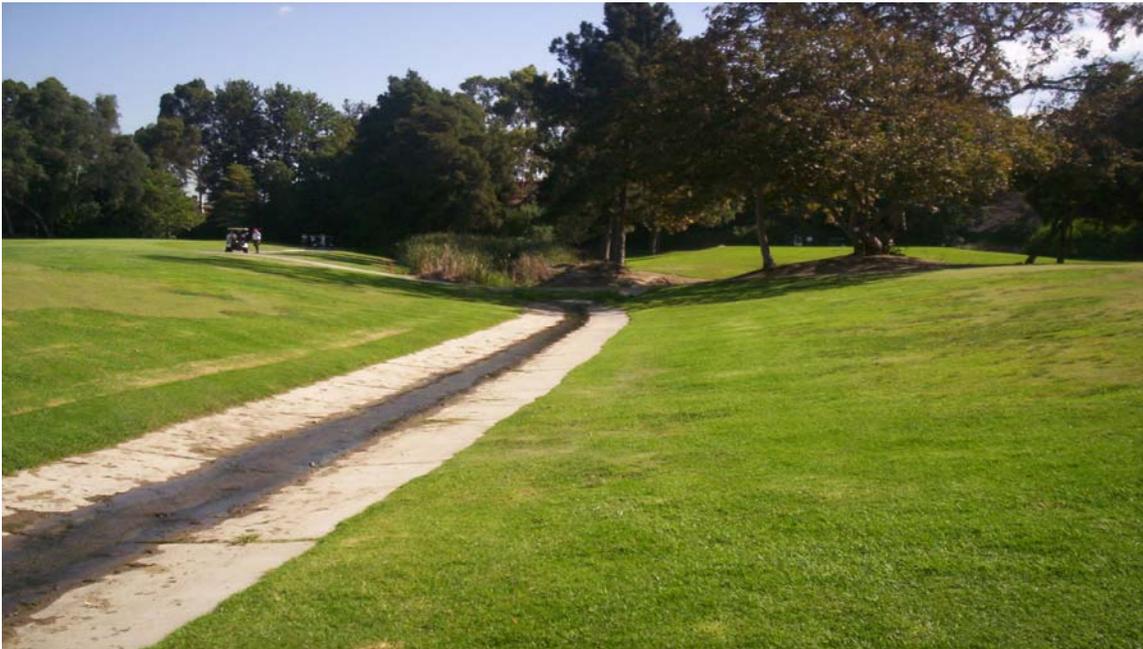
**Photo 6:** View upstream along RWQCB jurisdictional concrete ditch within Diamond Bar Creek (Exhibit 3). Note presence of flowing water and cattail-dominated wetland in the background.

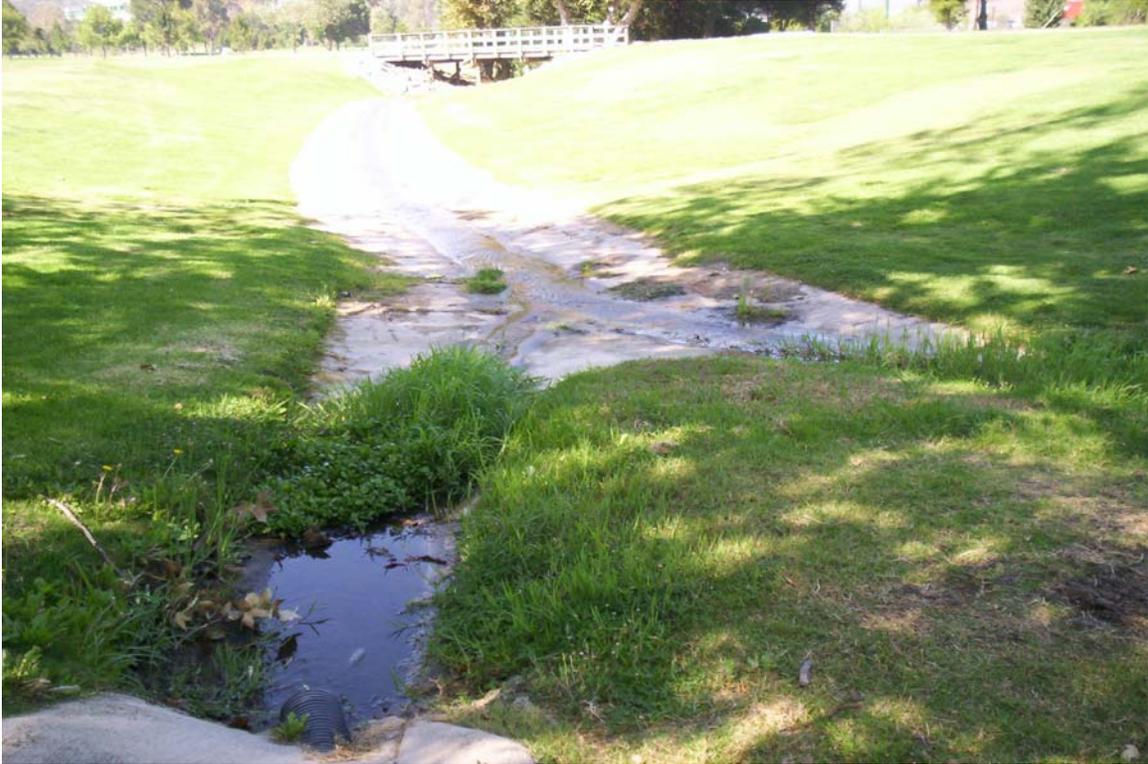
**Photo 7:** View downstream along RWQCB jurisdictional concrete-channelized portion of Diamond Bar Creek from fork adjacent to golf cart path (Exhibit 3).

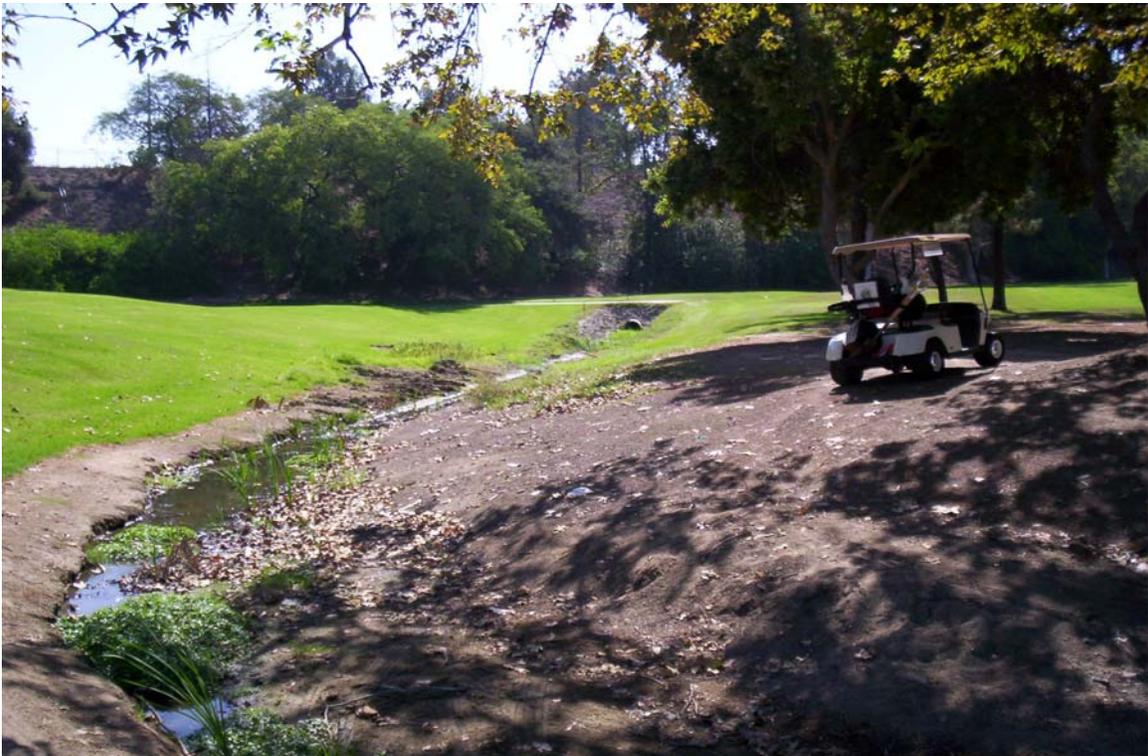
**Photo 8:** View upstream from fork at golf cart path of Diamond Bar Creek tributary (Exhibit 3). Note presence of water, landscaped surrounding banks, and drainage pipe in the background.

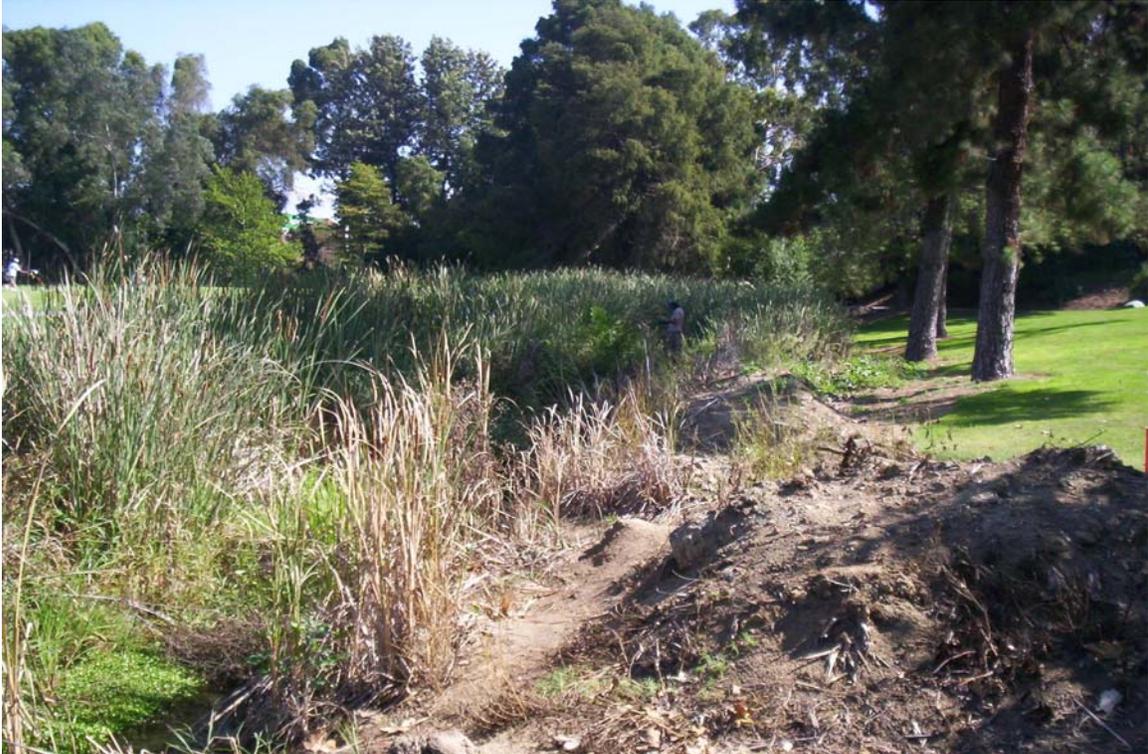
**Photo 9:** View upstream of cattail-dominated wetland section within Diamond Bar Creek (Exhibit 3). Note dumped soil and landscape trimmings at the edge.

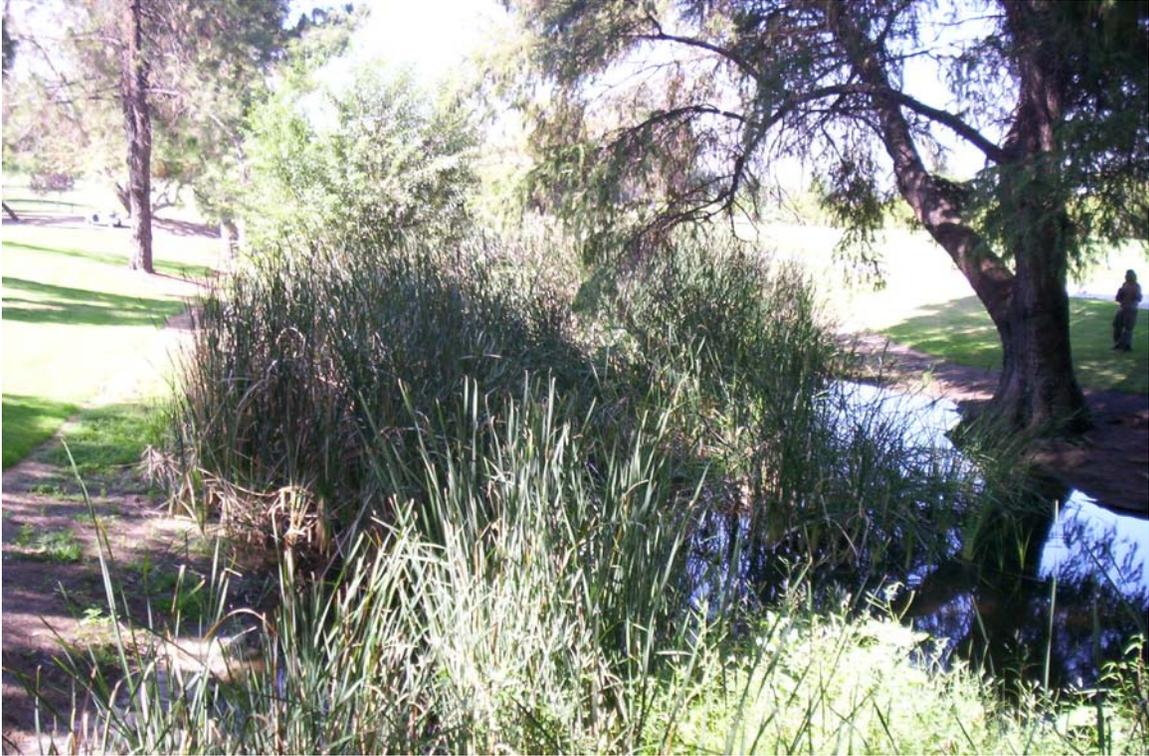
**Photo 11:** View downstream along cattail-dominated section of Diamond Bar Creek taken from golf cart path above box opening (Exhibit 3).

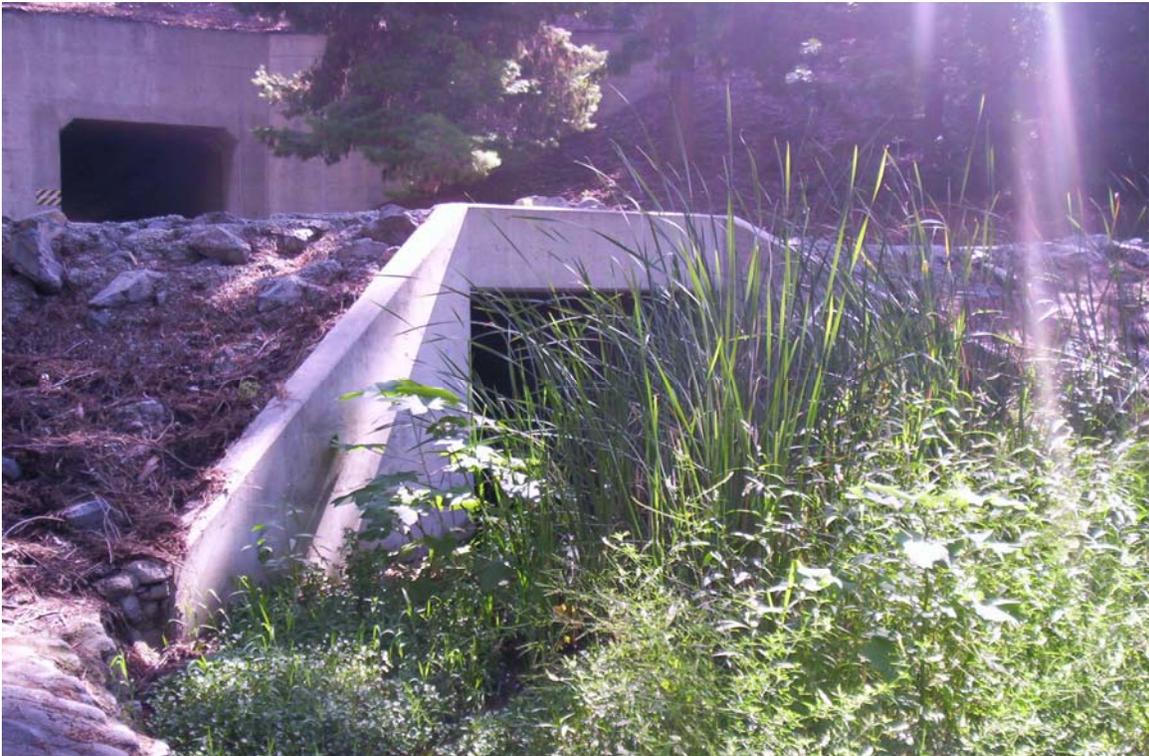
**Photo 12:** View of wetland vegetation and box opening at upstream edge of the cattail-dominated wetland section of Diamond Bar Creek (Exhibit 3).

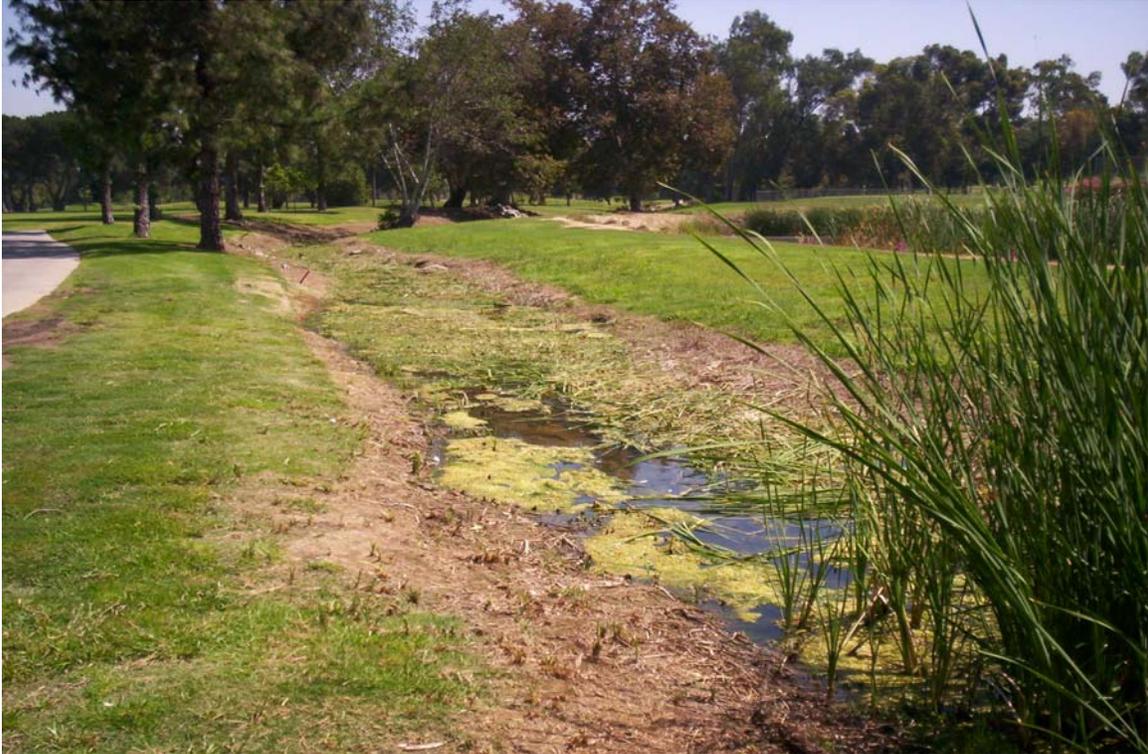
**Photo 13:** View of cattail-dominated wetland section of Diamond Bar Creek east of Grand Avenue (Exhibit 4). Note standing vegetation, algae, water, and cut vegetation.

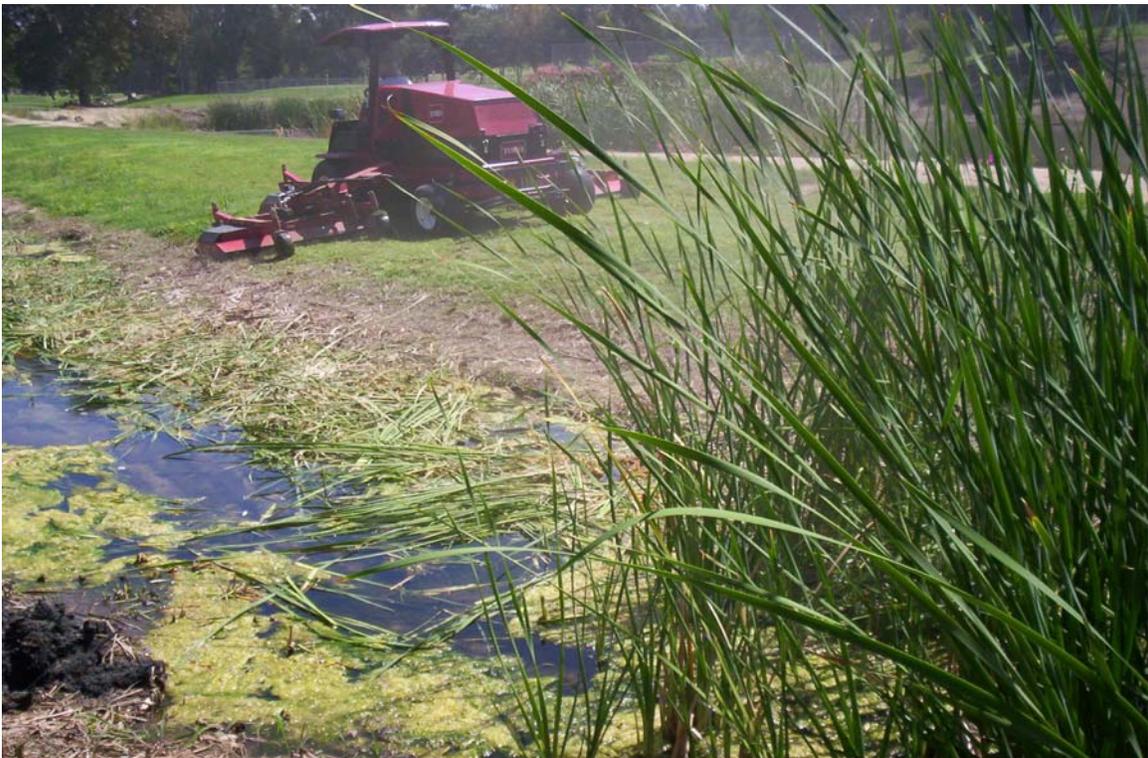
**Photo 14:** View of cattail-dominated wetland section of Diamond Bar Creek east of Grand Avenue (Exhibit 4). Mower shown was in the process of cutting the cattails down in this channel at the time of the survey.

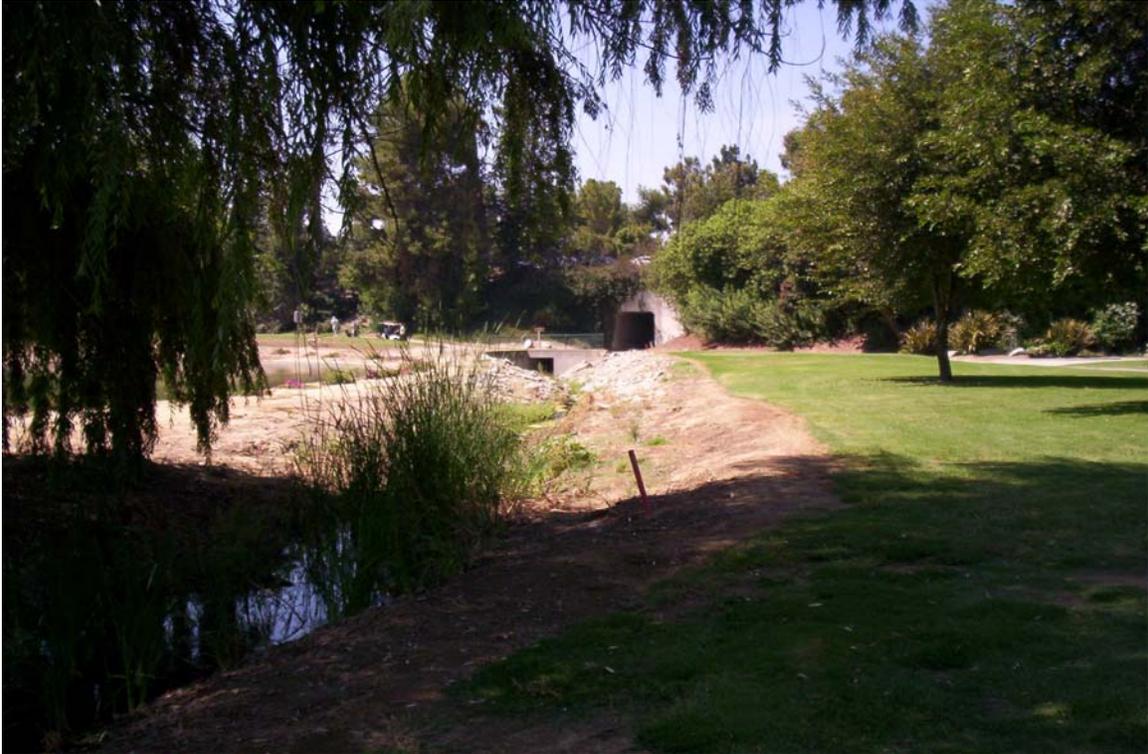
**Photo 15:** View downstream along Diamond Bar Creek (Exhibit 4). Note remnant standing cattails and weeping willow in foreground and riprap channel and box opening in background.

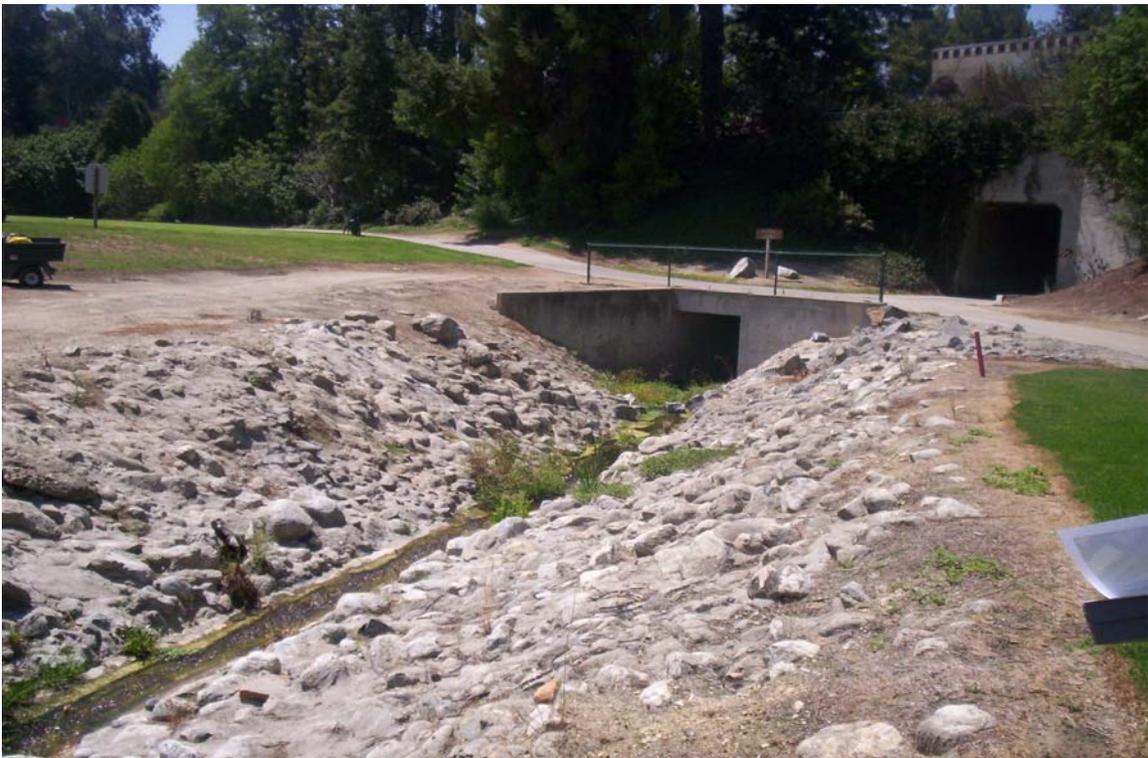
**Photo 16:** View downstream along channelized riprap portion of Diamond Bar Creek (Exhibit 4). This portion is RWQCB jurisdictional, and it extends under Grand Avenue before emptying into the cattail-dominated wetland just west of Grand Avenue.

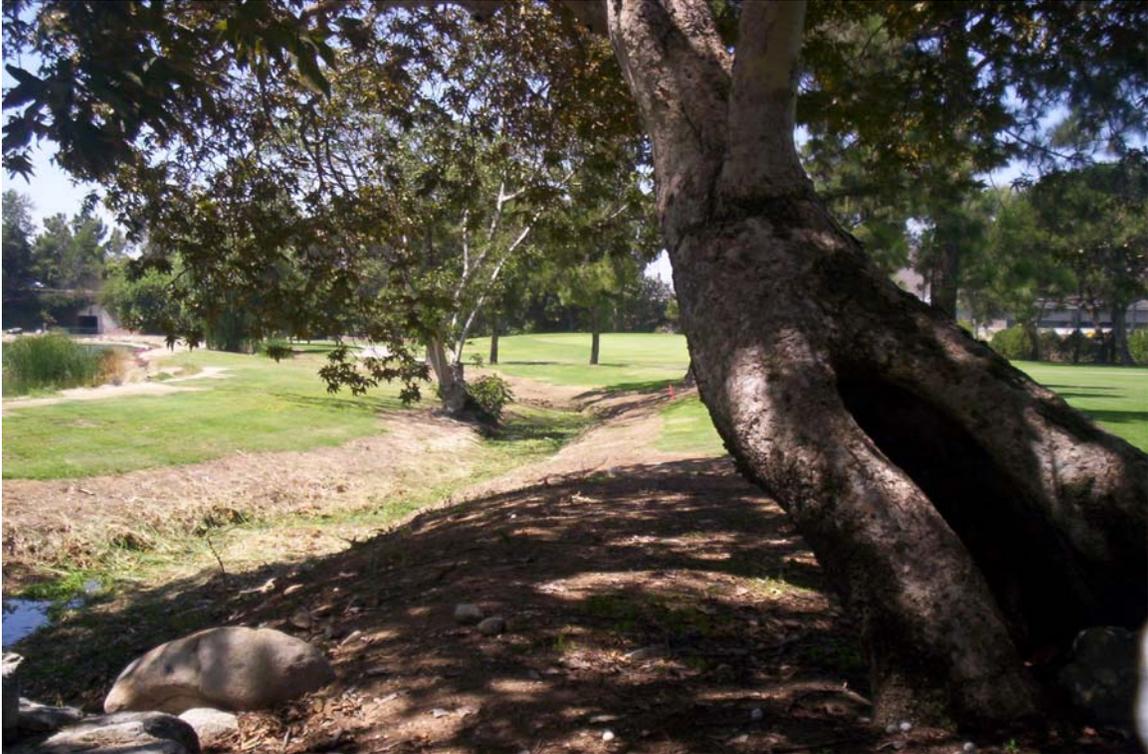
**Photo 17:** View downstream from below California sycamore canopy along recently-mowed cattail-dominated section of Diamond Bar Creek (Exhibit 4).

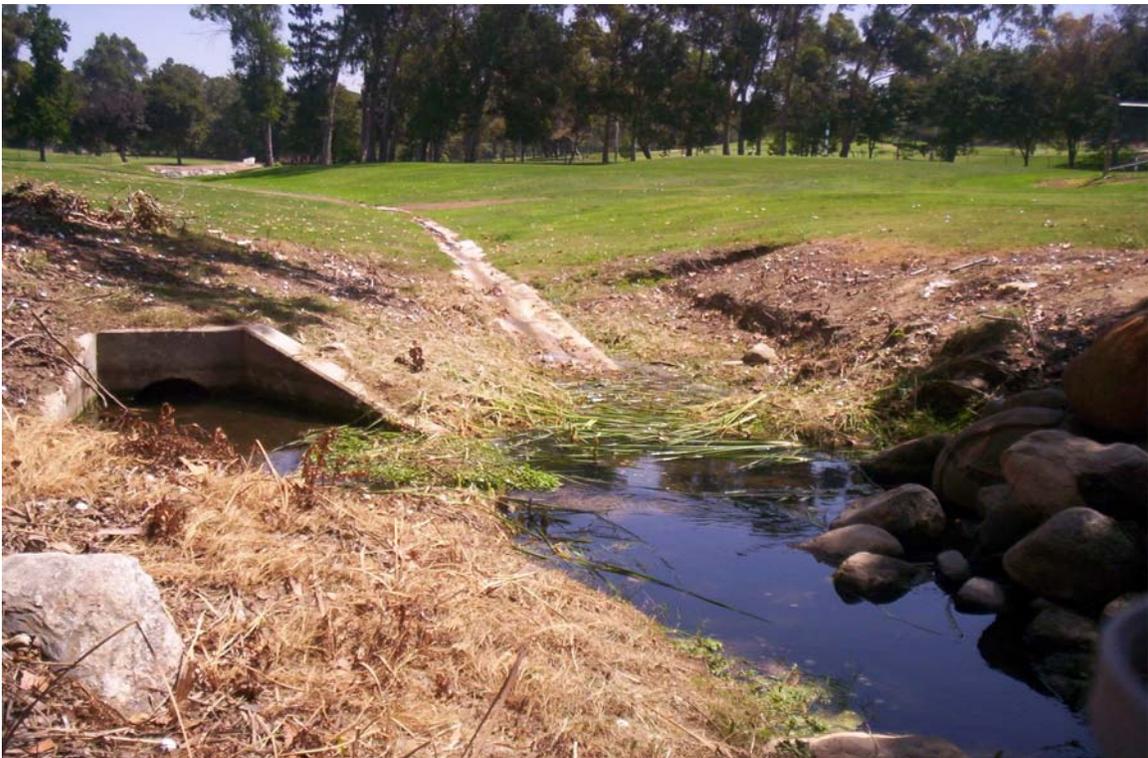
**Photo 18:** View upstream along RWQCB jurisdictional concrete channel of Diamond Bar Creek (Exhibit 4). Note cut cattails, water, and pipe opening.
