**Subject: Results of 2011 Focused Least Bell's Vireo Survey**

**JURISDICTIONAL DELINEATION  
(EXISTING CONDITIONS)  
FOR  
GRAND AVENUE/SR-60 CONFLUENCE PROJECT  
CITY OF INDUSTRY, LOS ANGELES COUNTY, CALIFORNIA**

# State Route 57/State Route 60 Confluence at Grand Avenue Project Grand Avenue Interchange and Confluence Improvements

## Natural Environment Study

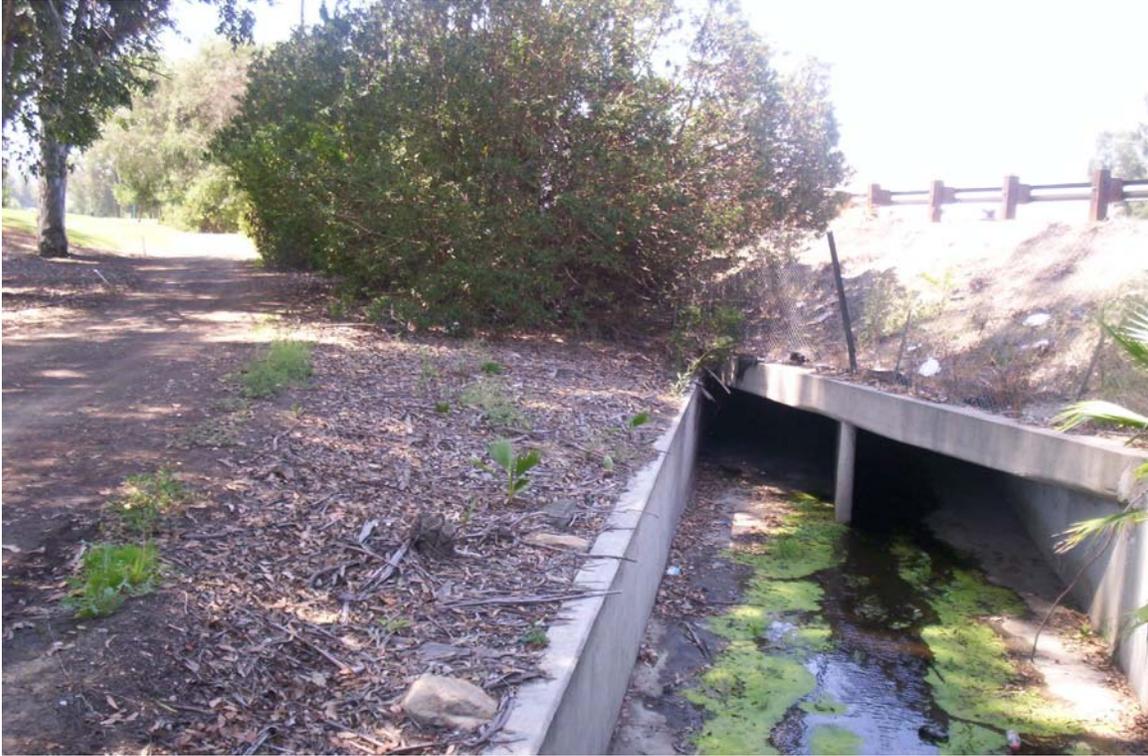
**Photo 19:** View downstream of RWQCB jurisdictional connective box culvert (Exhibit 6). Note flowing water and duckweed.

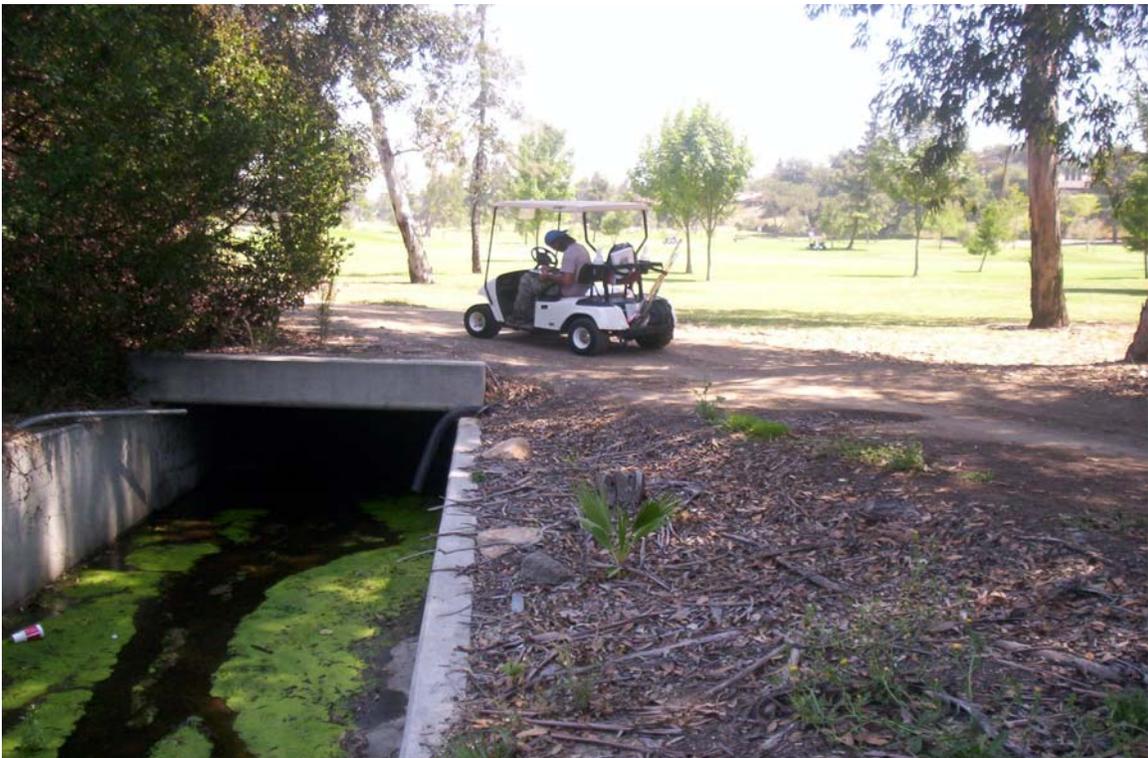
**Photo 20:** View upstream of RWQCB jurisdictional connective box culvert (Exhibit 6). Note flowing water and duckweed.

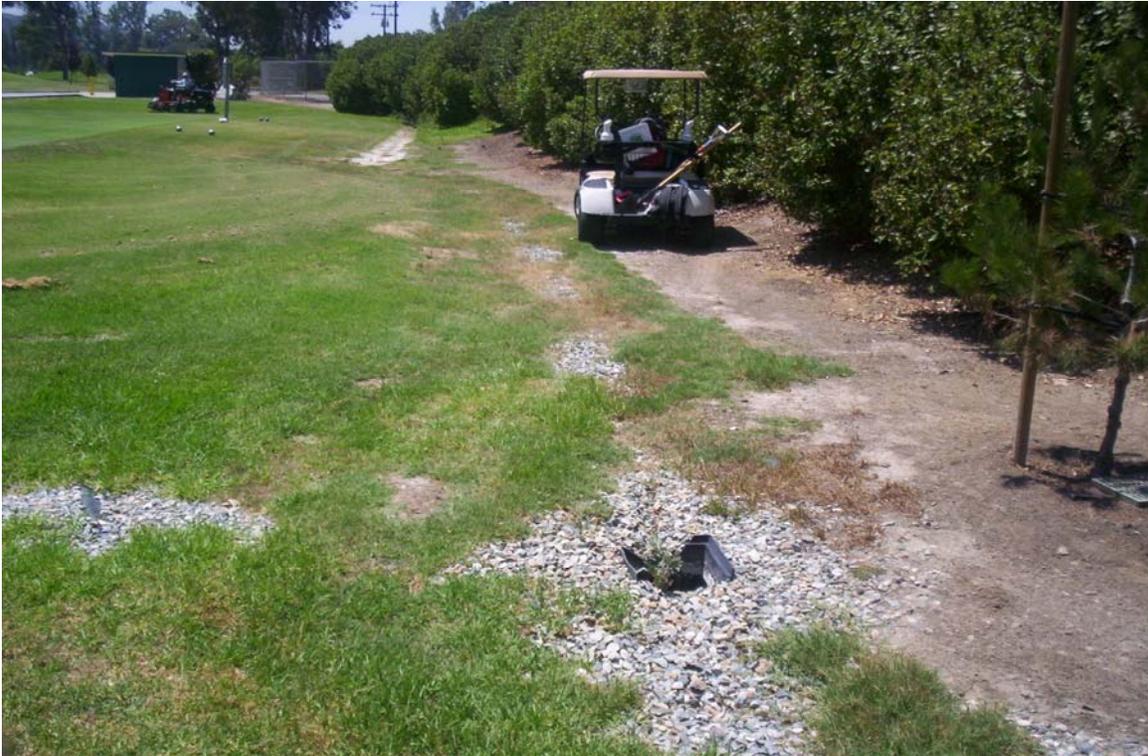
**Photo 21:** This photo depicts a gravel-topped area and drainage that diverts water underground (Exhibit 7).

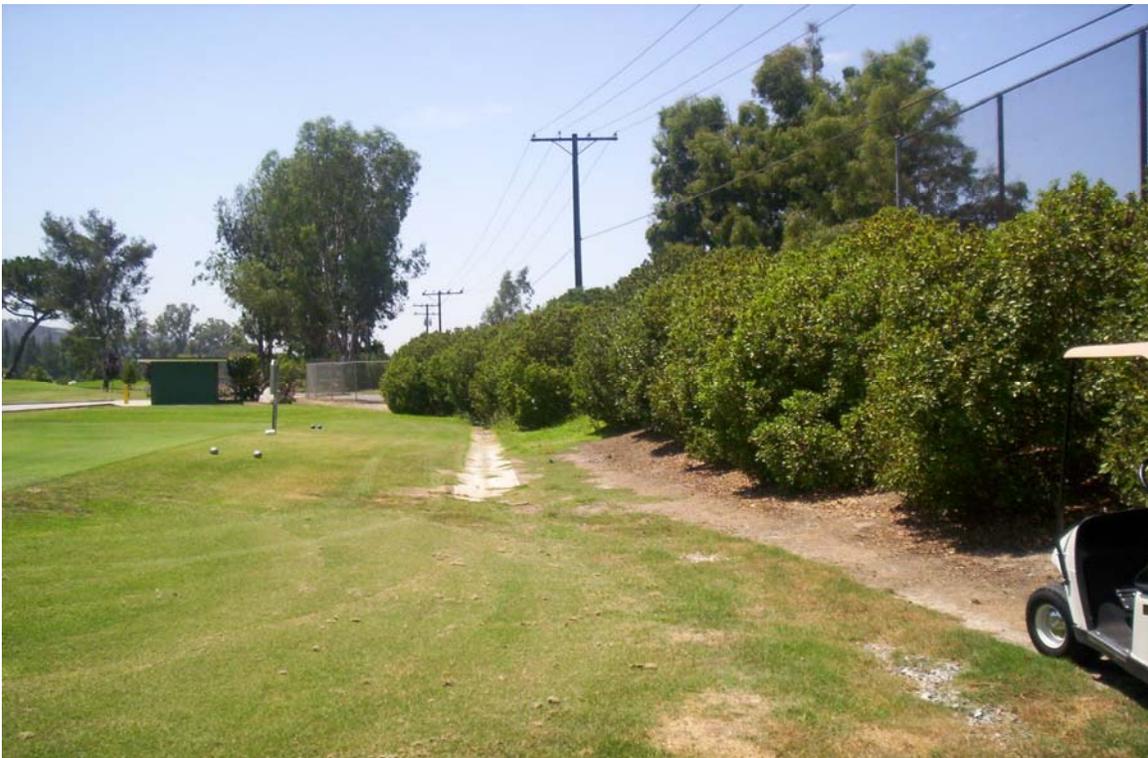
**Photo 22:** This photo shows a RWQCB jurisdictional concrete ditch devoid of water just downslope from the area shown in Photo 21 (Exhibit 7). Note gravel-topped area at lower right.

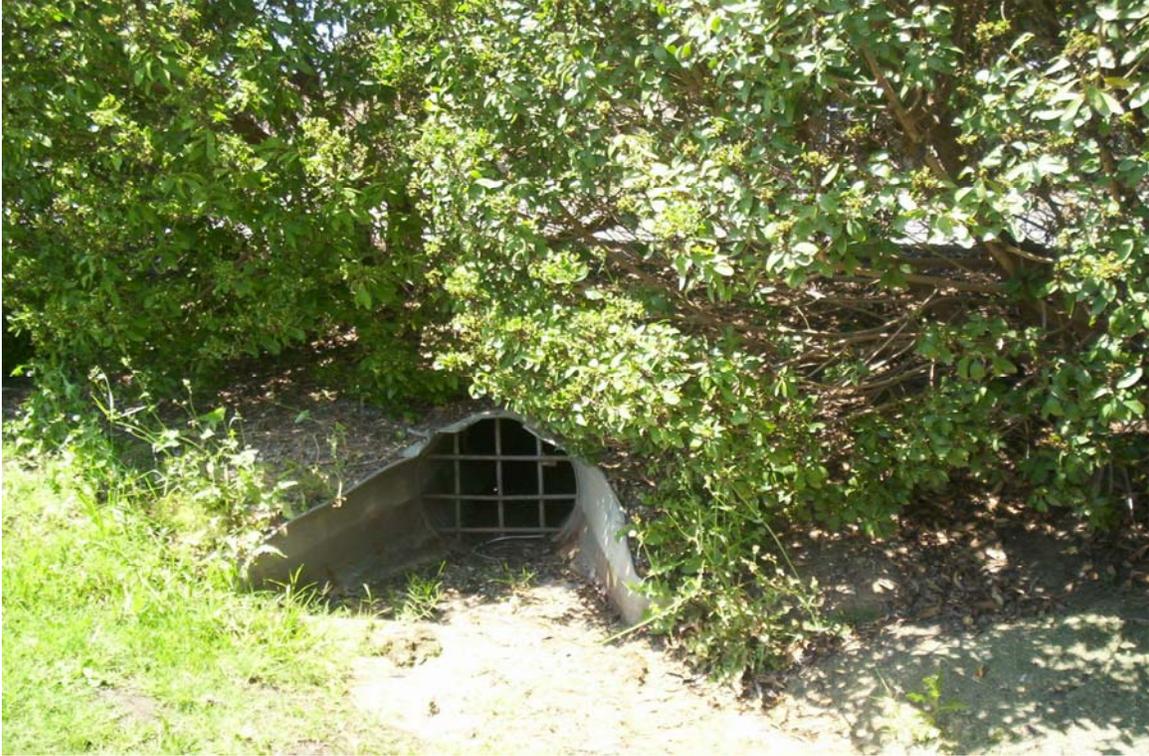
**Photo 23:** Small pipe opening at the downstream end of the concrete ditch shown in Photo 22 (Exhibit 7).

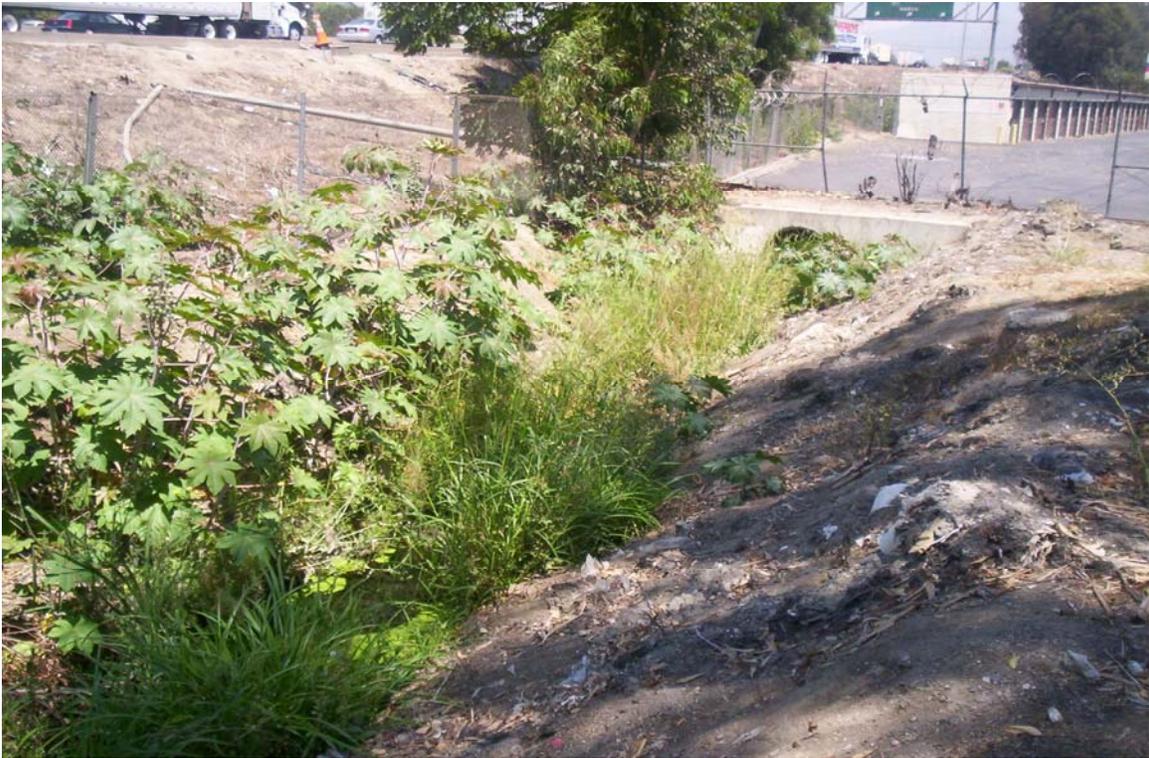
**Photo 24:** Wetland vegetation in the upstream portion of the linear wetland shown in Exhibit 7. Note presence of castor bean and the barren, recently denuded fill banks.

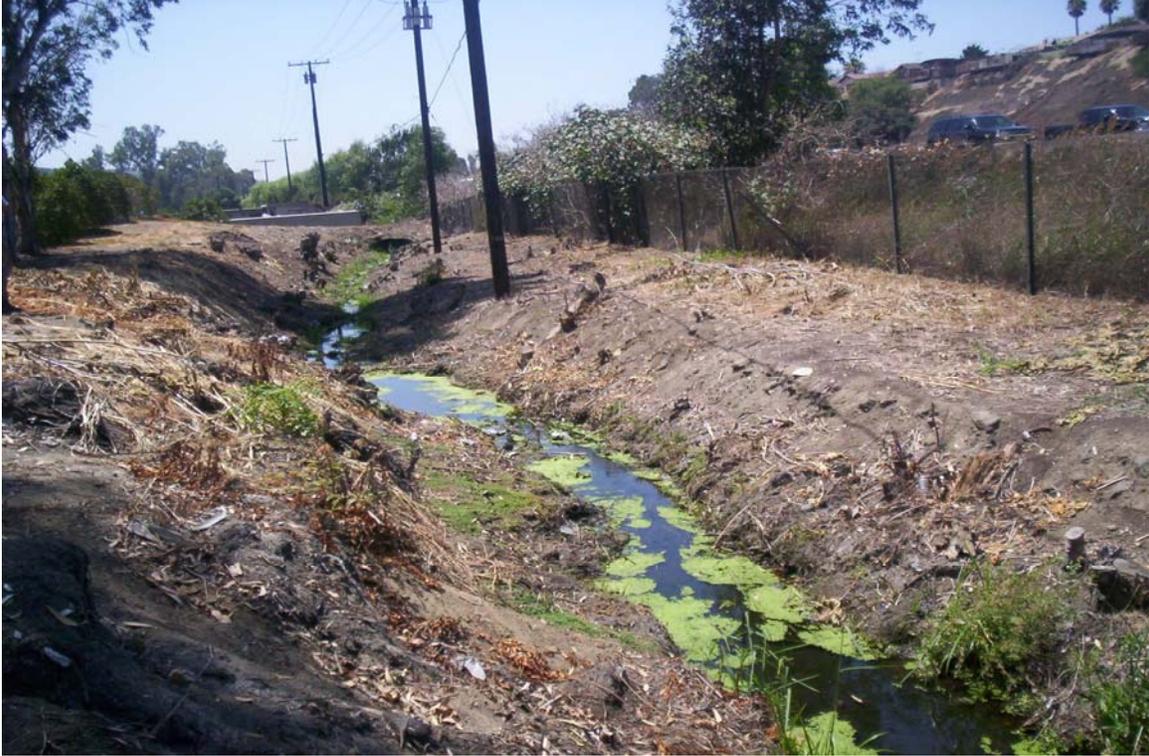
**Photo 25:** Downstream portion of the linear wetland shown in Exhibit 7. Note presence of surface water, duckweed, and recently denuded, barren fill banks. This wetland was in poor general quality at the time of the survey.

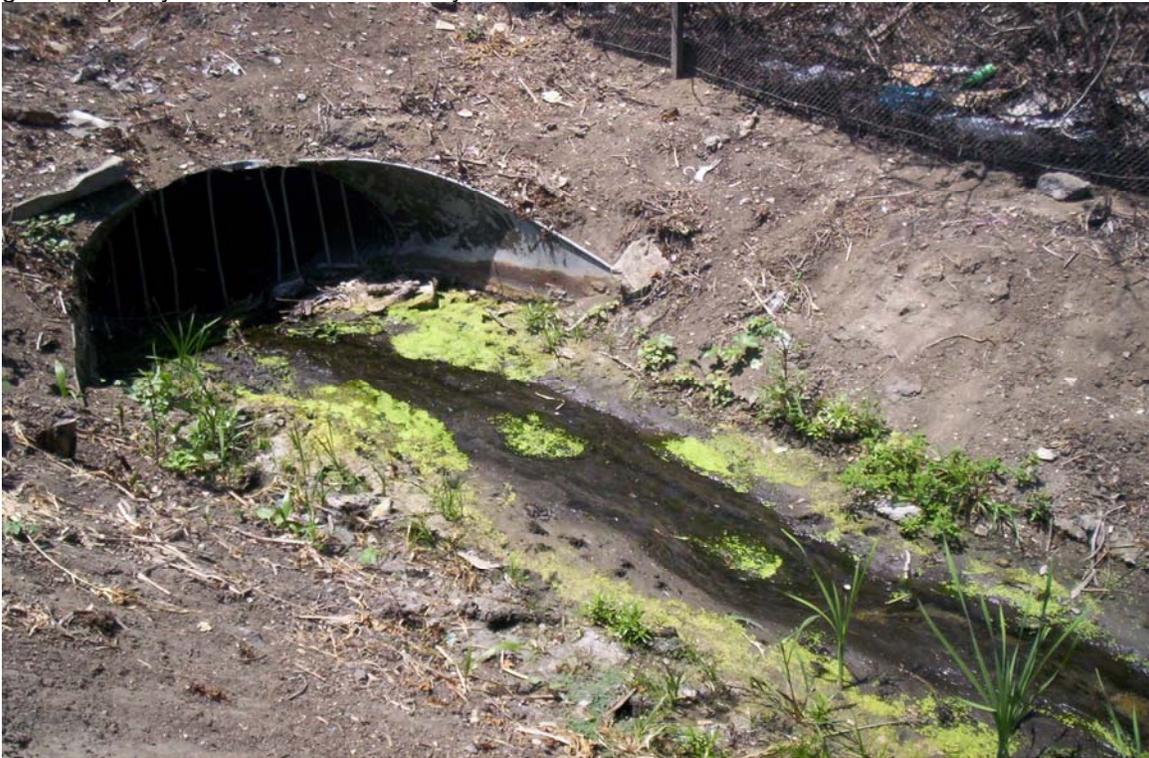
**Photo 26:** Large pipe opening at the downstream end of the wetland shown in Exhibit 7.

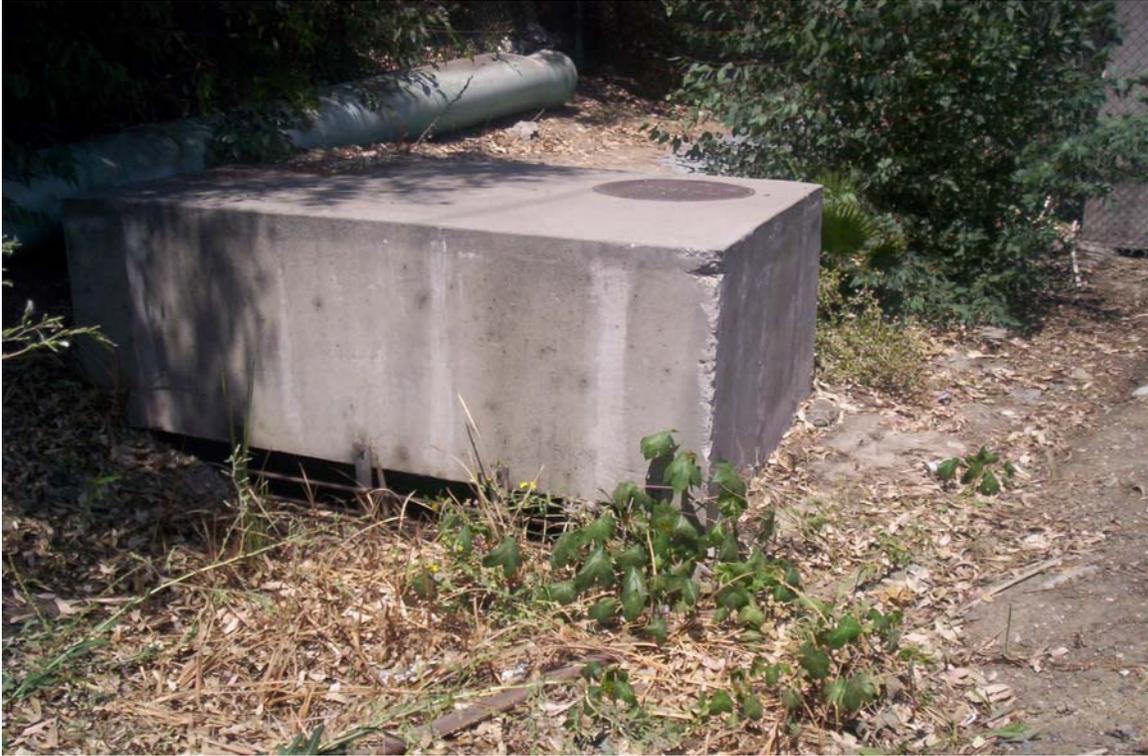
**Photo 27:** Large distribution box adjacent to the golf course facilities shown in Exhibit 7.

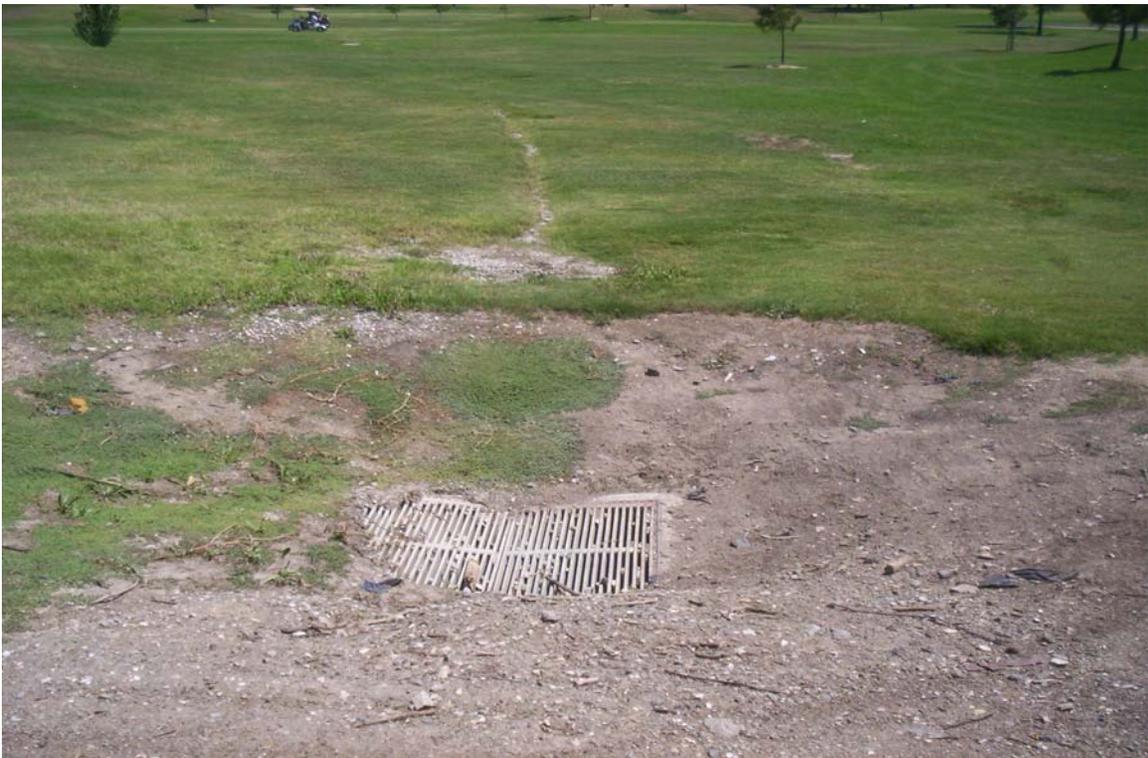
**Photo 28:** Drainage grate at golf course edge (Exhibit 6).

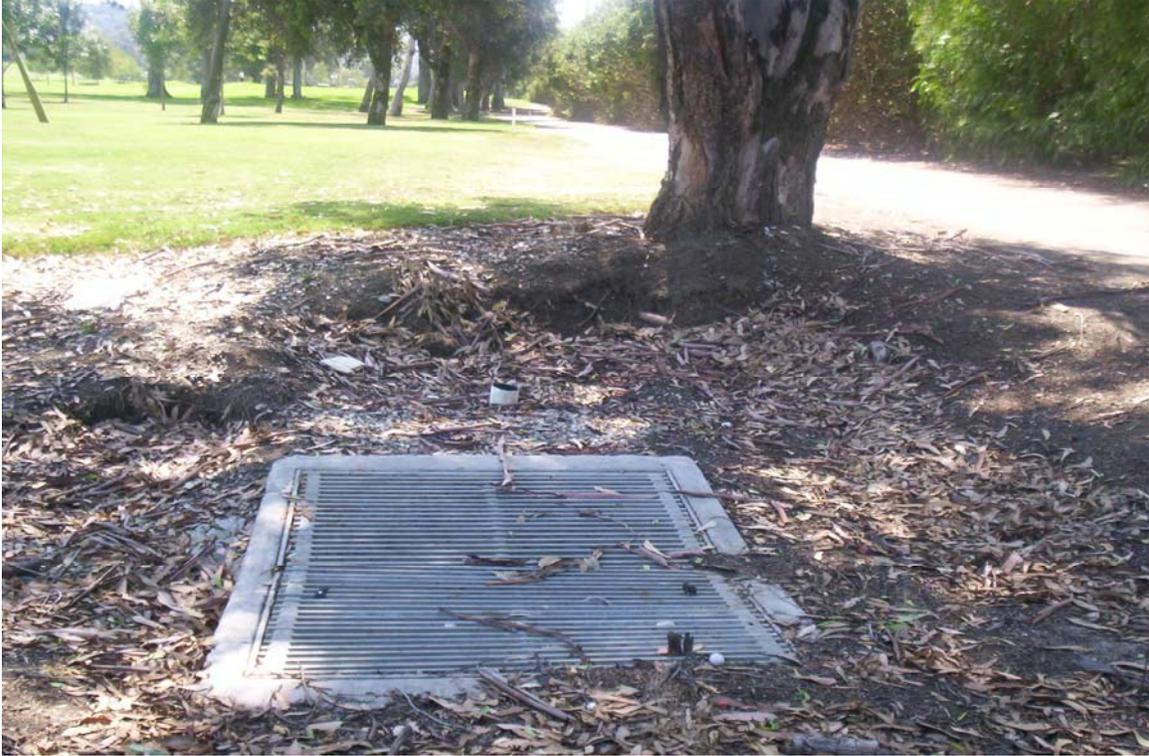
**Photo 29:** Another large drainage grate at golf course edge (Exhibit 6).

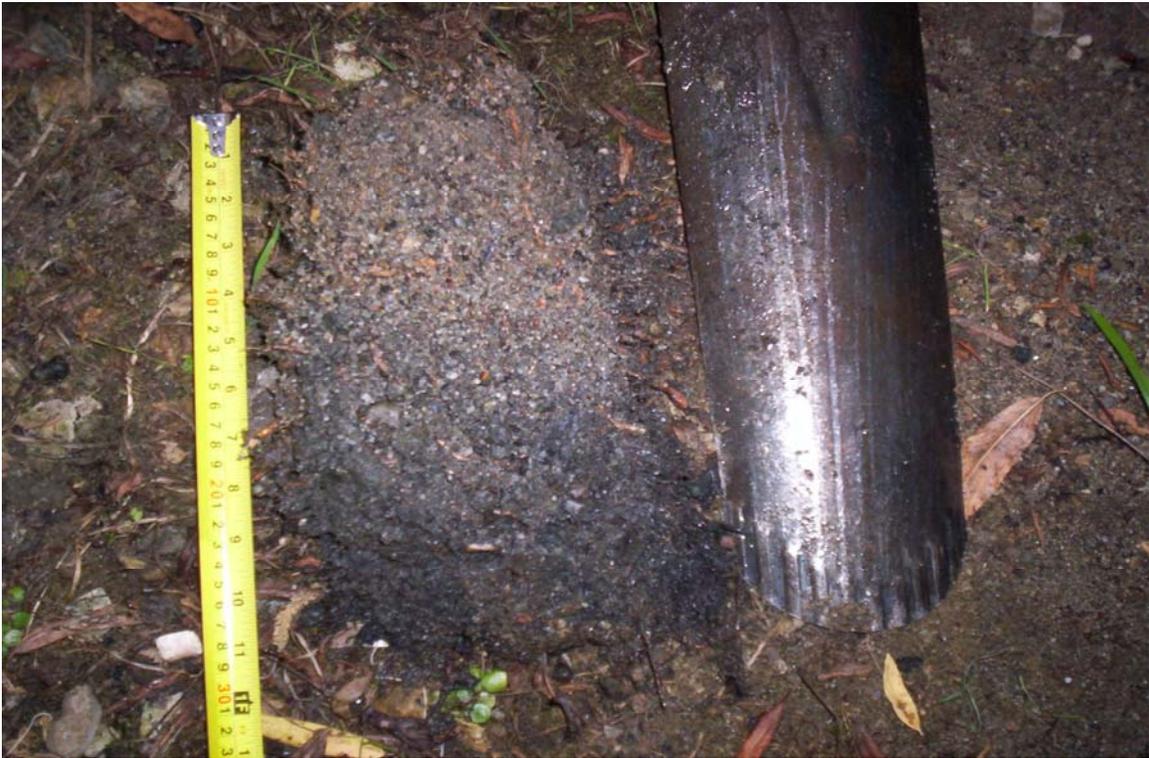
**Photo 30:** Soil profile of the small sheetflow wetland within Exhibit 2. This soil smelled of hydrogen sulfide, a very strong indicator of hydric soils.

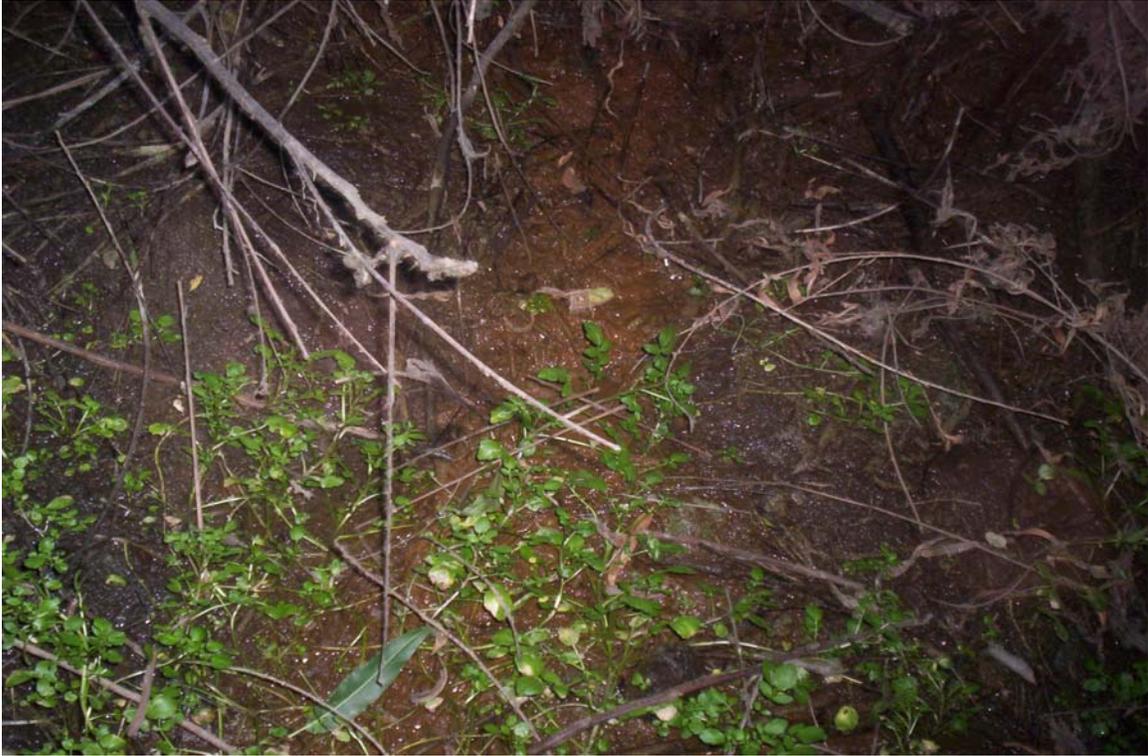
**Photo 31:** The sheetflow-induced wetland of Exhibit 2. Note presence of surface water, watercress, and algal mats. This unusual wetland was defined by a distinct line of water seepage upslope about 20 feet from the water's edge.

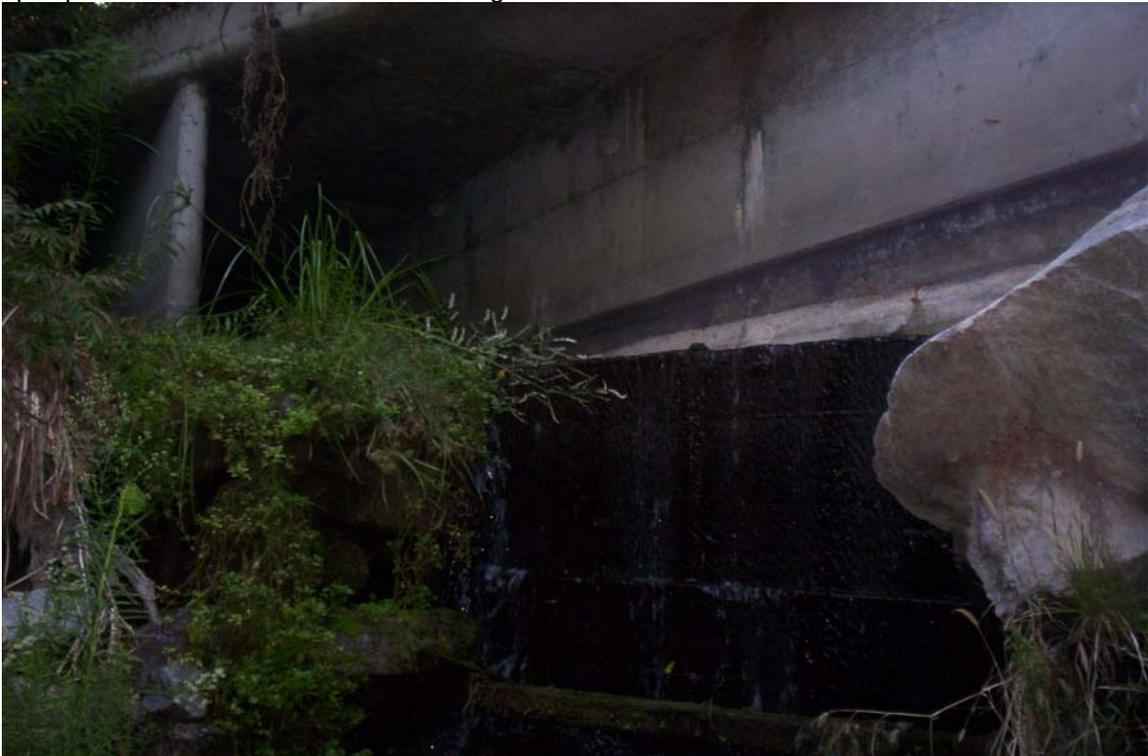
**Photo 32:** Underpass large box opening at upstream origin of large riparian channel shown in Exhibit 2. This water passed below Grand Avenue and the developed area footprint from the cattail-dominated concrete channels in the ramp area upstream and northeast of this point.

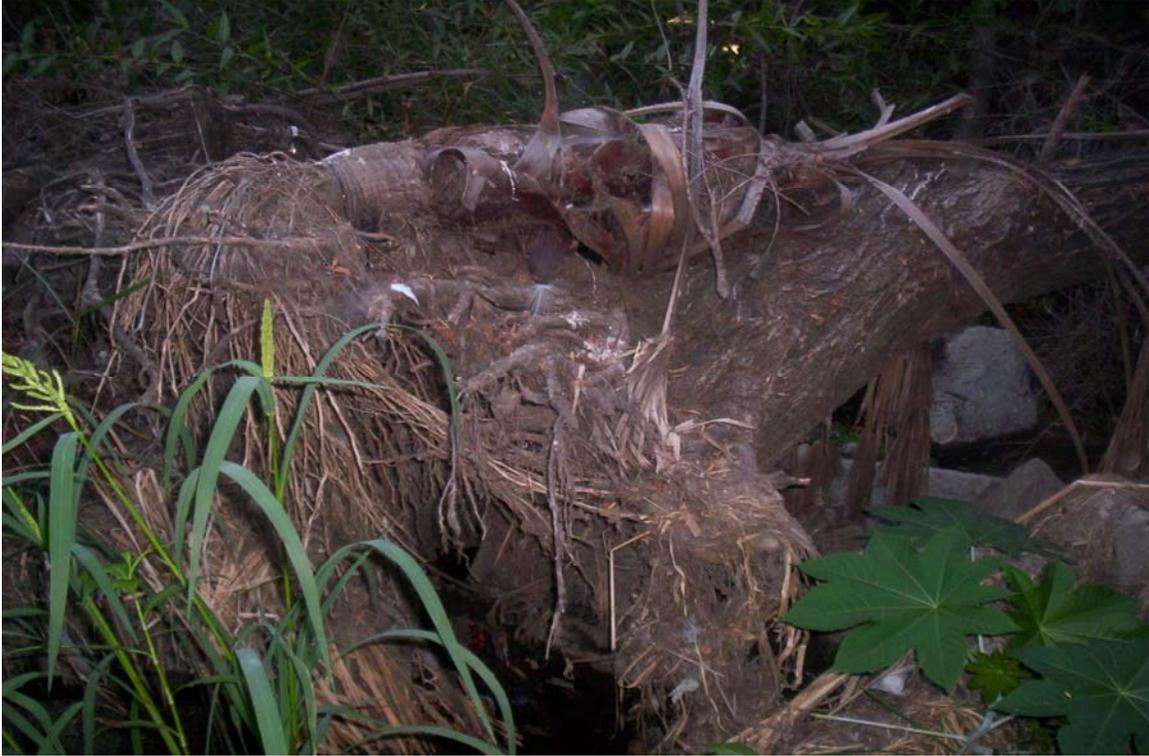
**Photo 33:** Fallen trees and high drift lines seen in this photo taken just below the water entry point of the large riparian channel suggest recent rapidly moving and high waters, most likely a result of the extensive rainfall of 2005.

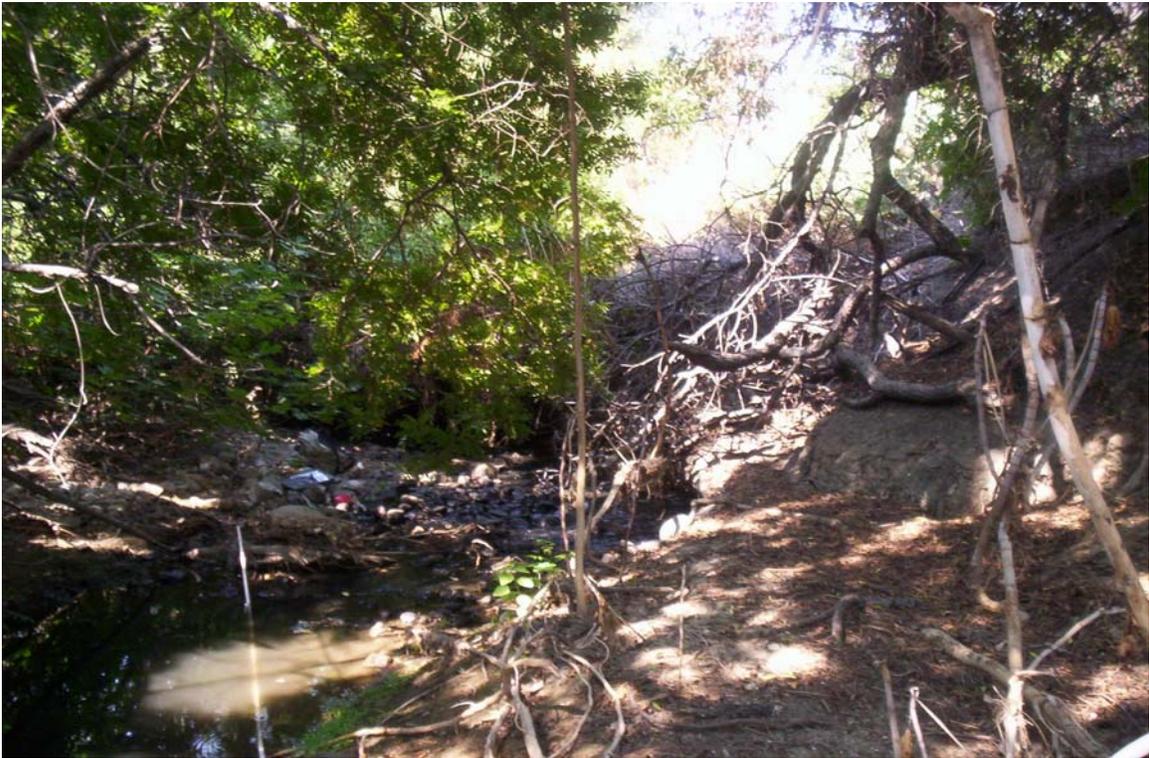
**Photo 34:** A view within the riparian channel of Exhibit 2.

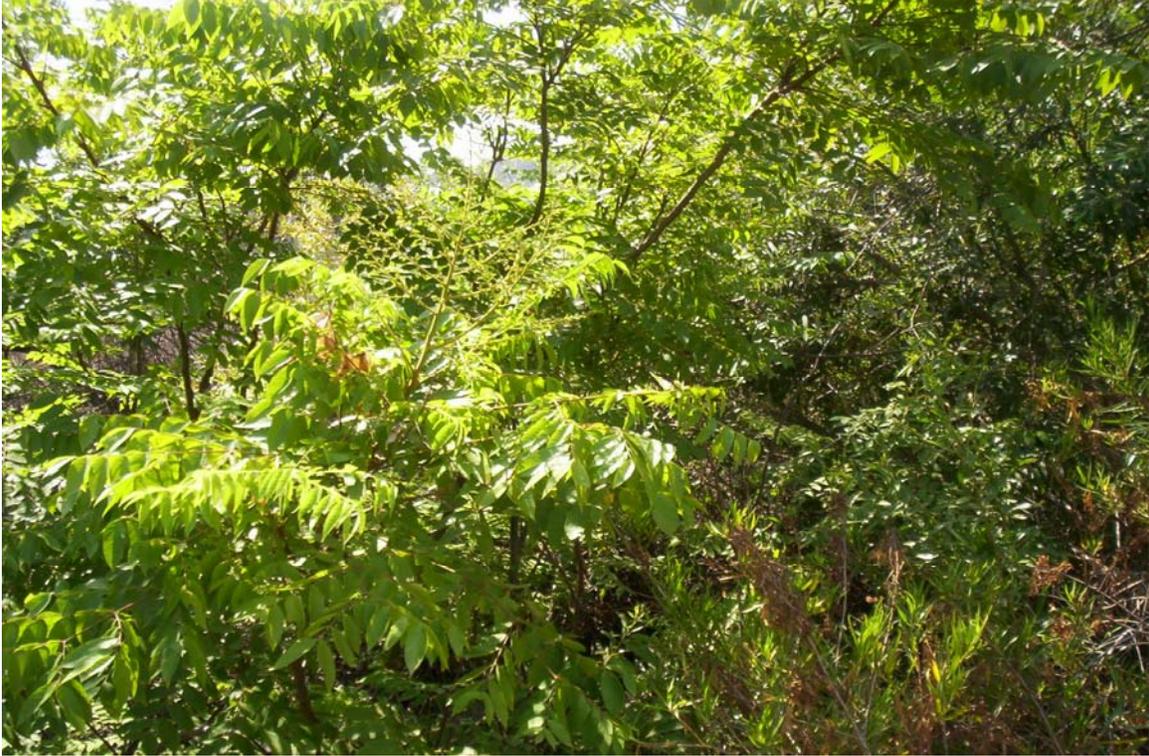
**Photo 35:** A view of the canopy structure within the riparian channel of Exhibit 2. Although a mix of native and non-native species thrive in this woodland, the area is dominated by California walnut and several willow species.

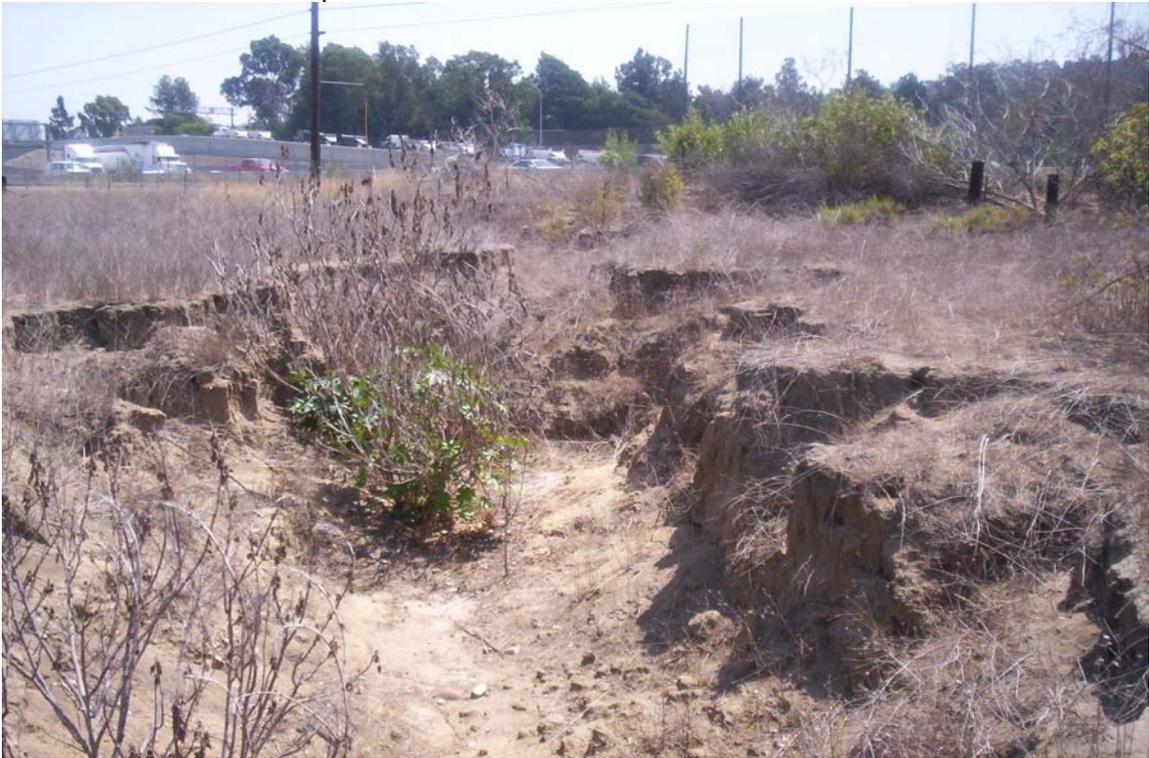
**Photo 36:** Non-jurisdictional erosion gulch within Exhibit 2. Upon examination, this erosional feature had no upstream source. It may have resulted from flood backwash in high flow conditions of 2005, or a number of other reasons (i.e. land slump, fault line, road runoff, etc.).

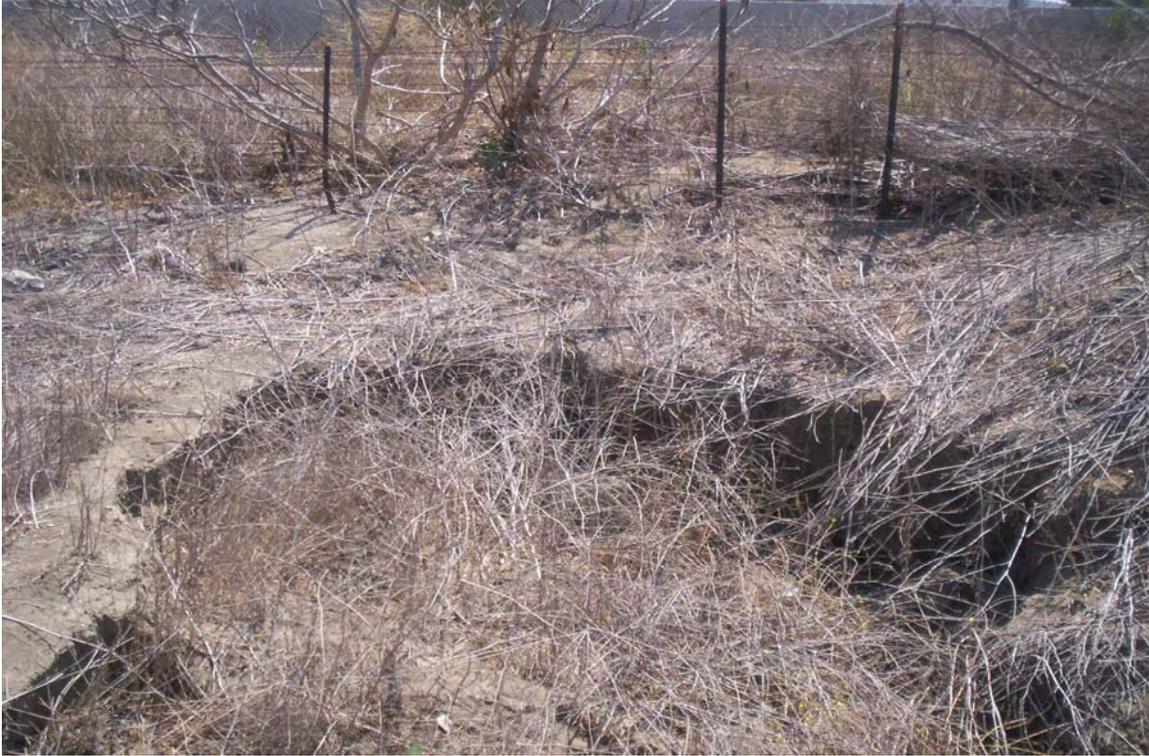
**Photo 37:** Upper terminus of the non-jurisdictional erosional gulch feature within Exhibit 2. Note the lack of water, dry forbs, and the curious sunken sharp edge.

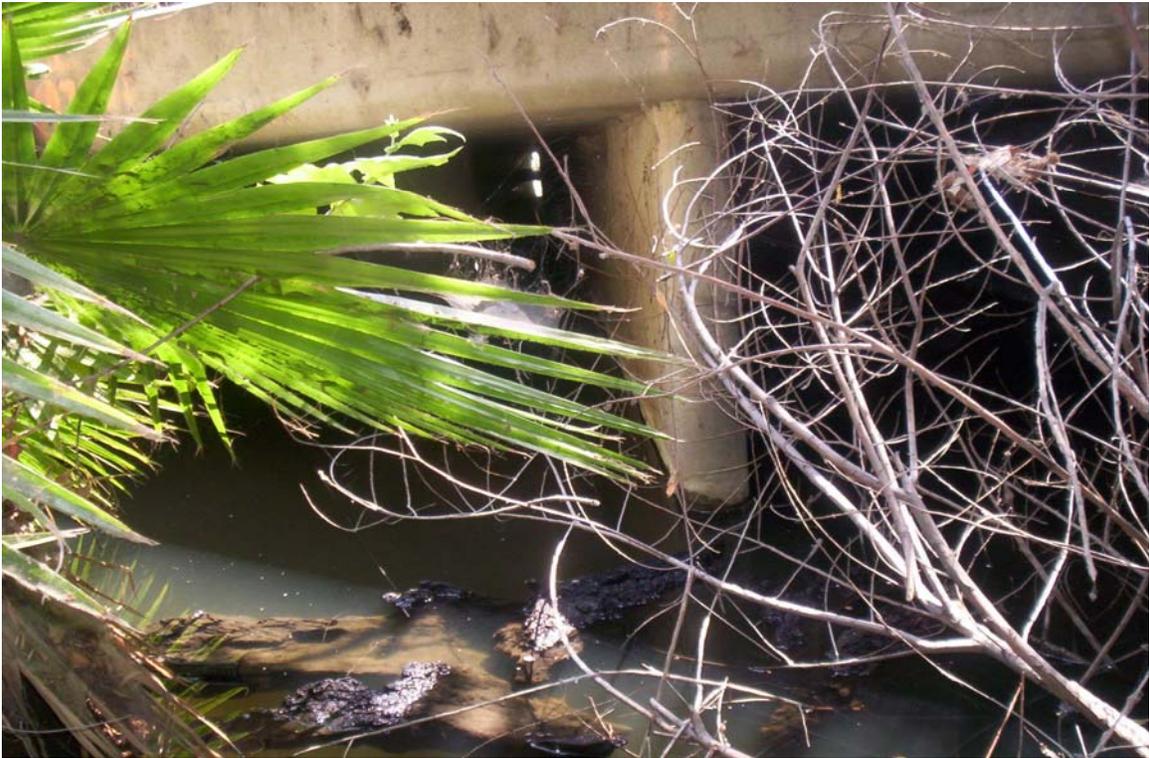
**Photo 38:** Water port of entry for Diamond Bar Creek on the west side of SR-57/60 into the large riparian channel (Exhibit 2). This underpass box opening extends from this point to the east side of SR-57/60 in a wetland channel on Diamond Bar Golf Course.

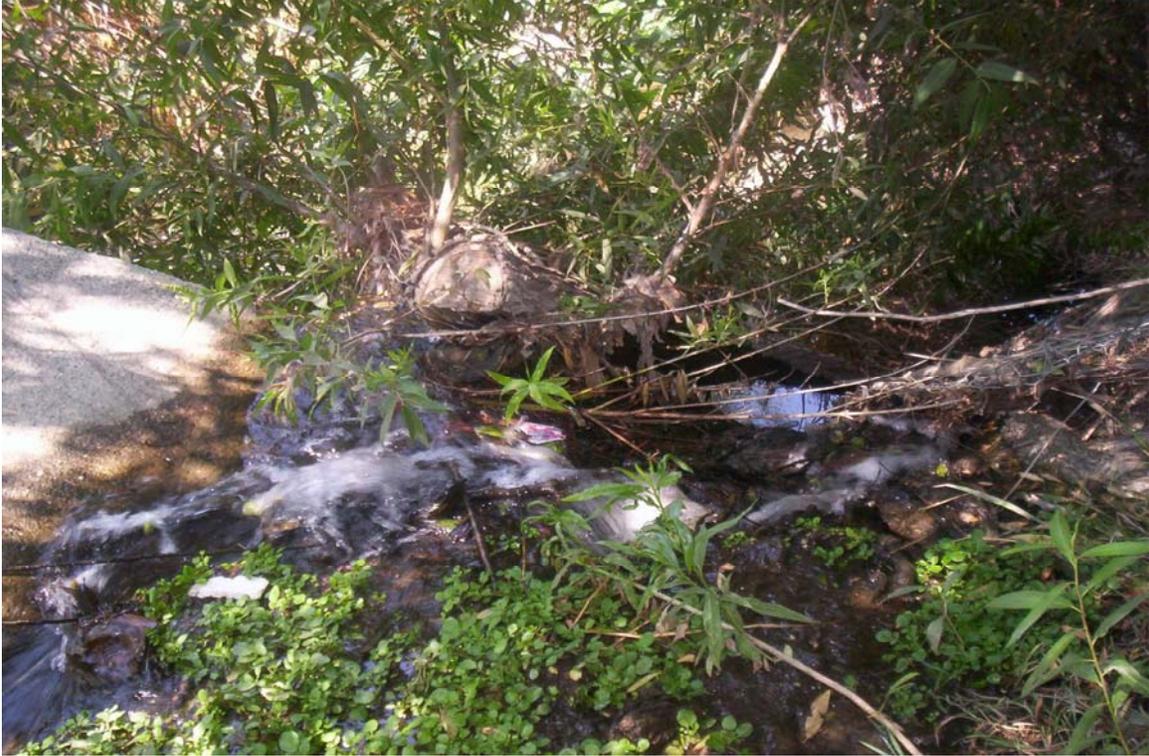
**Photo 39:** Water spillway for Diamond Bar Creek into the large riparian channel (Exhibit 2). Note the presence of red willow and watercress, and the generally moderate flow rate.

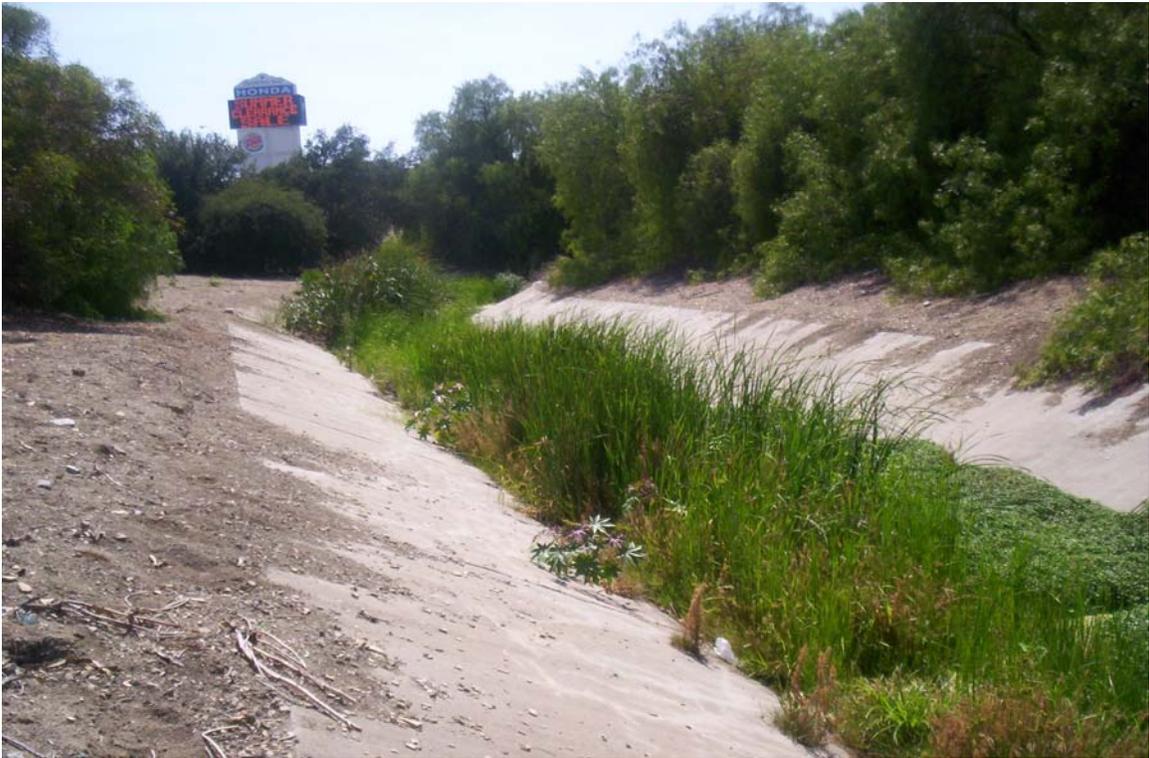
**Photo 40:** Cattail-dominated concrete channel within the ramp area of SR-57/60 and Grand Avenue (Exhibit 5). The vegetation in this manmade channel is dense and full, indicating that this channel is not maintained and has returned to a more natural state.

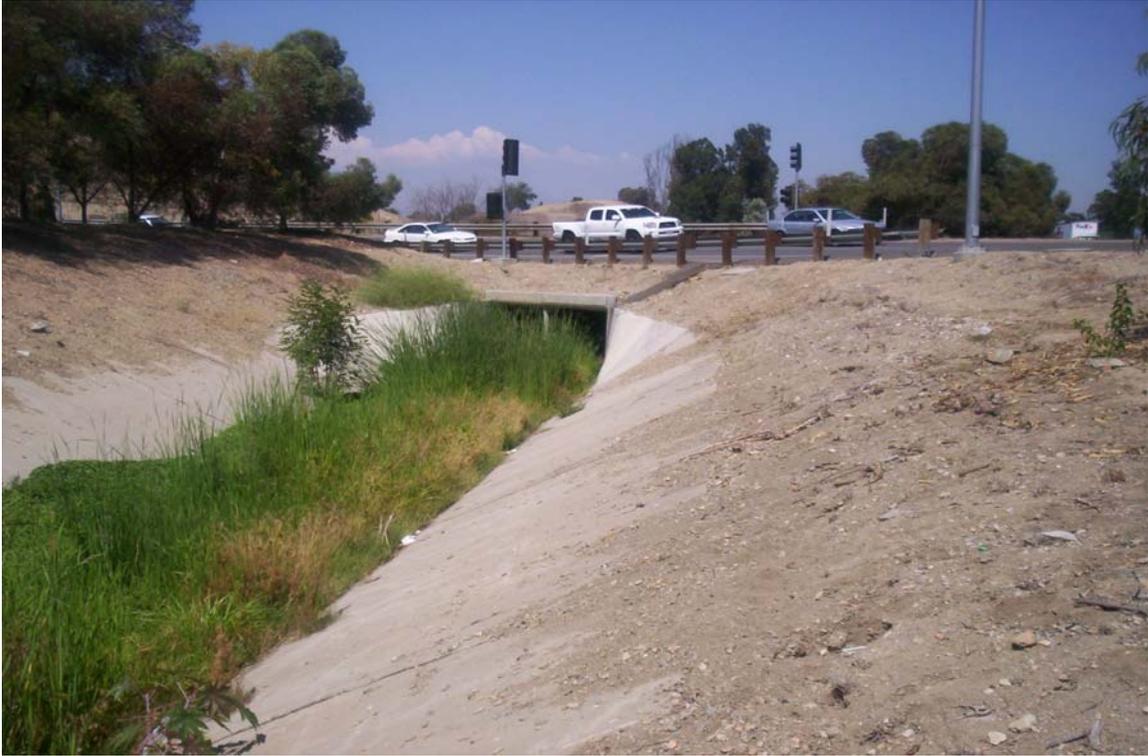
**Photo 41:** Upstream extension of the area shown in Photo 40 (Exhibit 5). Note the continued prominence of wetland vegetation and the underpass box opening below the metered stop of the on-ramp for southbound SR 57/60.

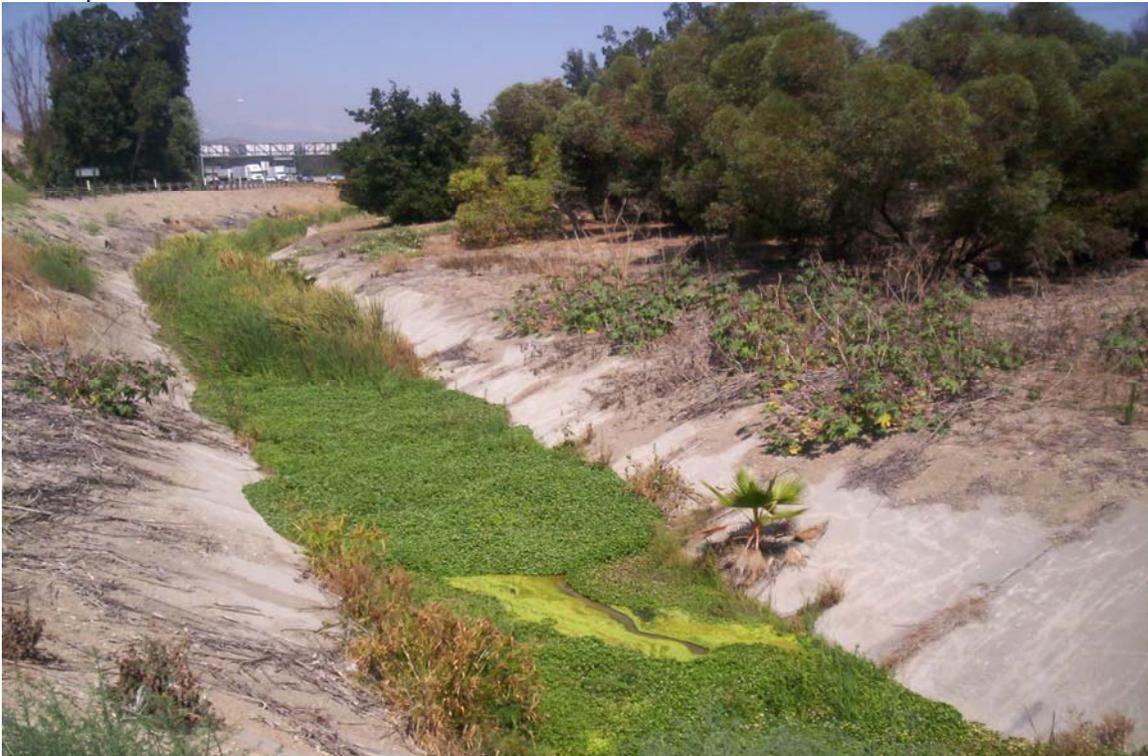
**Photo 42:** Upstream extension of the concrete channels of Exhibit 5. Note the continued prevalence of wetland vegetation, flowing water, and upland soil along the angled walls.

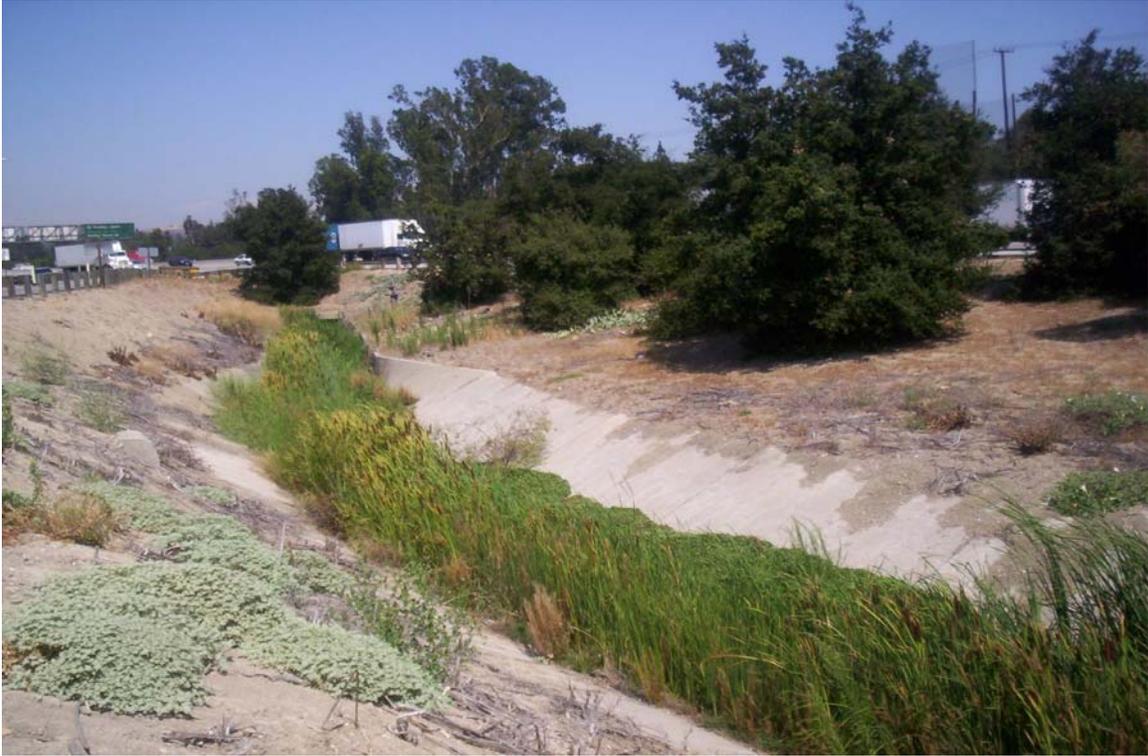
**Photo 43:** Upper terminus of manmade channels of Exhibit 5. The entire length of these concrete channels were strongly vegetated with wetland plants at the time of this survey.
