**Subject: Results of 2011 Focused Least Bell's Vireo Survey**

**JURISDICTIONAL DELINEATION  
(EXISTING CONDITIONS)  
FOR  
GRAND AVENUE/SR-60 CONFLUENCE PROJECT  
CITY OF INDUSTRY, LOS ANGELES COUNTY, CALIFORNIA**

# State Route 57/State Route 60 Confluence at Grand Avenue Project Grand Avenue Interchange and Confluence Improvements

## Natural Environment Study

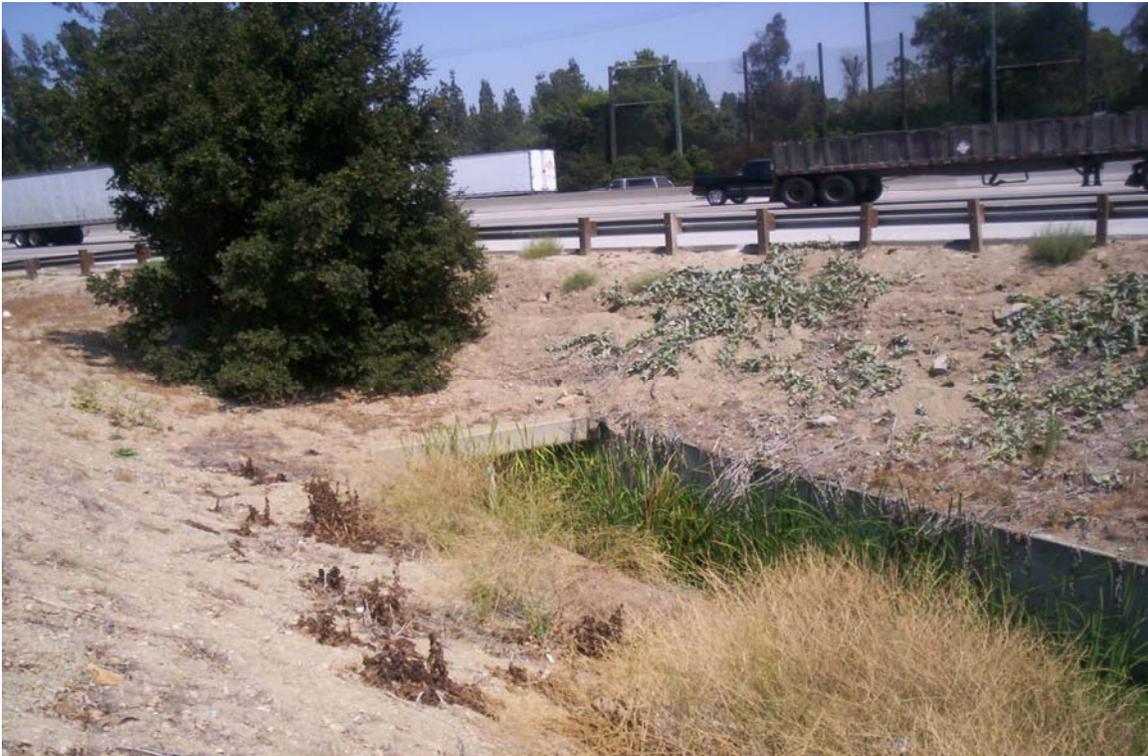
**Photo 44:** Box opening at the upper terminus of the manmade channels of Exhibit 5. From this point, the water passes below SR-57/60 and presumably connects to the RWQCB jurisdictional box culvert on the edge of Diamond Bar Golf Course shown in Exhibit 6.

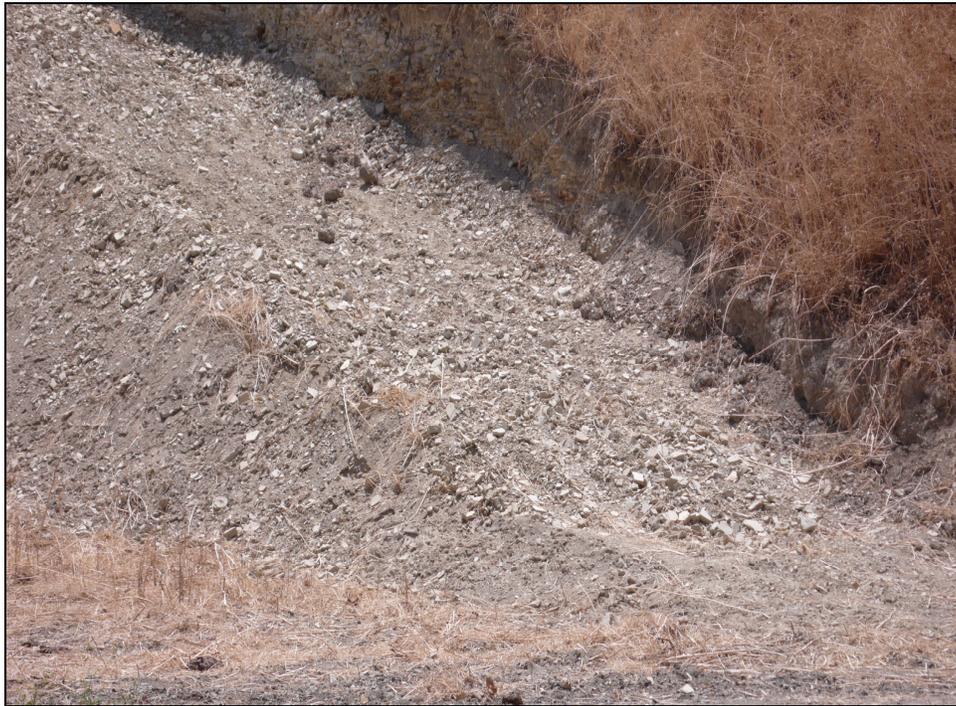
**Photo 1.** This photo is representative of the carbonate soils present onsite.

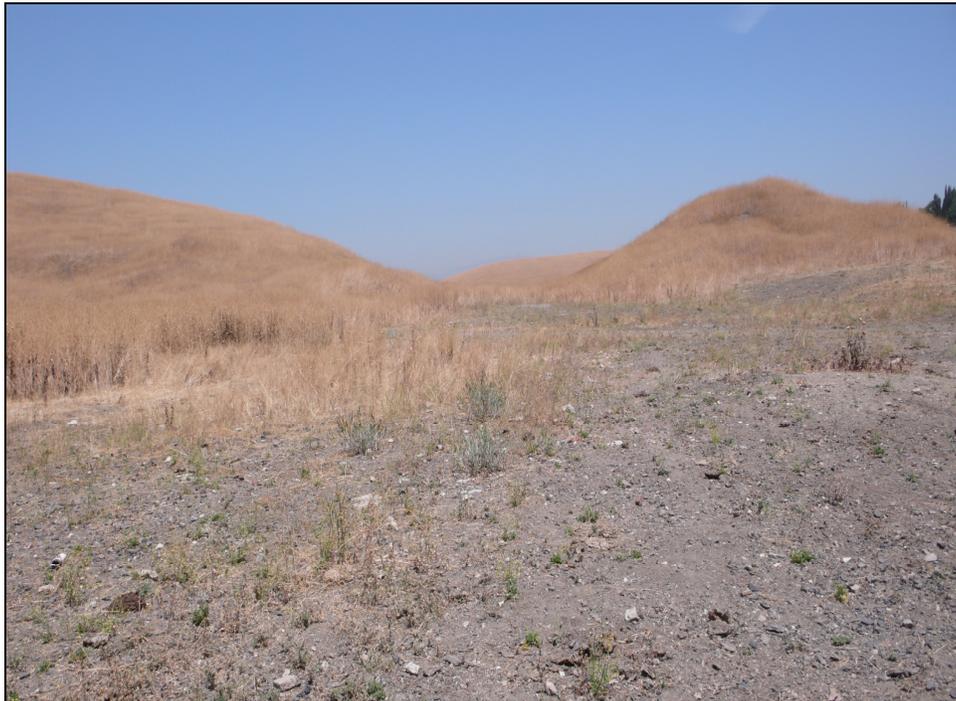
**Photo 2.** This photo is representative of the Ruderal vegetation community present within the focused plant survey area.

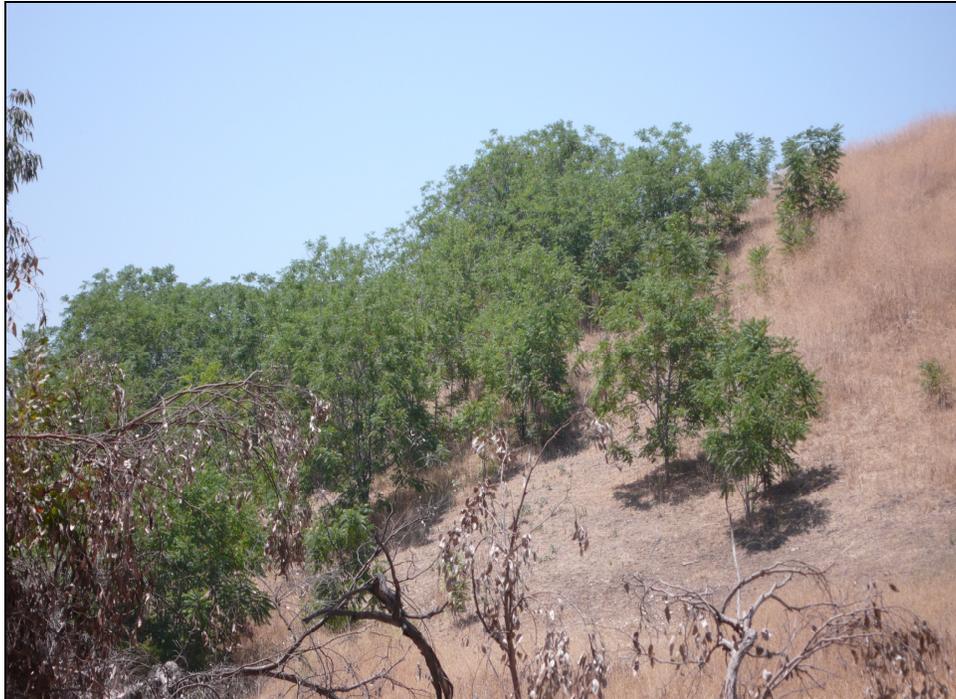
**Photo 3.** This picture shows a tree of heaven (*Ailanthus altissima*) stand towards the southwestern edge of the survey boundary.

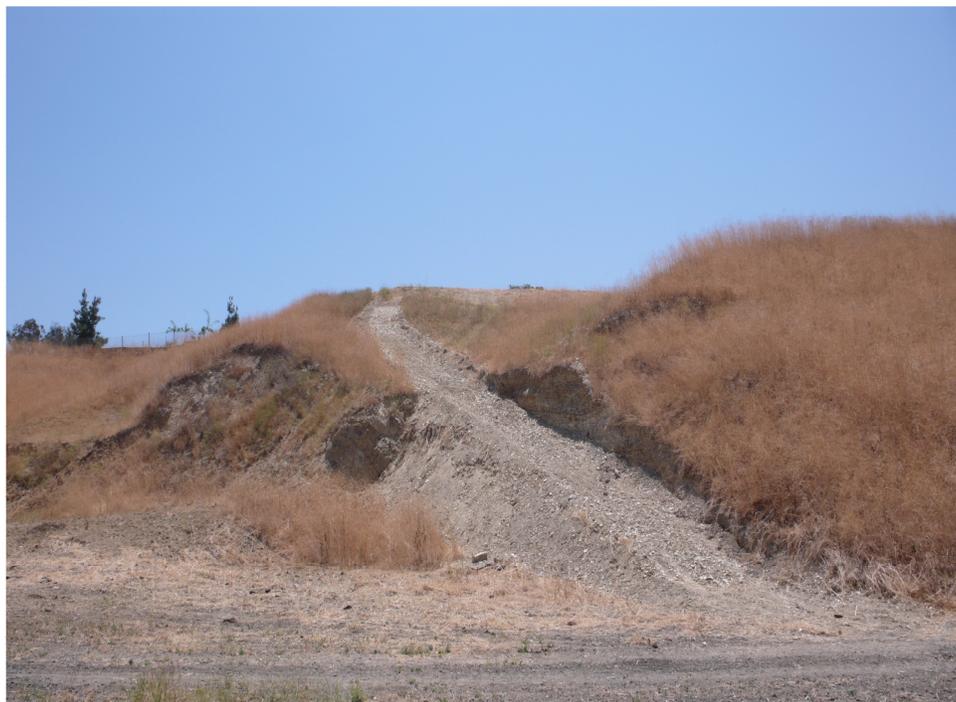
**Photo 4.** This photo shows the Ruderal vegetation growing on the carbonate soils within the project site.

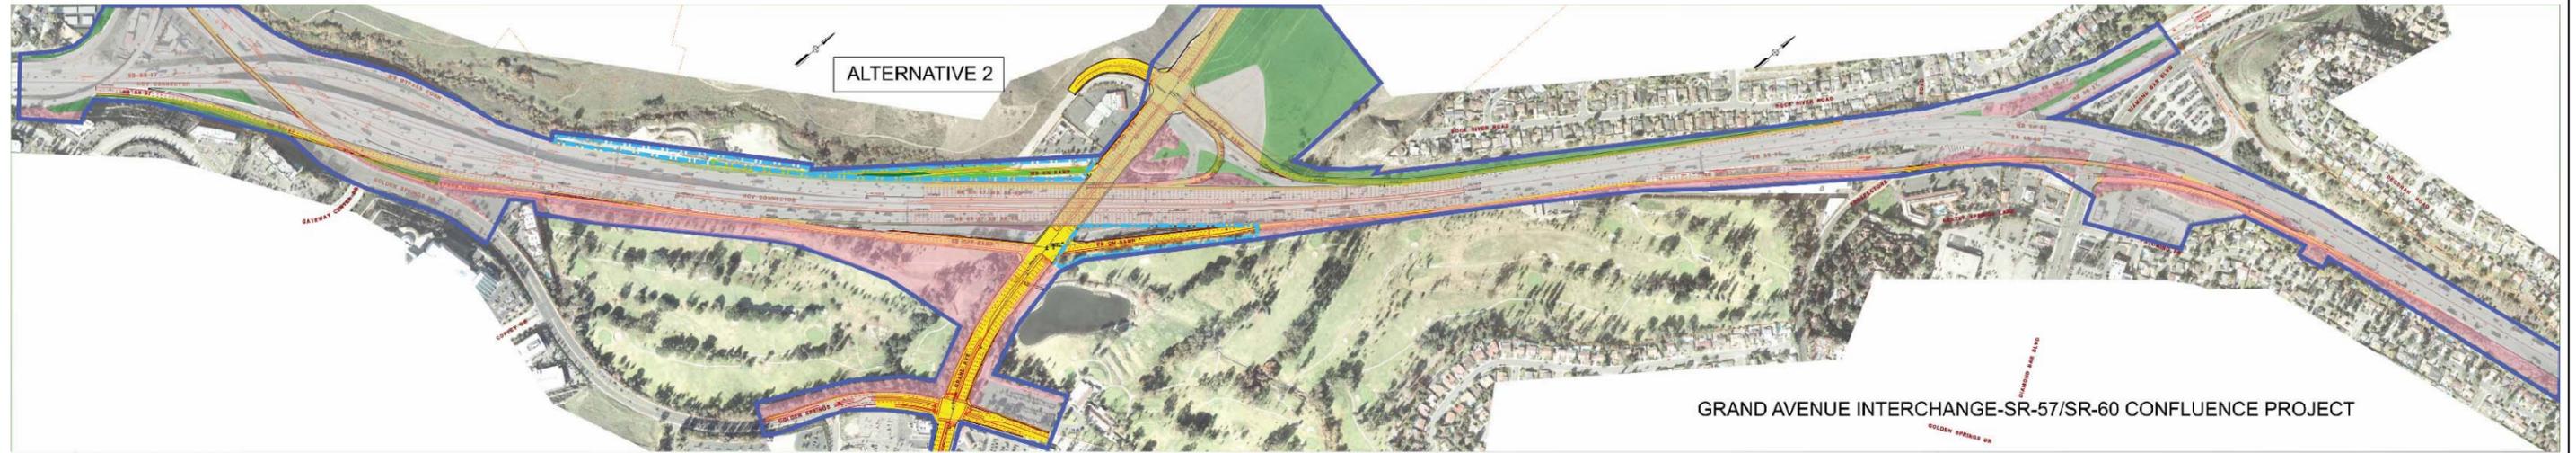
**Figure 6: Alternative 2 - Vegetation Communities**

■ BSA  
 ■ NAP – included in the Westbound On-Ramp at Grand Avenue/SR-60 Interchange Improvements Project BSA

The common vegetation type within these developed areas consists of exotic landscaping. In addition to these concentrated communities, the remainder of the study area contains a few scattered native riparian species located within and around the tributaries to Diamond Bar Creek within the BSA. These native trees include coast live oak (*Quercus agrifolia*), red willow (*Salix laevigata*), arroyo willow (*Salix lasiolepis*), black willow (*Salix gooddingii*), California sycamore (*Platanus racemosa*), white alder (*Alnus rhombifolia* Nutt.), and California walnut (*Juglans californica*). It is noted that all but one coast live oak individuals were landscaped specimens along the freeway rights-of way. Vegetation communities mapped within the BSA and each proposed alignment area (Figure 6 and Figure 7).
