PROJECT NUMBER 02-281-(3)
OAK TREE PERMIT 200900050
ENVIRONMENTAL ASSESSMENT NO. IS02-281

The proposed project would authorize the removal of three (3) oak trees and the encroachment into the protected zone of nine (9) oak trees due to the construction of a 3,000 square foot single-family residence with an attached garage on a 5,998-square-foot property. A new septic system is proposed on the southeast corner of the property. Additional time extensions were granted, however, due to lengthy delays during review by the California Coastal Commission, the permit expired without use on July 1, 2009. This is a reissuance of a previous oak tree permit (OTP 02-281-(3)), as authorized by resolution of the Los Angeles County Board of Supervisors on September 22, 2009.

26247 Fairside Road, Malibu, CA 90265

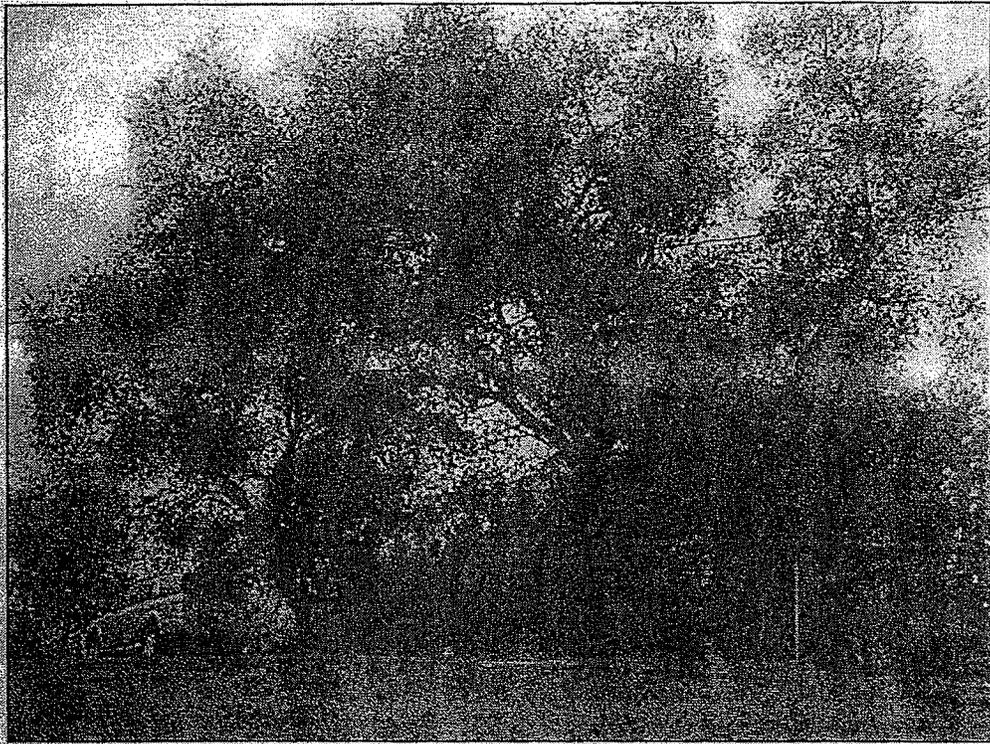
Front of site - Tree Number 1 (left), Tree Number 2 (right)

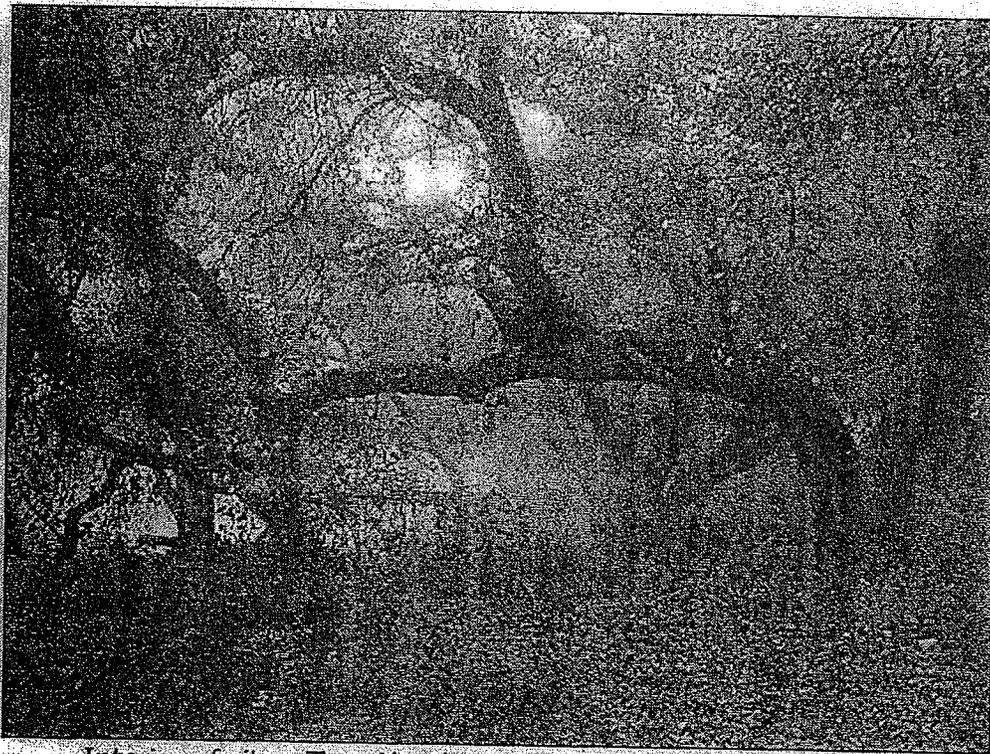
Interior of site - Tree Numbers 5, 4, 6, 7 and 3 (left to right)

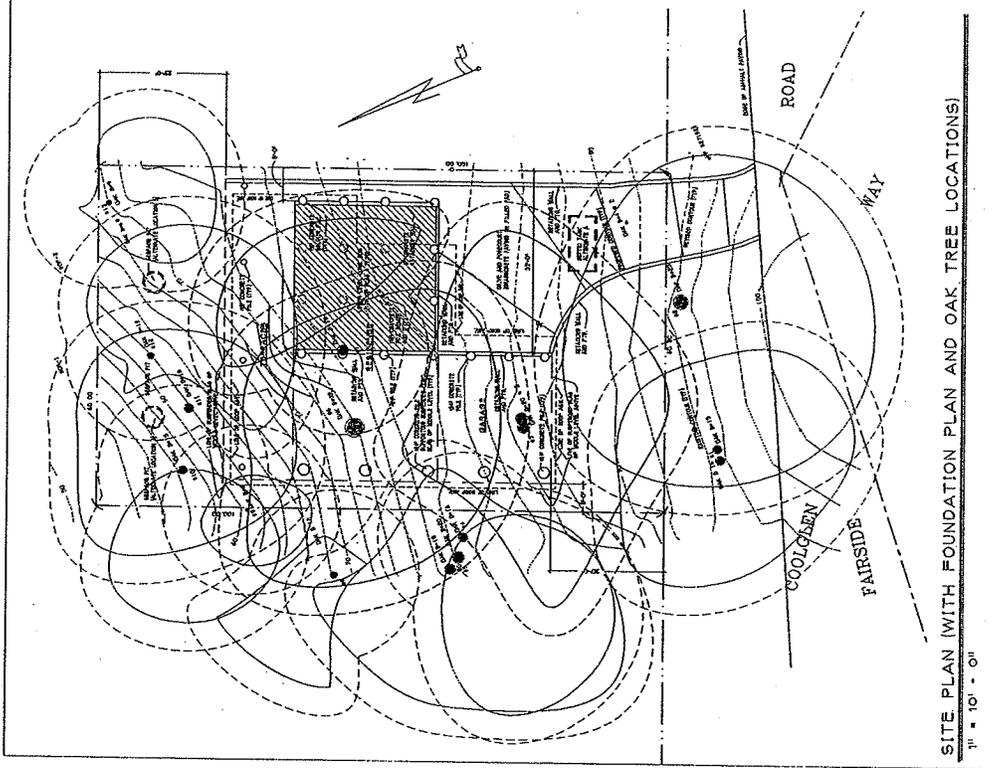
SITE PLAN (WITH FOUNDATION PLAN AND OAK TREE LOCATIONS)

1/4" = 10' - 0"

The site plan depicts the subject property with the proposed 3,000 sq. ft. single-family residence in the middle of the property. The attached garage is located on the south of the residence and faces Fairside Road. The proposed septic tank to service the house is located on the southeast corner of the property. The proposed oak trees to be removed are identified as oaks #3, #6, and #7. Oaks #6 and #7 are located where the single-family residence is proposed, and oak #3 is located where the garage is proposed to be built. The nine (9) oaks that are proposed to be encroached upon are located on the northern, western, and southern parts of the subject property.

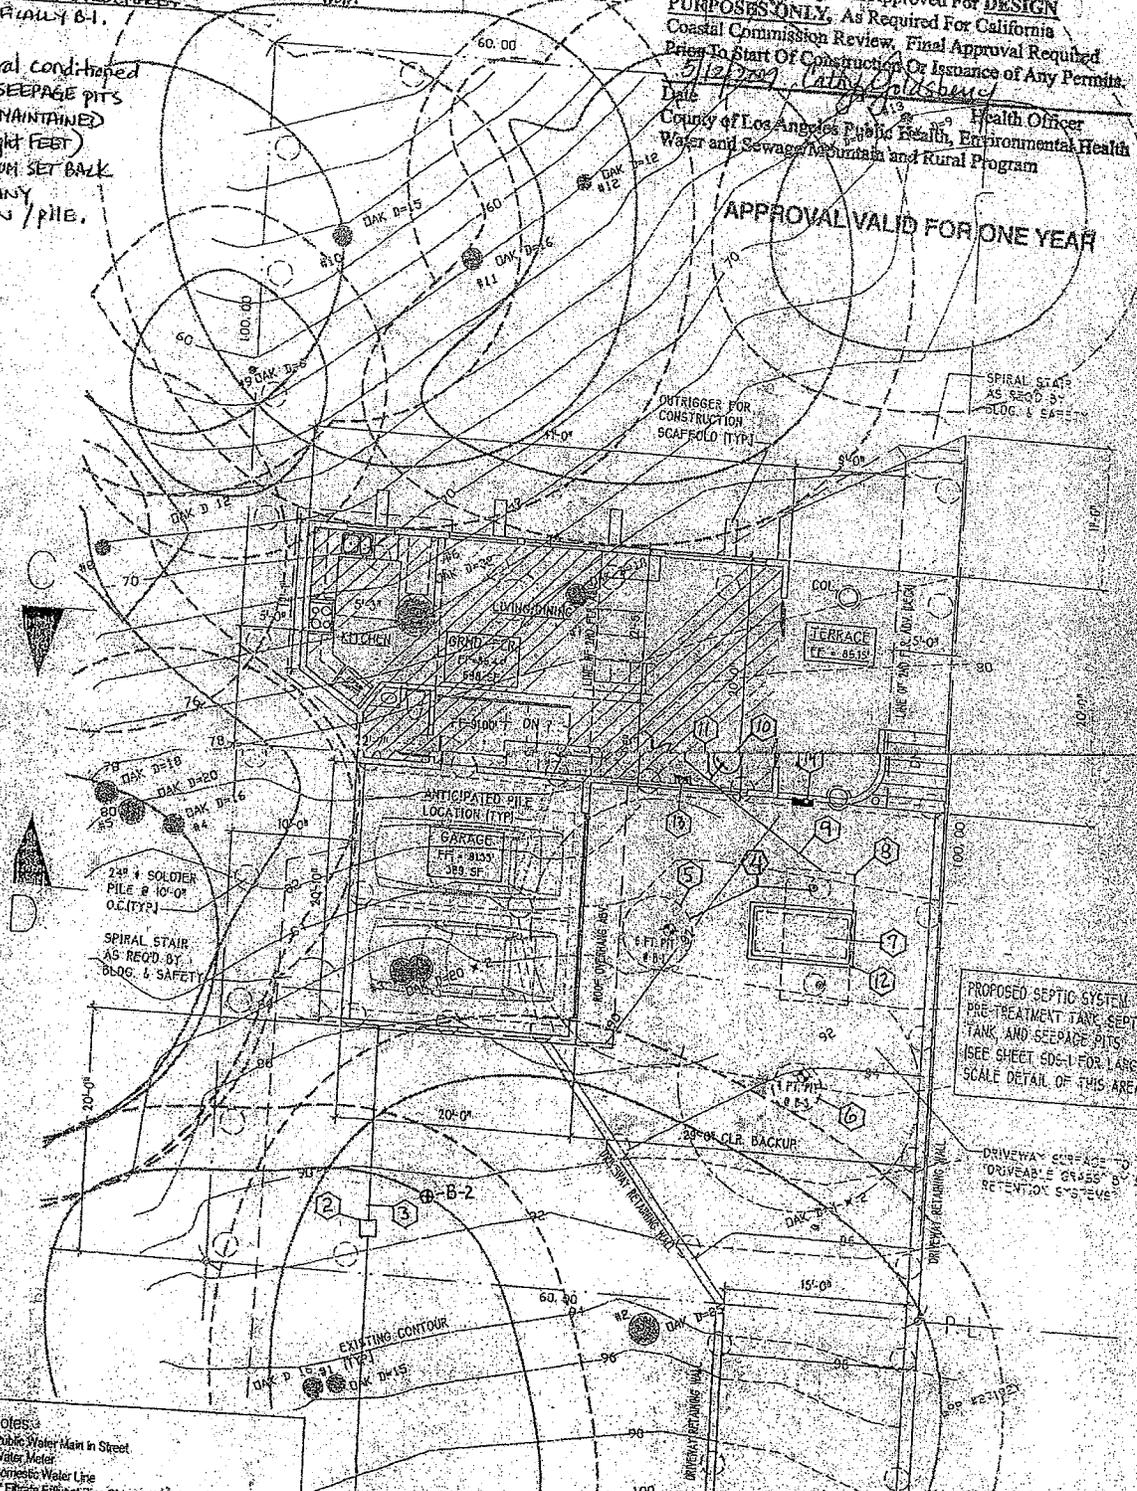
PROPOSED SEPTIC SYSTEM PRE-TREATMENT TANK, SEPTIC TANK, AND SEEPAGE PITS. SEE SHEET SDS-1 FOR LARGE SCALE DETAIL OF THIS AREA.

DRIVEWAY ESCAPE TO "OROVABLE CROSS" BY RETENTION SYSTEMS

On-site Wastewater Treatment & Disposal System Designed by:
Barton Sluiter
 Barton Sluiter, R.E.H.S.
 Cal Reg# 3140 Exp 12/31/2009
 Date: 5/12/09
