# Hearing Officer Transmittal Checklist

Los Angeles County Department of Regional Planning  
 320 West Temple Street  
 Los Angeles, California 90012  
 Telephone (213)  
**PROJECT NUMBER R2008-01118-(5)**  
**OAK TREE PERMIT 200800043**

Retroactive encroachment into the protected zone of three oak trees on the property for sewer line, electrical conduit and irrigation and drainage pipes

**STAFF ANALYSIS**  
**PROJECT NO. R2008-01118-(5)**  
**OAK TREE PERMIT NO. 2008-00043-(5)**

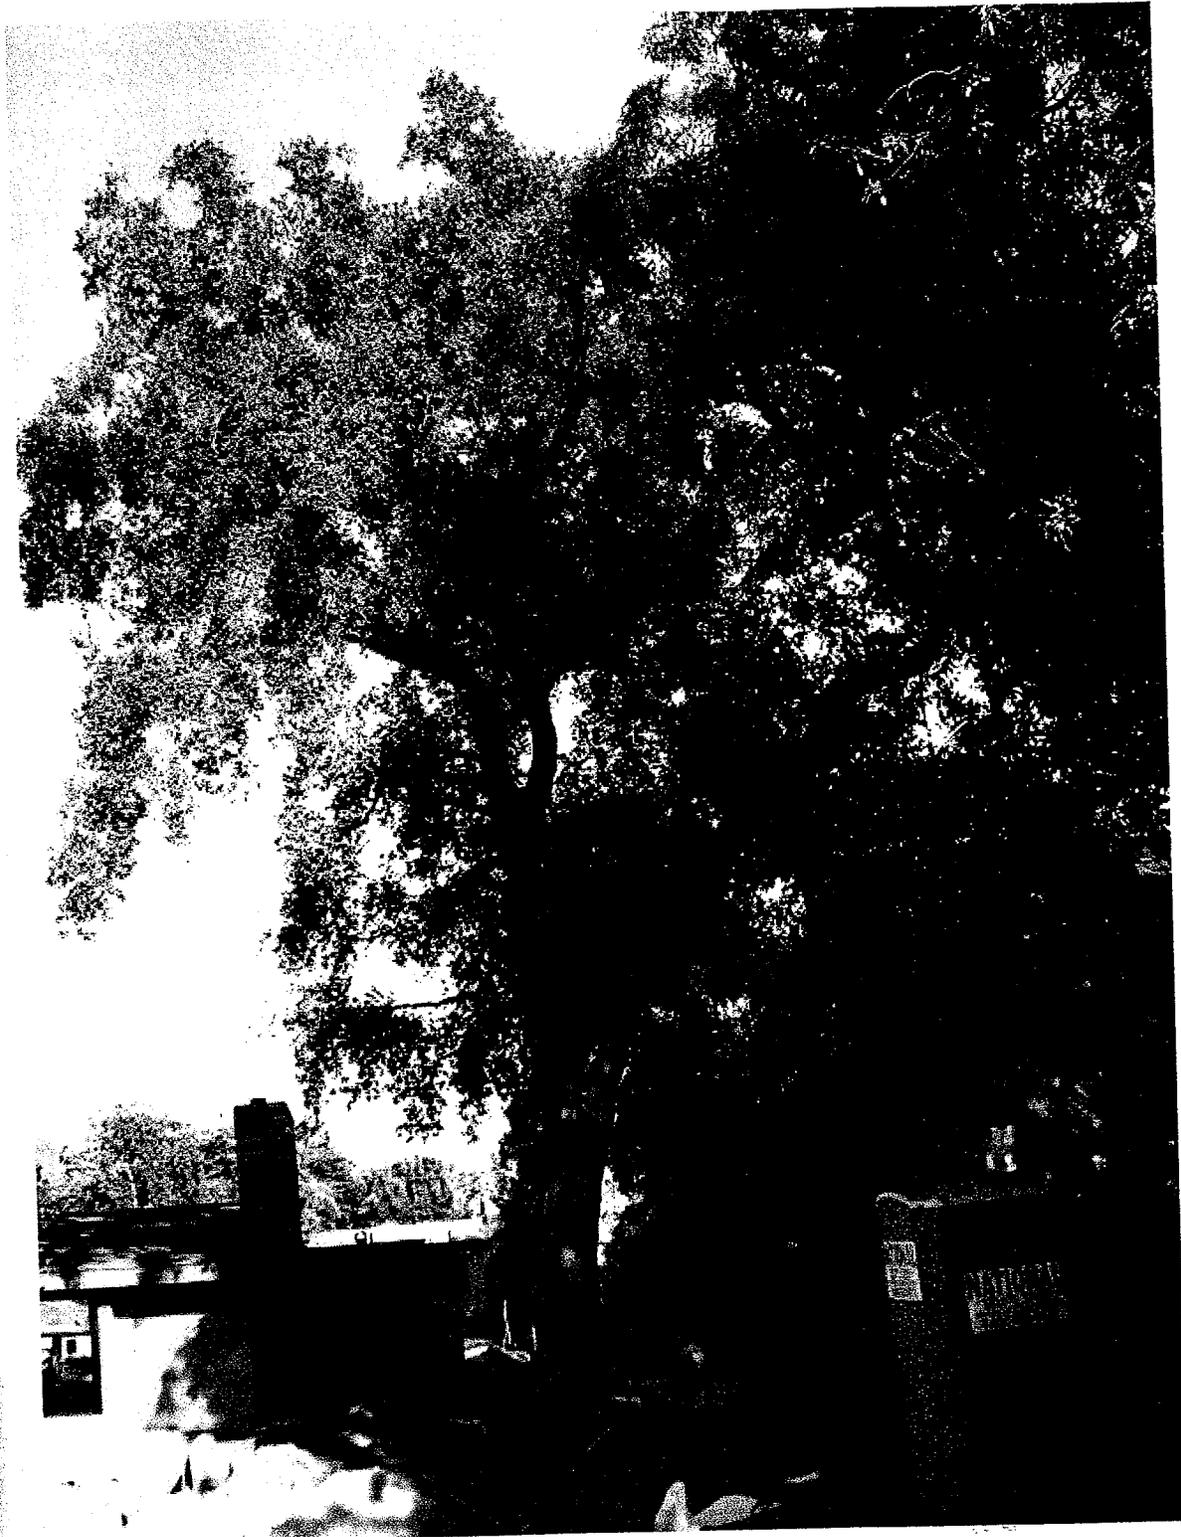
**Tree #1 (Photo #1)** is a Coast Live Oak, *Quercus agrifolia*. It is a mature specimen with a trunk diameter that measures 29 inches at 4 ½ feet above the natural grade. The tree has an approximate height of 45 feet and an average canopy spread of 40 feet. A visual inspection of the tree concluded that it is in good health, showing no signs of decay, disease or serious insect infestation. The entire canopy is alive and viable out to the terminal ends of all branches with ample foliage throughout.

Photo #1: Subject tree, *Quercus agrifolia*, Coast Live Oak, 29" DBH, 45'H, 40'W.

The installation of the portion of the driveway within the dripline of Tree #1 shall be monitored by the consulting arborist. This includes all excavation and setting of the forms for the concrete. The consultant is to ensure that no buttress roots or other significant roots shall be cut or damaged and it is the project manager's responsibility to make sure that the consultant is notified when the construction activity is to occur.

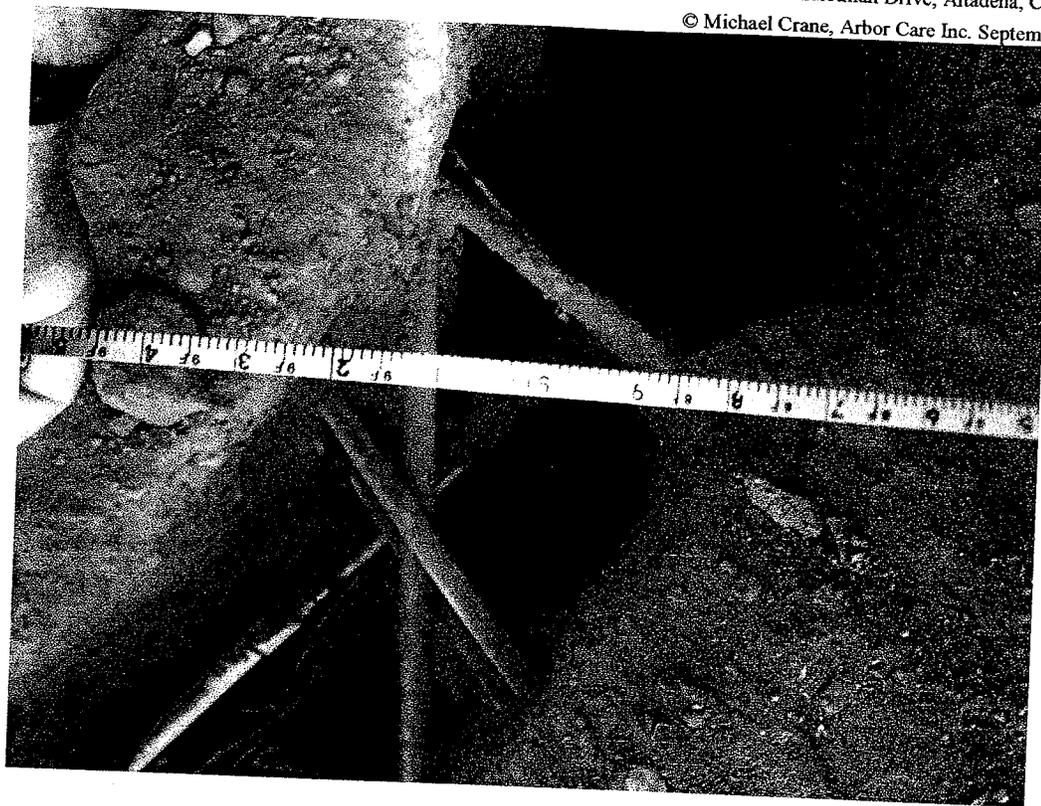
Photo #3 (Above): The closest point of excavation is nine feet from the outside of the trunk.

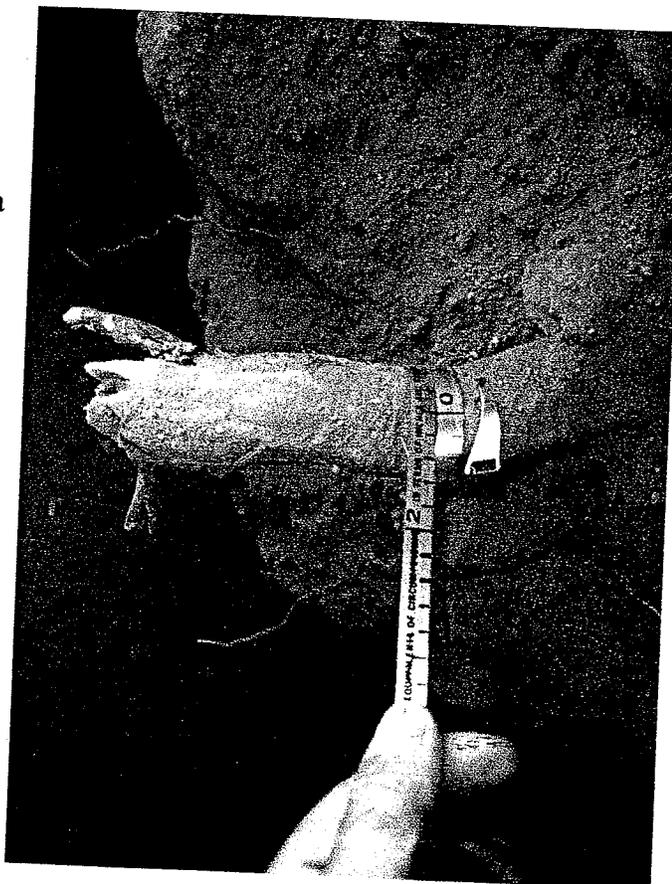
Photo #4 (Right): The largest encountered root measured one and a half inches in diameter.

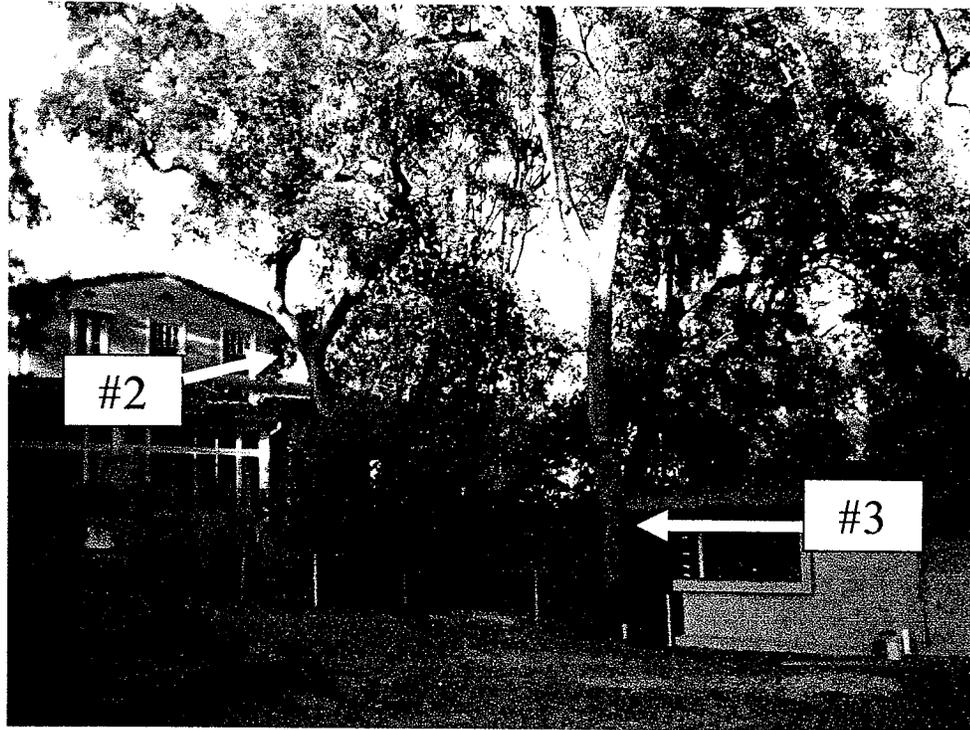
**Tree #2 (Photo #5)** is a Coast Live Oak, *Quercus agrifolia*. It is a mature specimen with a trunk diameter that measures 20 inches at 4 ½ feet above the natural grade. The tree has an approximate height of 40 feet and an average canopy spread of 30 feet. A visual inspection of the tree concluded that it is in good health, showing no signs of decay, disease or serious insect infestation. The entire canopy is alive and viable out to the terminal ends of all branches with ample foliage throughout.

**Tree #3 (Photo #5)** is an Engelmann Oak, *Quercus engelmannii*. It is a mature, multitrunked specimen with two trunks measuring 23 and 20 inches at 4 ½ feet above the natural grade. The tree has an approximate height of 40 feet and an average canopy spread of 30 feet. A visual inspection of the tree concluded that it is in good health, showing some slight decay at the base of the trunk which appears to have been adequately compartmentalized. There are no signs or symptoms of disease or serious insect infestation. The entire canopy is alive and viable out to the terminal ends of all branches with ample foliage throughout.

Photo #5: Trees #2 & #3.

- All further trenching within the TPZ's of Trees #2 & #3 which may be necessary for installing lateral irrigation lines shall be monitored by the consultant. An "Air Knife" is recommended for excavating so that the lines can be installed without severing any roots. The consultant has information regarding the use of this tool.

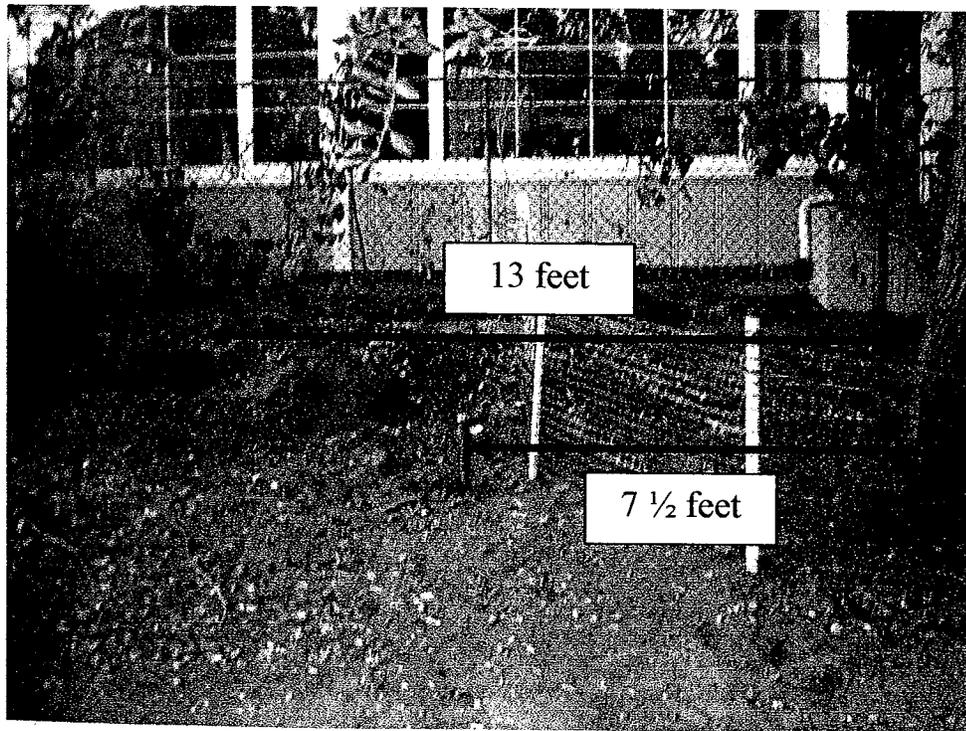
Photo #6: An irrigation valve manifold is 13 feet and an electrical conduit is seven and a half feet from the trunk of Tree #2. The trenches were dug radially from the trunk.

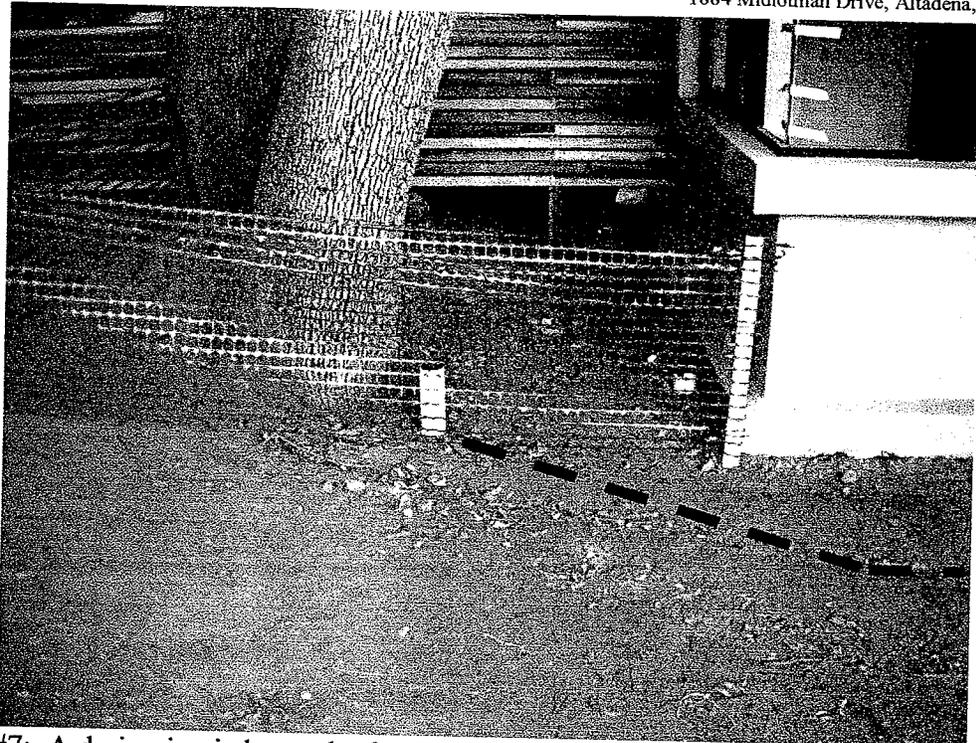
Photo #7: A drain pipe is located a foot from Tree #3. The pipe is 4-6 inches under grade and runs radially from the trunk.

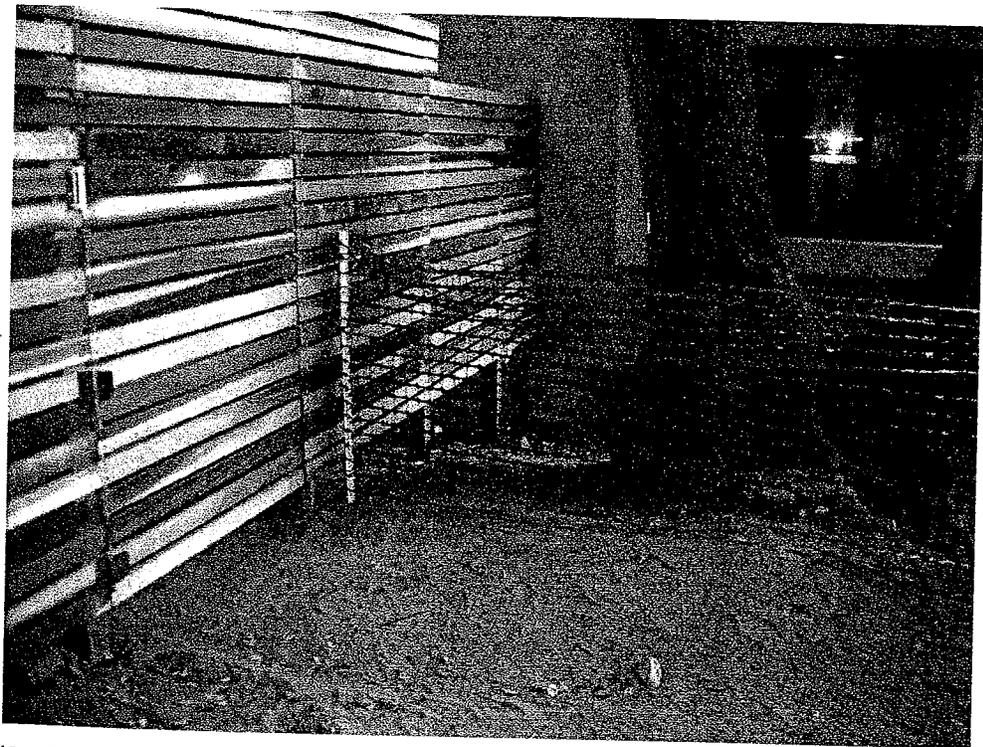
Photo #8: The wood fence was built using wood posts anchored in concrete. These types of post holes require little excavation and preserve the root mass from being severed.
