Camp Vincent Kilpatrick, APN 4471-003-900, 4471-004-902, 4471-004-903, 4471-004-905
427 Encinal Road, Malibu CA 90265
R2012-02386, CDP 201500030

Biological Documents, Table of Contents

CAMP KILPATRICK REPLACEMENT PROJECT

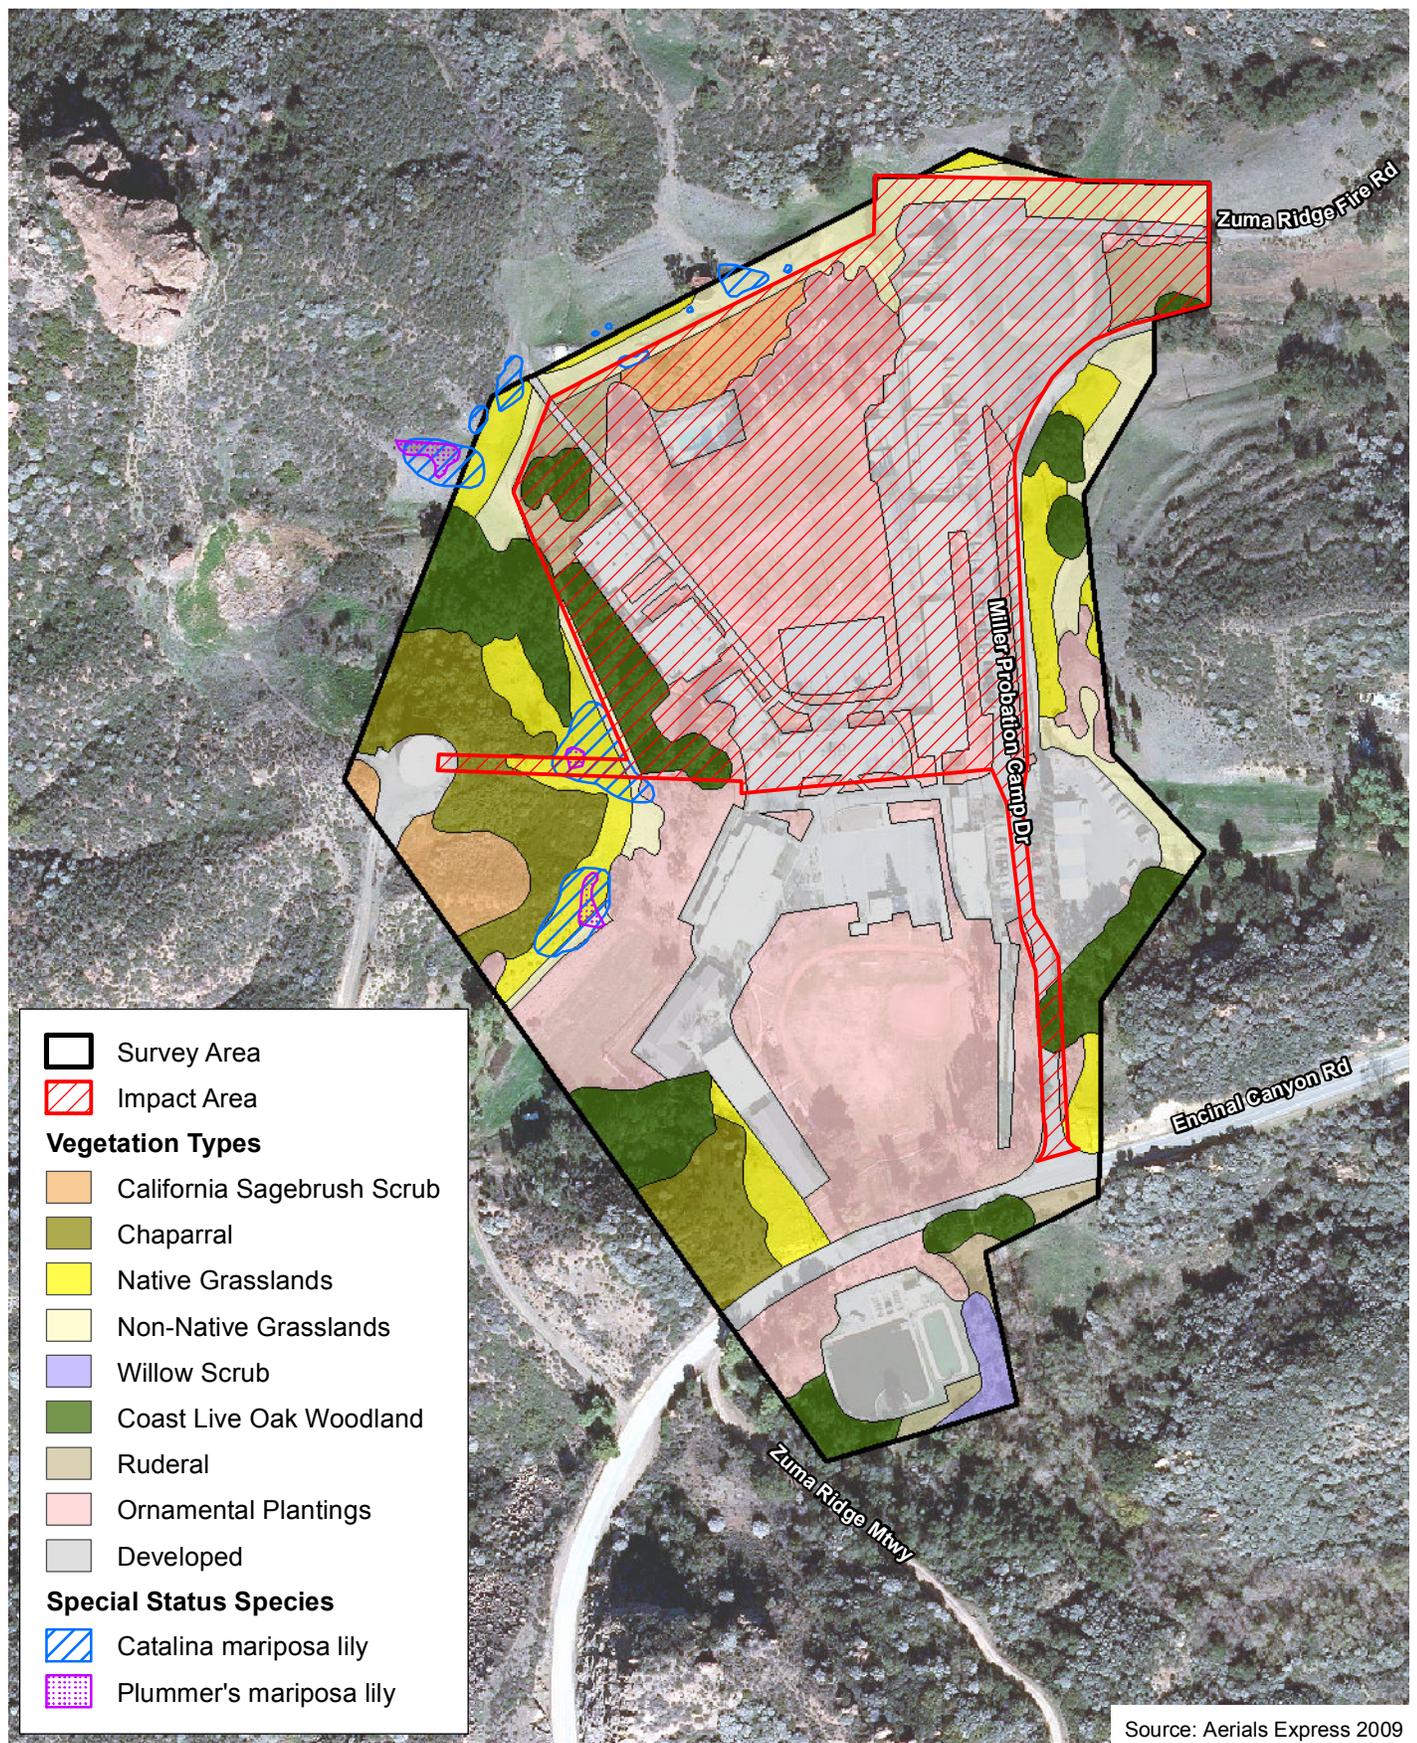
Project Impacts

Source: Aerials Express 2009

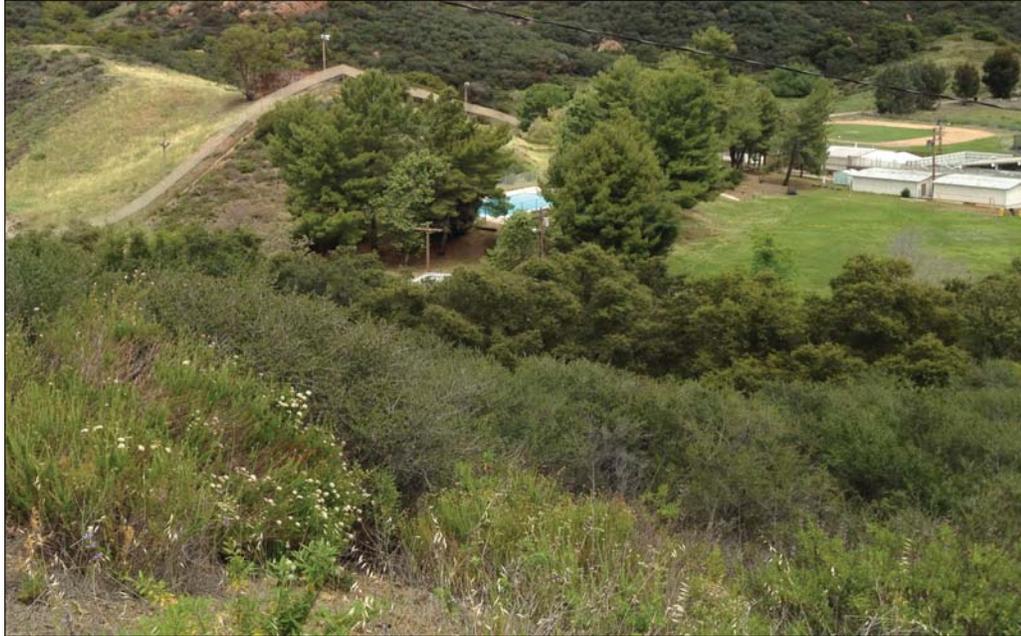
Attachment A-1

View of the northern portion of the facility from the hilltop near the water tower. In the foreground is California sagebrush scrub, chaparral, and coast live oak woodland vegetation. From the midground to background are ornamental plantings within the fenced area of the facility. The northernmost hill above the swimming pool and the old water tower behind the fence are visible at upper left.

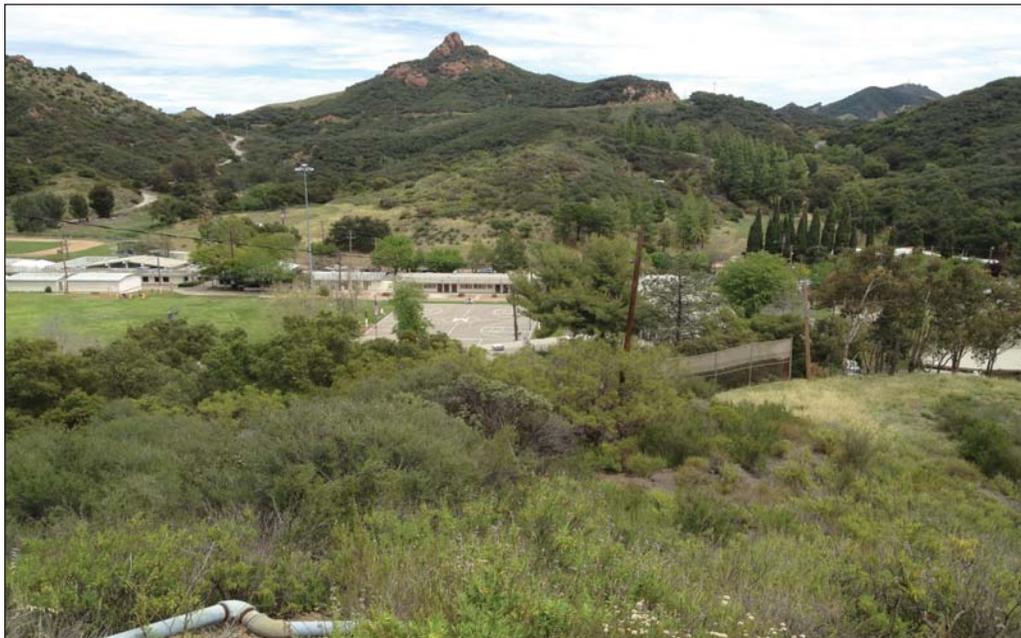
View of the central portion of the facility from the hilltop near the water tower. In the foreground is California sagebrush scrub, chaparral, and coast live oak woodland vegetation. From the midground to background are ornamental plantings within the fenced area of the facility. The buildings that may be replaced are visible in a horizontal band just a bit above the middle of the photograph. Part of the grassland in which Catalina mariposa lily and Plummer's mariposa lily grow is visible at the lower right.

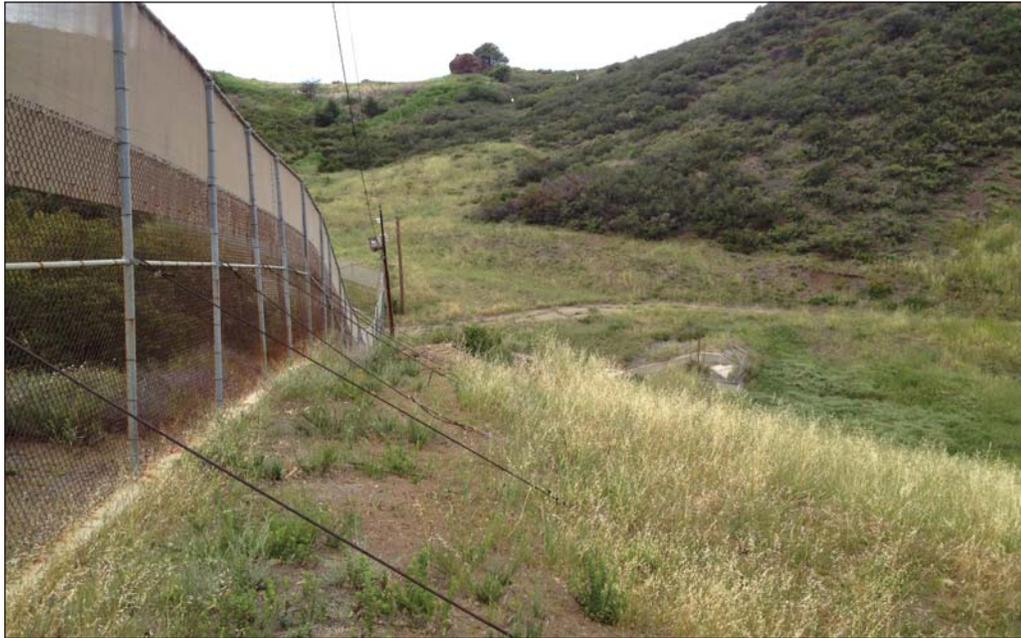
Attachment A-2

View of the north region toward the southwest. This area is within a fuel modification area and is mowed annually for fire prevention. Catalina mariposa lilies grow from the hilltop surrounding the old water tower, down to the grassland that is visible in the distant center in the area from the fence to about 15 feet toward the north (right). Plummer's mariposa lilies are far less common here; they grow in the grassland that is visible in the distant center.

Location 1 (UTM 11S 3773950, 330372): A total of 428 plants were observed in native grassland with clay soils. Associated species include foothill needlegrass (*Stipa lepida*) and woolly blue curls (*Trichostema lanatum*). The lower slope of this location is within an existing fuel modification area.

Location 2 (UTM 11S 3773919, 330344): A total of 504 plants were observed in native grassland with clay soils. Associated species include foothill needlegrass and woolly blue curls. The lower slope of this location is within an existing fuel modification area.

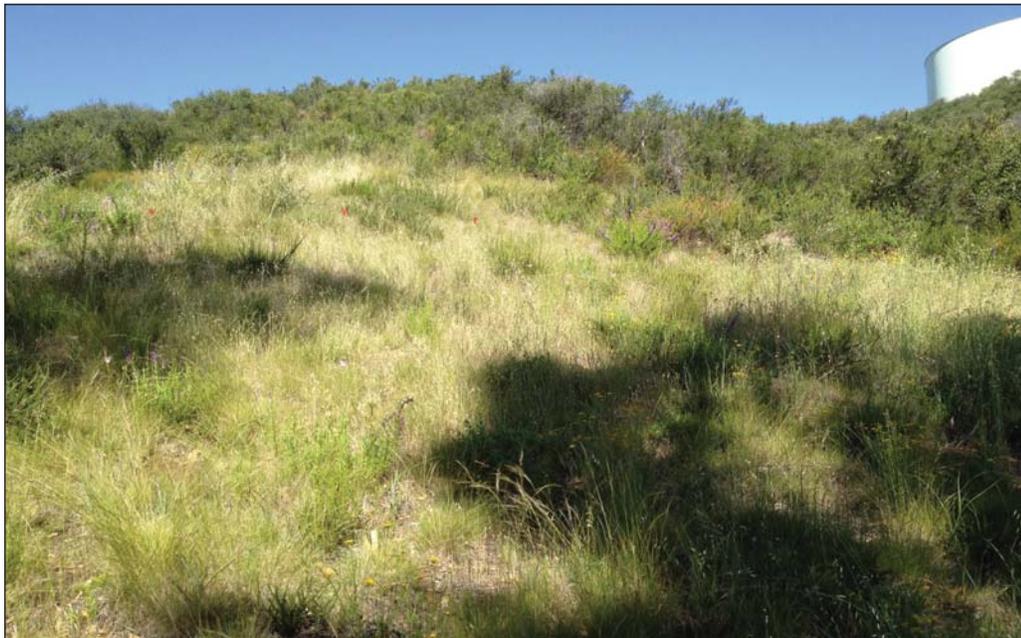
View of native grassland and chaparral. This area lies downslope and southeast from the large water tower on the west side of the facility. The grassland is vegetated with purple needlegrass, woolly blue curls, Catalina mariposa lilies, and Plummer's mariposa lilies. The chaparral on the hill above the grassland is vegetated by woody shrubs, primarily chamise.

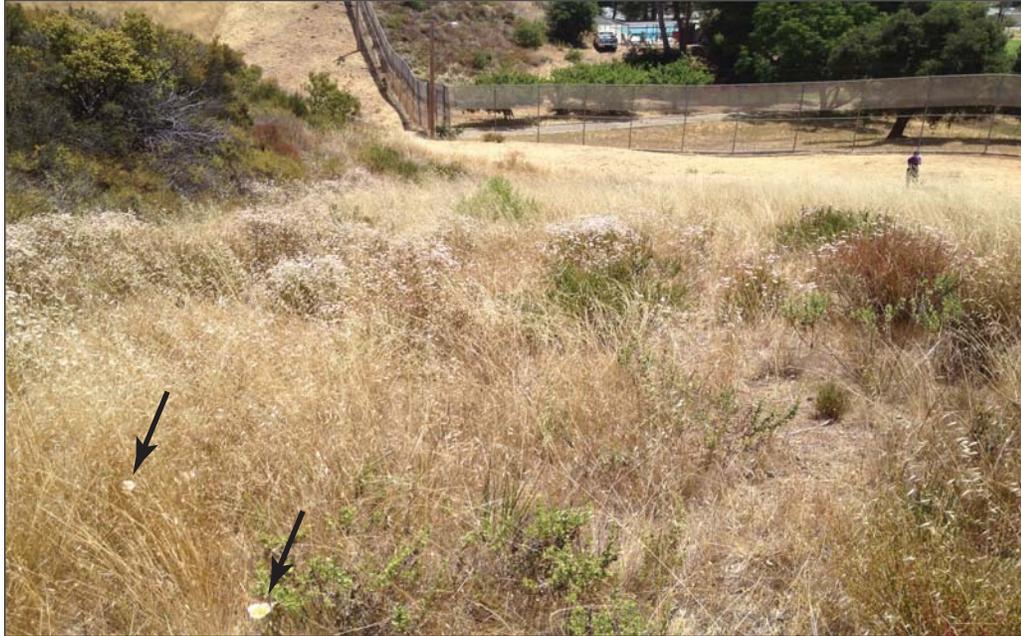
Attachment A-3

View from the northwest, toward the east-southeast of a mixture of native and non-native grassland species. The mariposa lilies grow in the grassland on this hillside. A few Plummer's mariposa lilies are visible in the foreground.

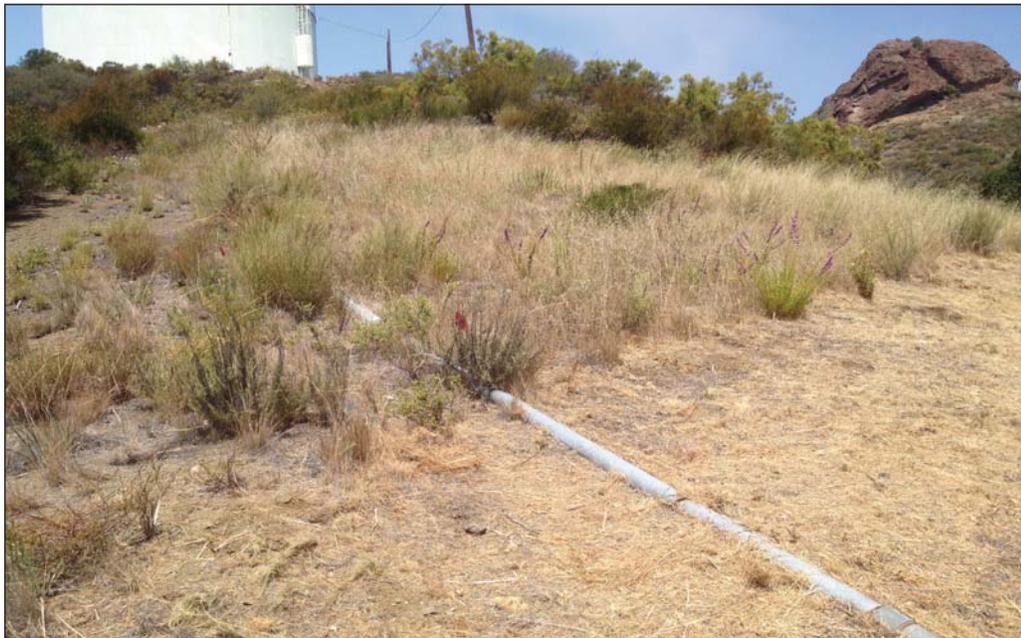
View of native grassland, looking up at the water tower. Just prior to this survey visit, the lower area down to the fence was cleared of vegetation for fuel modification. The mariposa lilies are scattered throughout this grassland area.

These mariposa lilies were initially observed in bud and counted during the June 4, 2012 survey. Due to the late timing of blooming, it was assumed that they were Plummer's mariposa lily, and the species was confirmed during the July 5, 2012 survey. The fuel modification was conducted between the June and

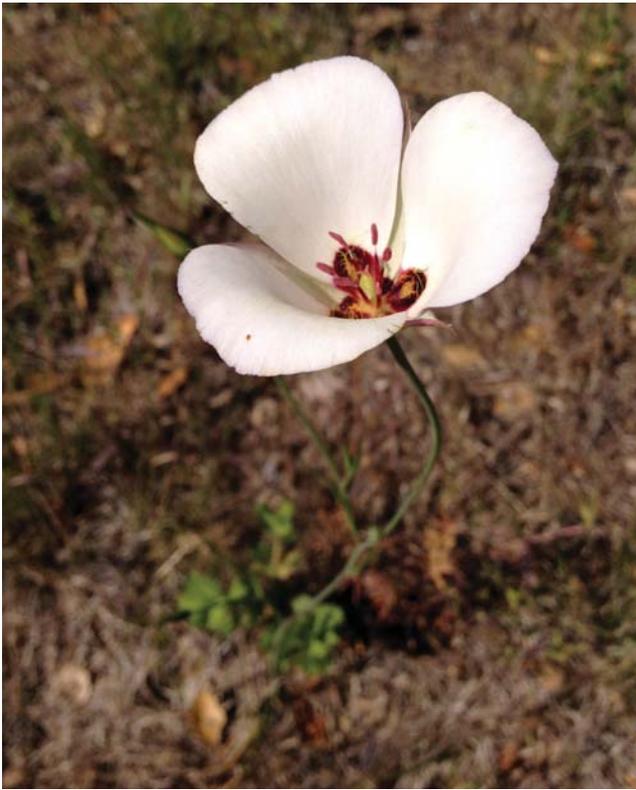
Catalina mariposa lily (*Calochortus catalinae*).

Catalina mariposa lily (*Calochortus catalinae*) has a CRPR of 4.2. This lily grows in heavy soils, especially clay, among grassland, scrub, and oak woodland vegetation. It has a small underground bulb surrounded by a thin papery bulb coat. In early winter, it sends up a few grass-like leaves. Its tulip-like flowers are produced atop medium to long slender stalks, which open between February and June, depending on weather conditions. Suitable habitat for this species is present in many grassland and open areas of the survey area.

Four locations of this species were observed in the survey area. All locations were in the open space outside the facility fencing, west and northwest of the facility (Exhibit 5).

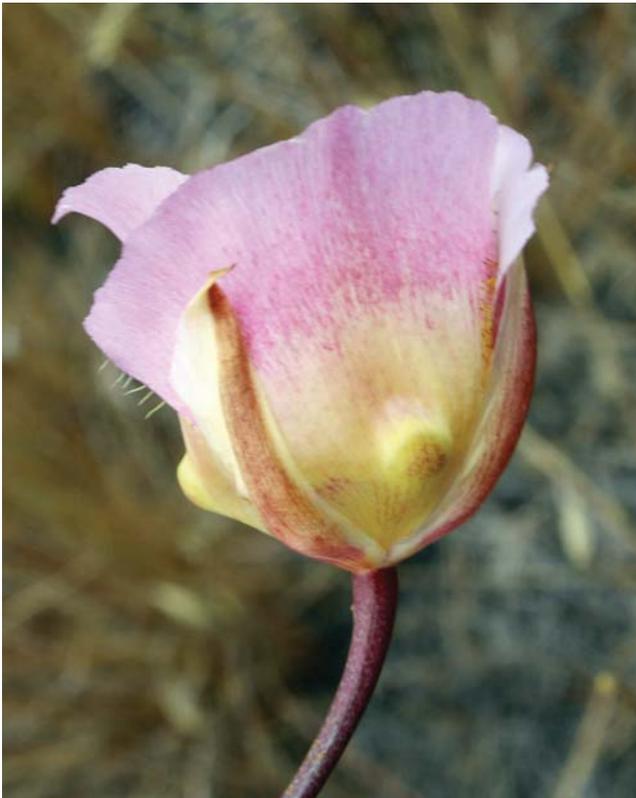
Plummer's mariposa lily (*Calochortus plummerae*).

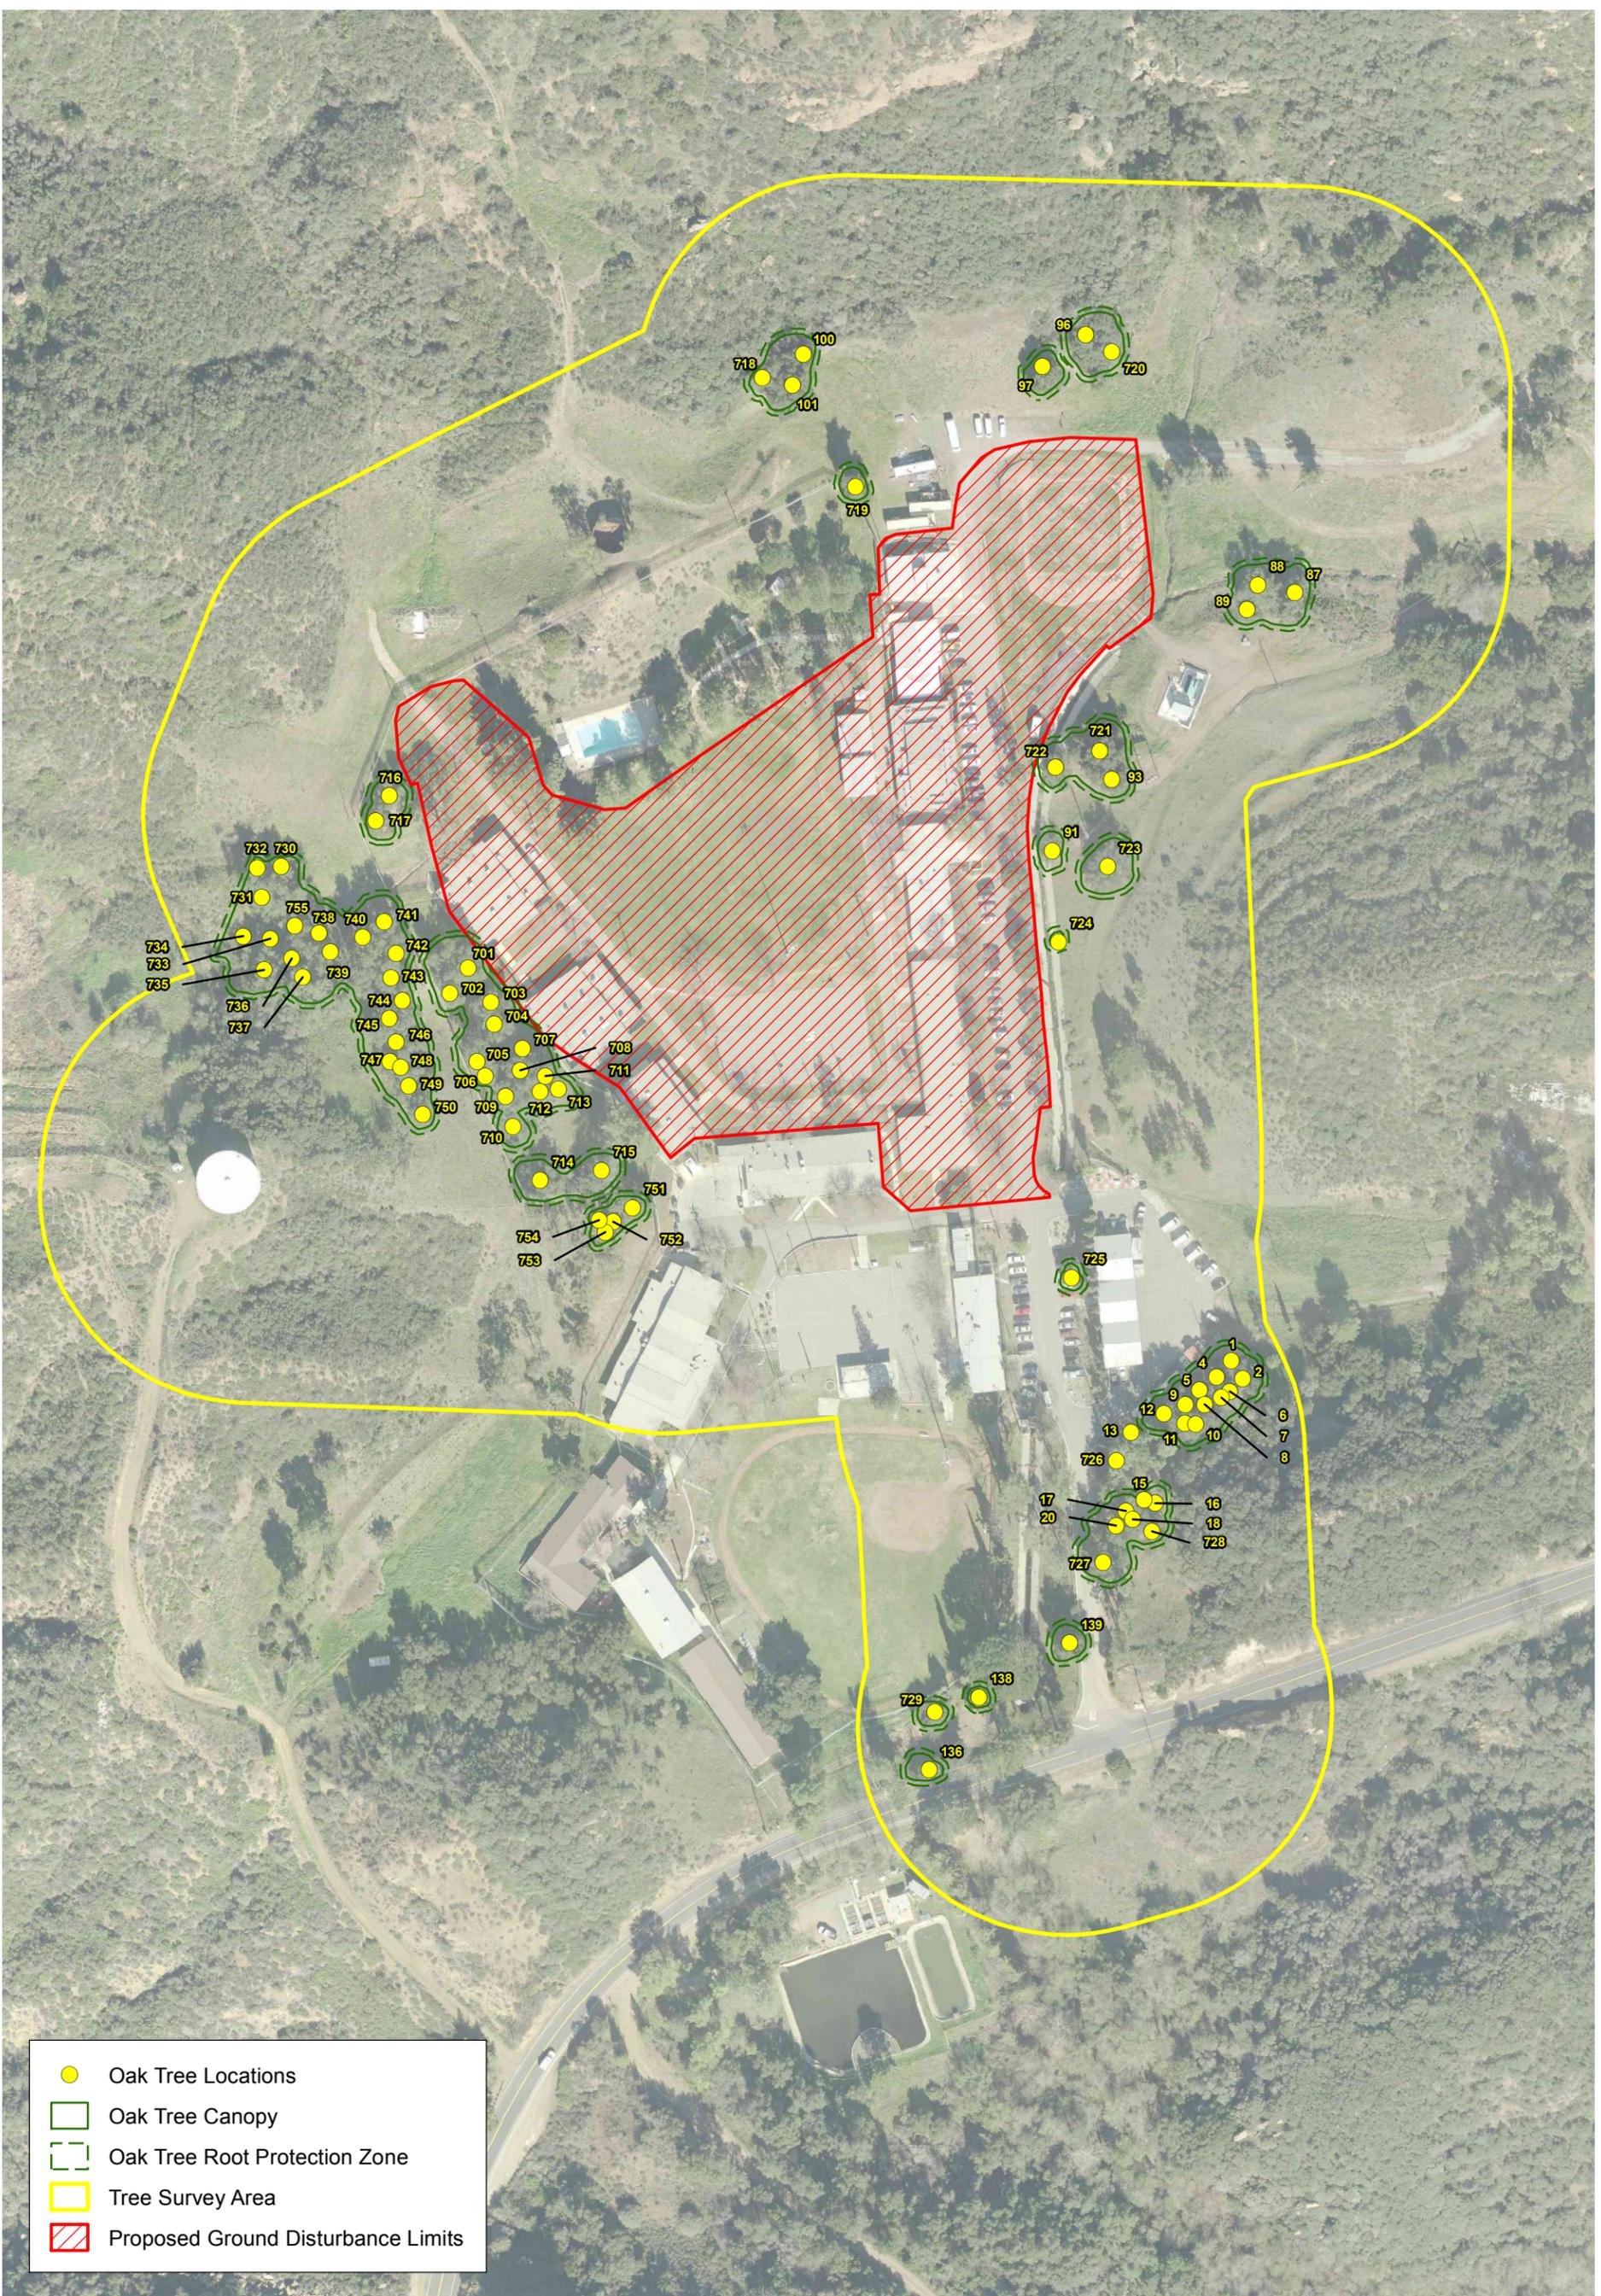
- Oak Tree Locations
- Oak Tree Canopy
- Oak Tree Root Protection Zone
- Tree Survey Area
- Proposed Ground Disturbance Limits

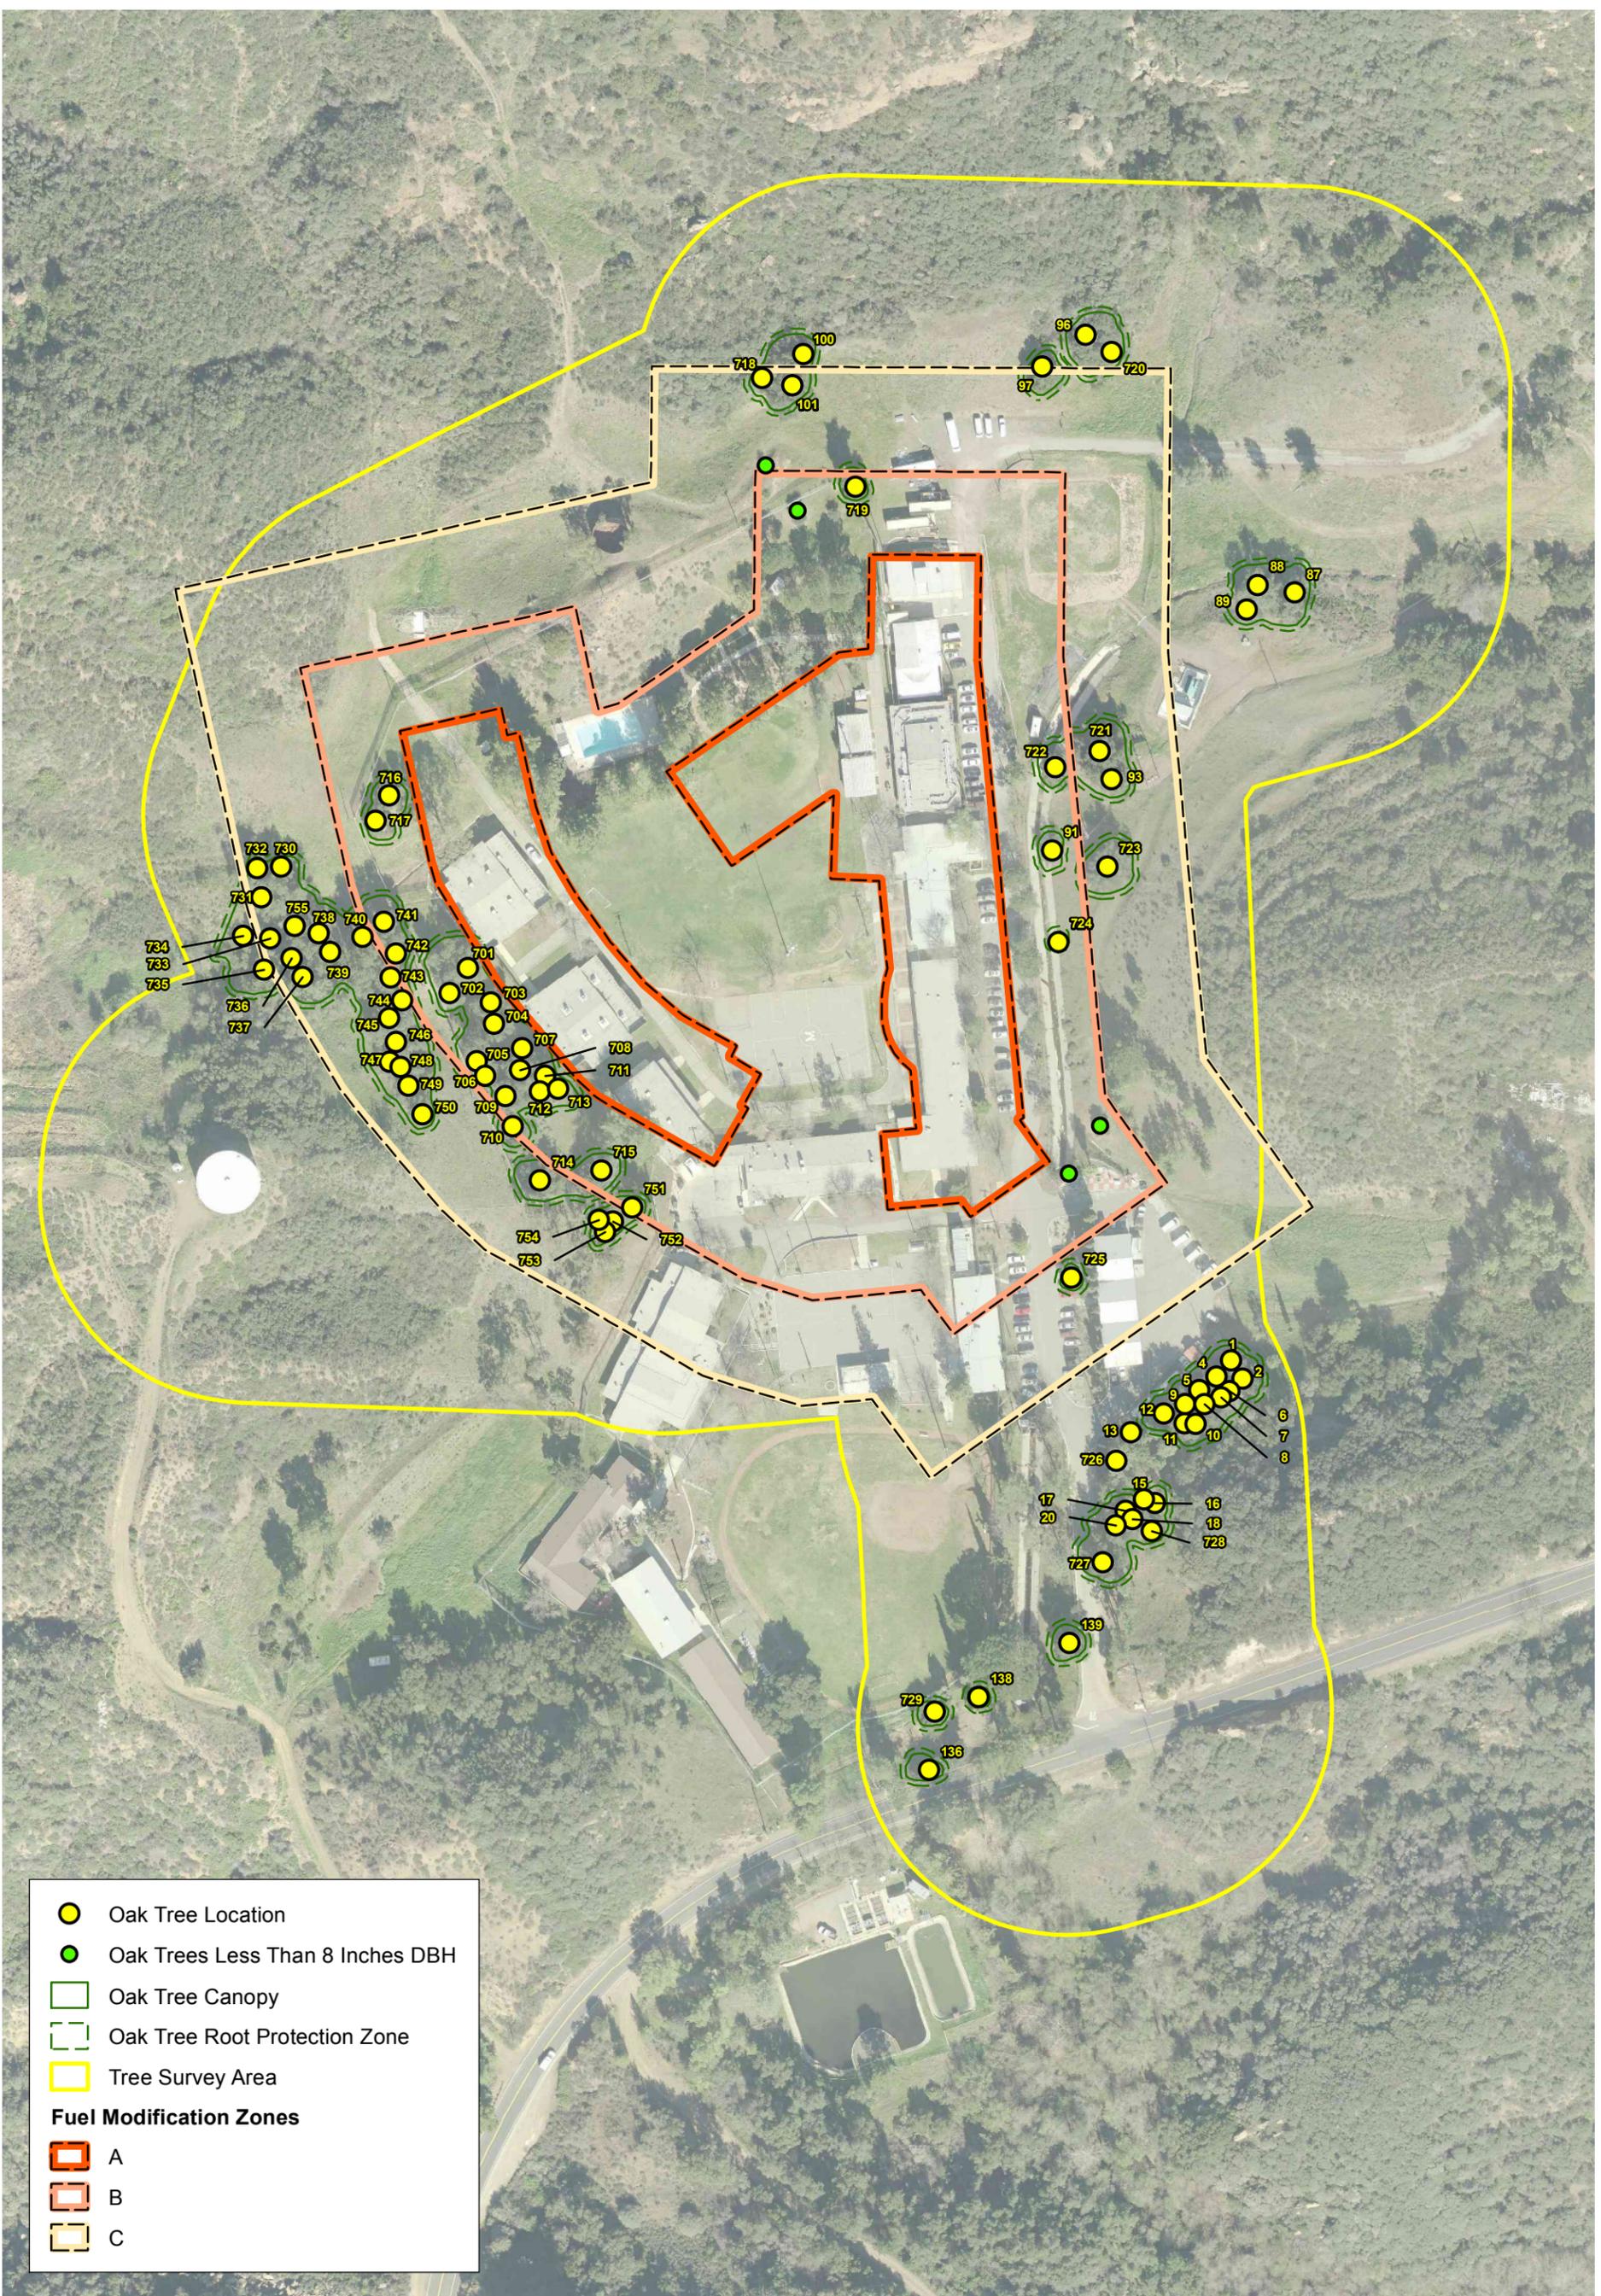
Oak Tree Survey – Fuel Modification Zones

● Oak Tree Location
 ● Oak Trees Less Than 8 Inches DBH
 □ Oak Tree Canopy
 □ Oak Tree Root Protection Zone
 □ Tree Survey Area
Fuel Modification Zones
 A
 B
 C

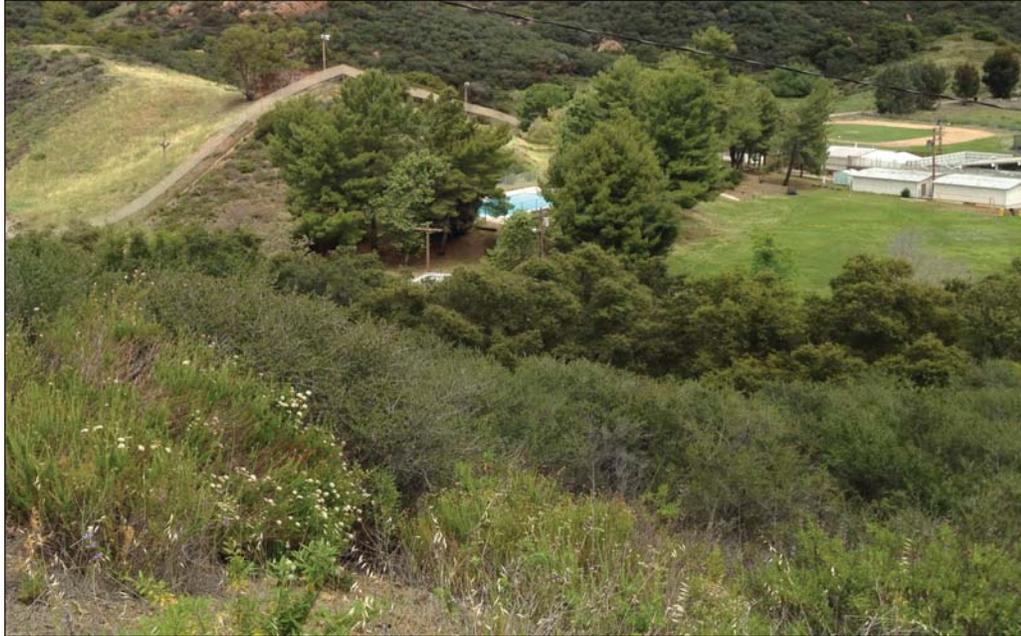
Attachment A-1

View of the northern portion of the facility from the hilltop near the water tower. In the foreground is California sagebrush scrub, chaparral, and coast live oak woodland vegetation. From the midground to background are ornamental plantings within the fenced area of the facility. The northernmost hill above the swimming pool and the old water tower behind the fence are visible at upper left.

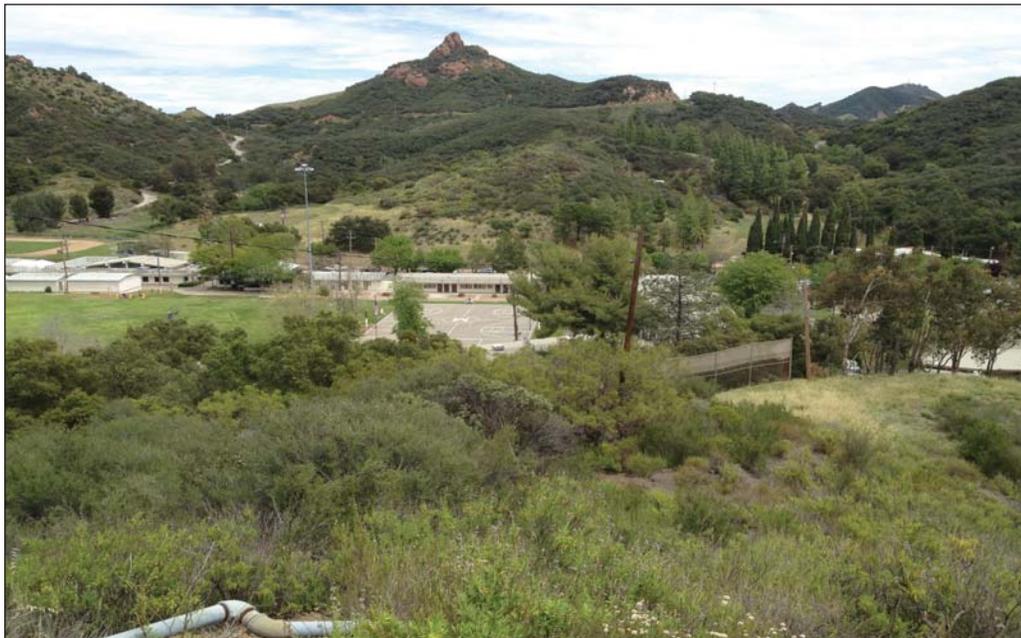
View of the central portion of the facility from the hilltop near the water tower. In the foreground is California sagebrush scrub, chaparral, and coast live oak woodland vegetation. From the midground to background are ornamental plantings within the fenced area of the facility. The buildings that may be replaced are visible in a horizontal band just a bit above the middle of the photograph. Part of the grassland in which Catalina mariposa lily and Plummer's mariposa lily grow is visible at the lower right.

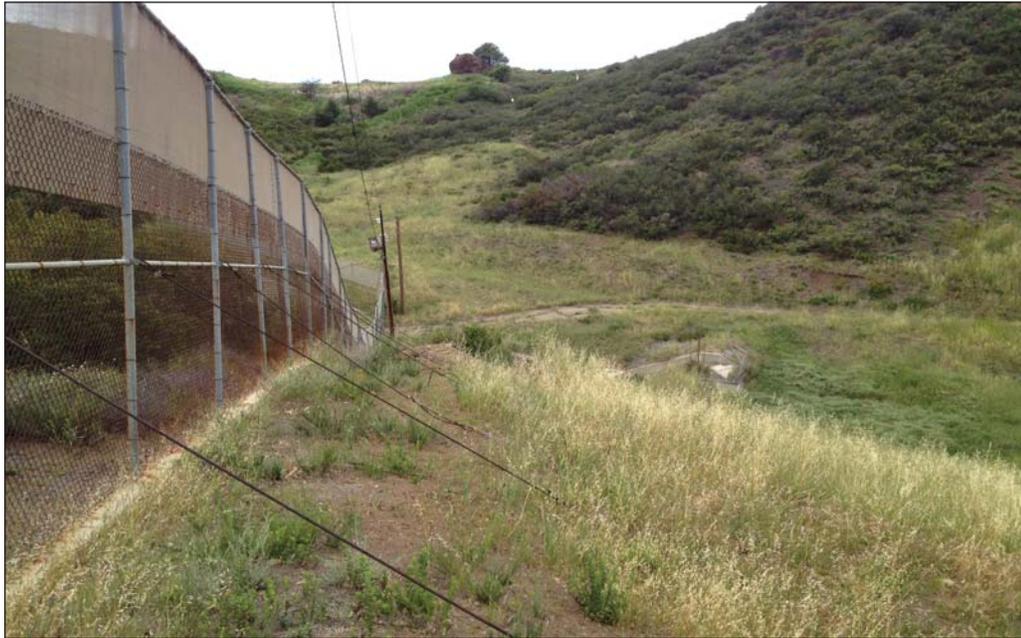
Attachment A-2

View of the north region toward the southwest. This area is within a fuel modification area and is mowed annually for fire prevention. Catalina mariposa lilies grow from the hilltop surrounding the old water tower, down to the grassland that is visible in the distant center in the area from the fence to about 15 feet toward the north (right). Plummer's mariposa lilies are far less common here; they grow in the grassland that is visible in the distant center.

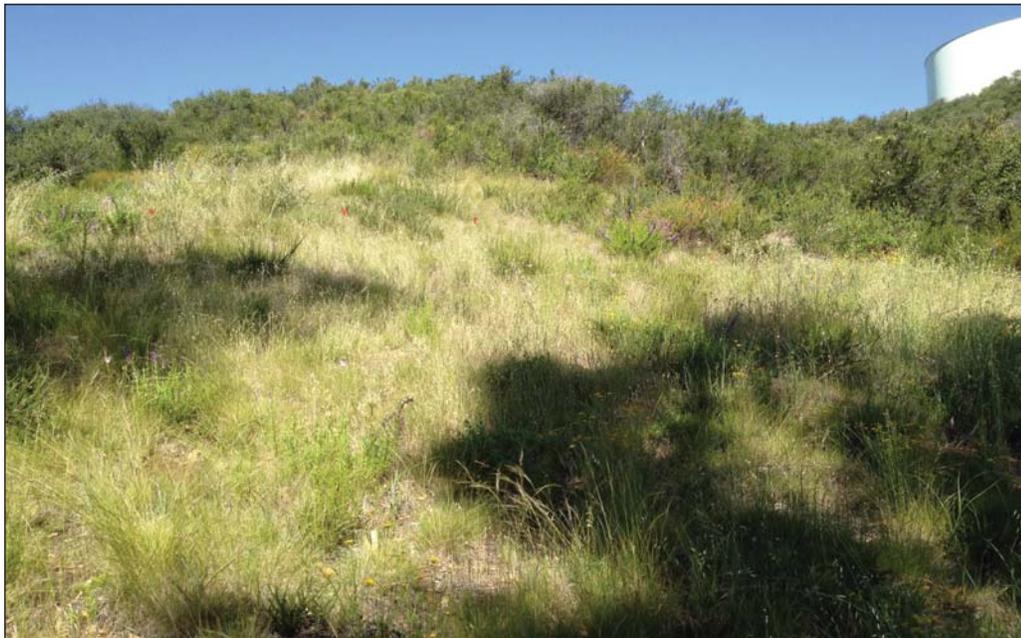
View of native grassland and chaparral. This area lies downslope and southeast from the large water tower on the west side of the facility. The grassland is vegetated with purple needlegrass, woolly blue curls, Catalina mariposa lilies, and Plummer's mariposa lilies. The chaparral on the hill above the grassland is vegetated by woody shrubs, primarily chamise.

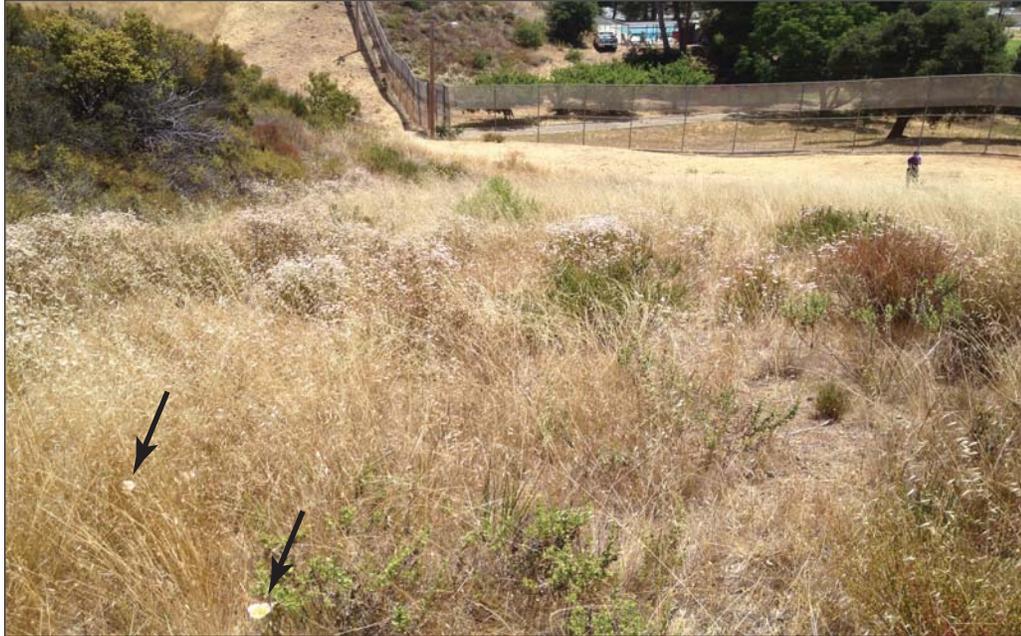
Attachment A-3

View from the northwest, toward the east-southeast of a mixture of native and non-native grassland species. The mariposa lilies grow in the grassland on this hillside. A few Plummer's mariposa lilies are visible in the foreground.

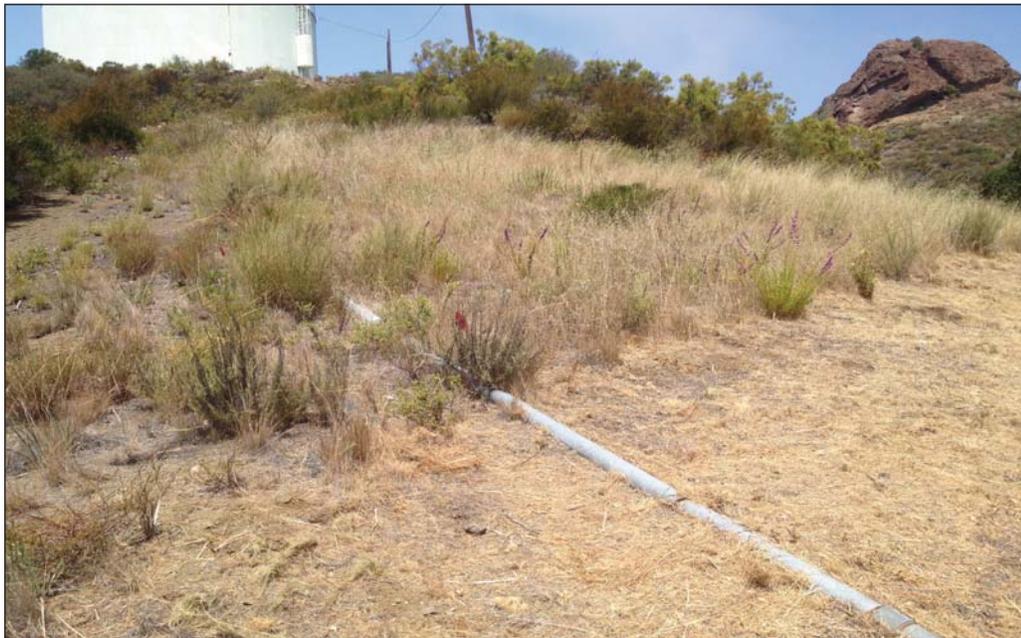
View of native grassland, looking up at the water tower. Just prior to this survey visit, the lower area down to the fence was cleared of vegetation for fuel modification. The mariposa lilies are scattered throughout this grassland area.

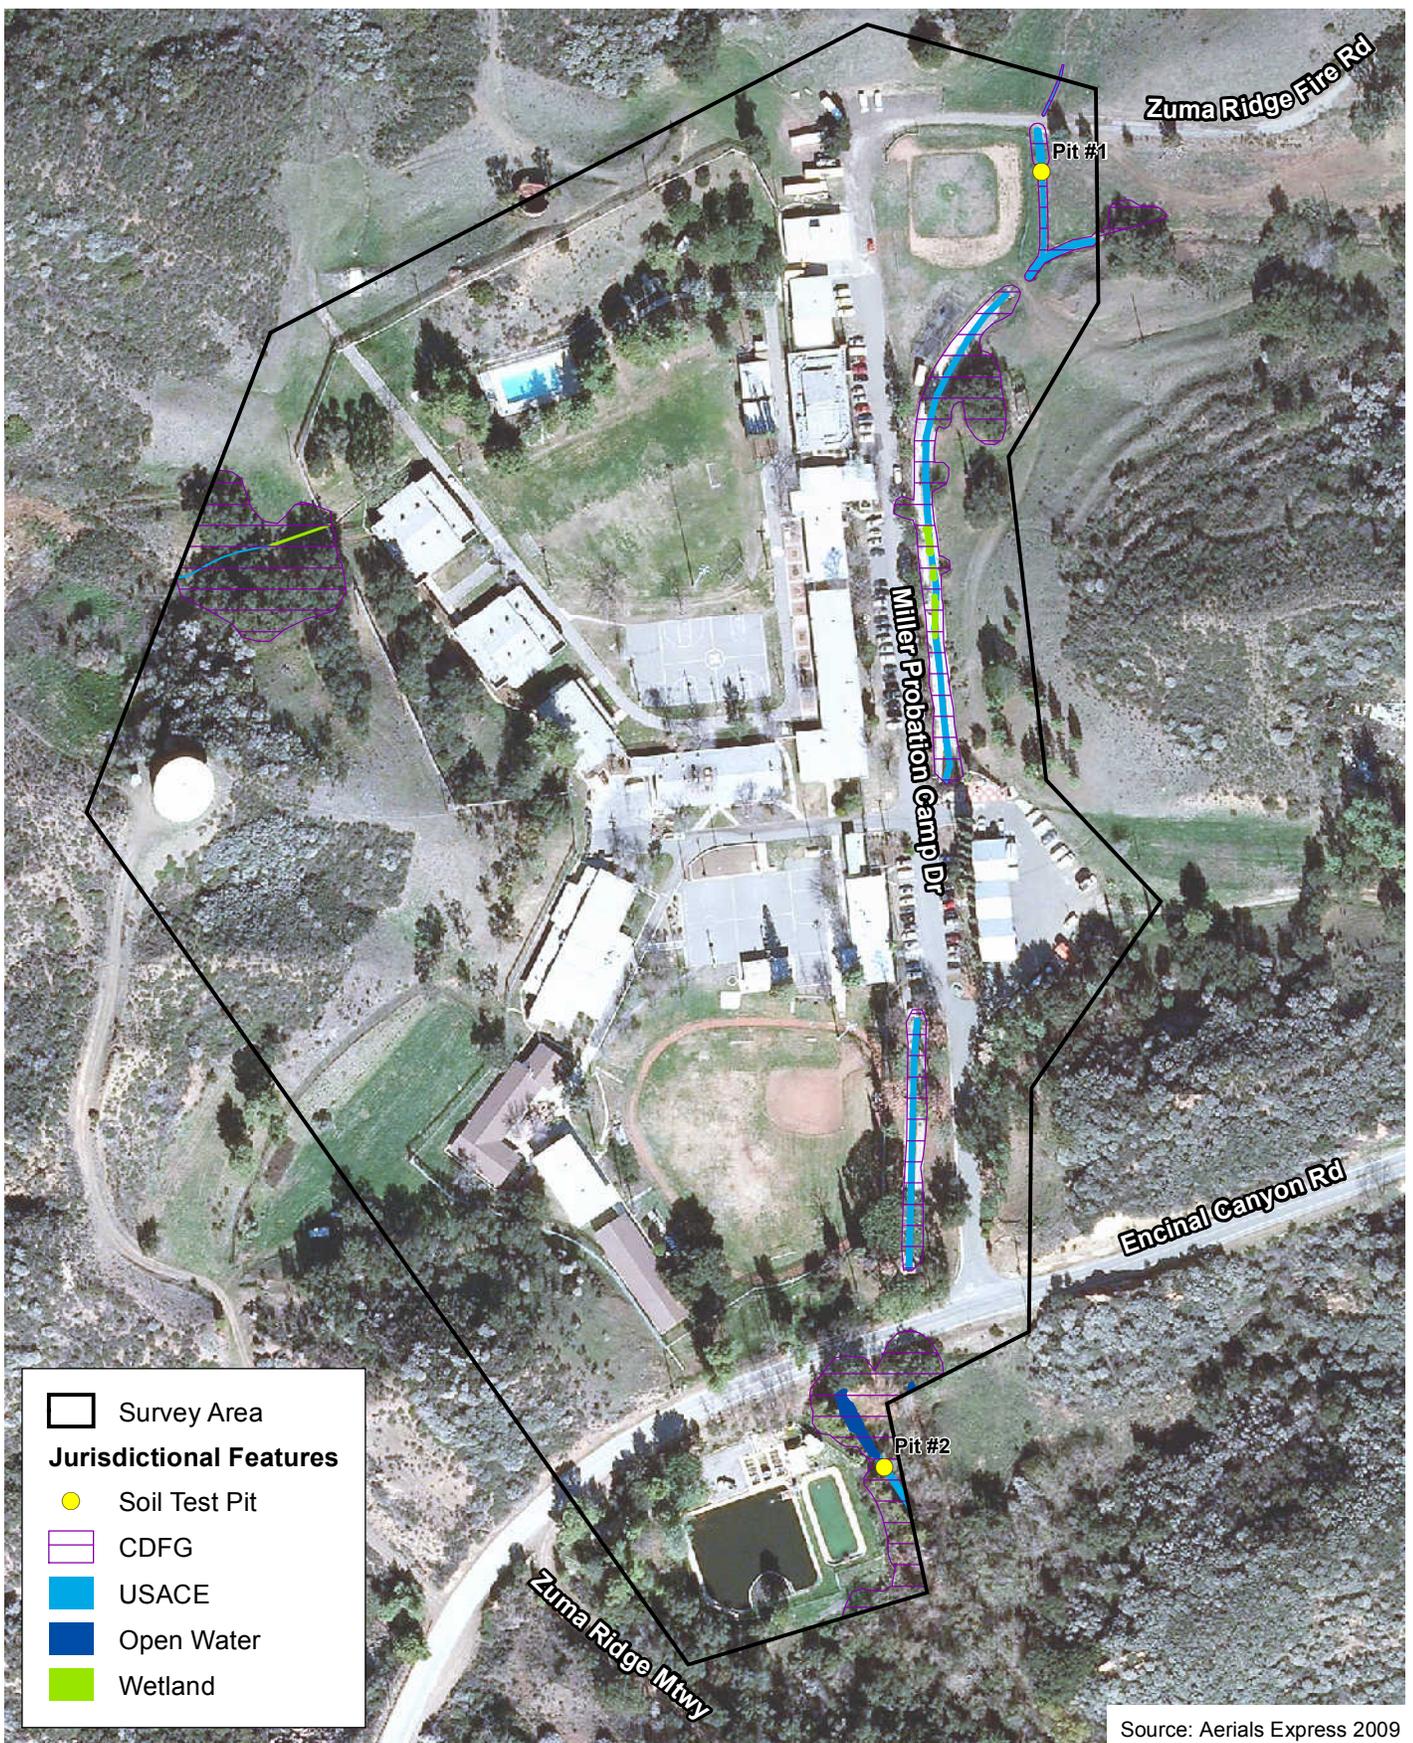
Exhibit 5

USACE and CDFG Jurisdictional Resources
 Camp Vernon Kilpatrick Replacement Project
