Subject: Biological Assessment
Million Gallon Tank Repair Project
Catalina, California

Southern California Edison (SCE) is proposing repairs to the Million Gallon Tank (MGT) located above Two Harbors on Santa Catalina Island, in Los Angeles County, California (see Figure 1). LSA Associates, Inc. (LSA) reviewed potential impacts associated with the proposed repair activities and identified no major constraints. However, some native vegetation is likely to be impacted. Representative photographs of the project site are provided as an attachment.

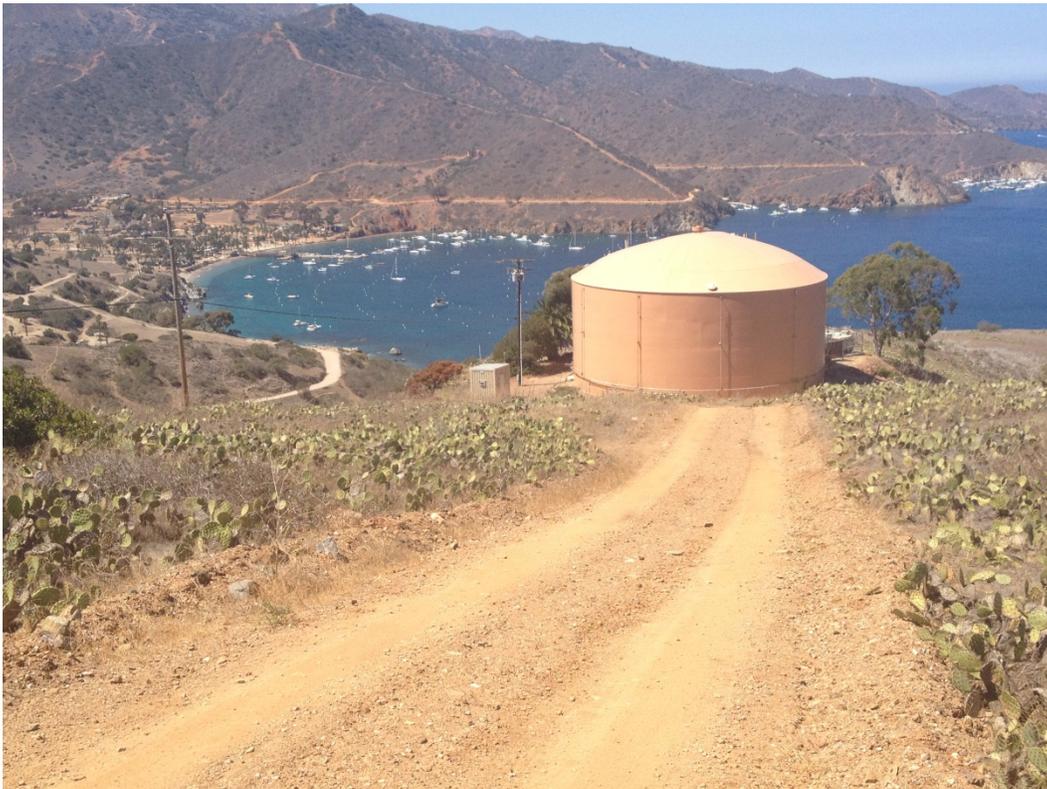
The MGT is on a gentle ridge at the end of an existing road system. The immediate area around the tank is highly disturbed with only a minimal amount of ruderal vegetation. That area will be used to accommodate work equipment and a number of temporary water tanks to be used while the MGT is empty for repairs. Vegetation surrounding this work area is primarily ornamental and nonnative, and will not be impacted during repairs. The tree and shrub species include eucalyptus (*Eucalyptus* sp.), pine (*Pinus* sp.), Canary Island date palm (*Phoenix canariensis*), sugar bush (*Rhus ovata*), and lemonade berry (*Rhus integrifolia*).

Million Gallon Tank with Two Harbors in the distance, facing west.

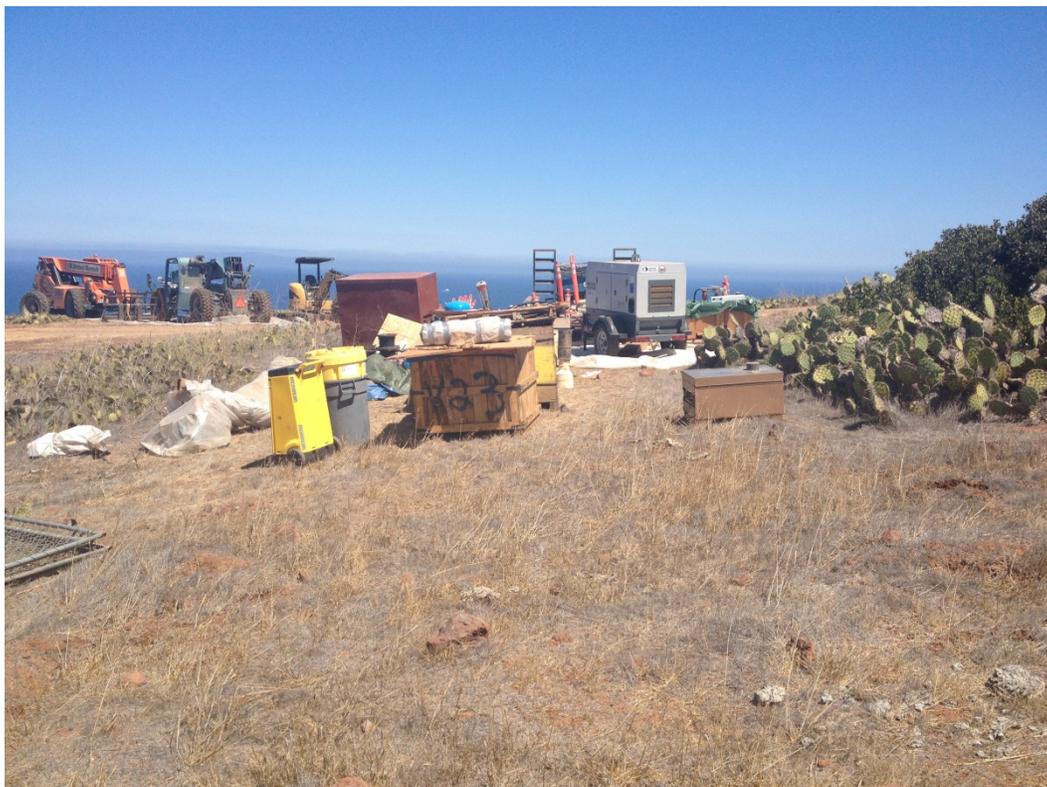
Three laydown areas for materials and equipment are located up the ridge next to the road. Two of the areas were already in use for storage, and the third appeared to have been used in the past. All three were vegetated with ruderal grasses and herbs. A patch of coastal prickly pear (*Opuntia littoralis* var. *littoralis*) was present in one area and had been avoided in the placement of materials there.

Two lower laydown areas already in use, with the access road dividing them, facing northeast.

- Best Management Practices should be implemented to contain excavated sediment or spoils from the pipeline repair site.
- During all construction activities, cactus patches and all trees and shrubs should be avoided to the maximum extent feasible. Vegetation such as this generally provides better wildlife habitat than the ruderal grassland within the proposed laydown areas.

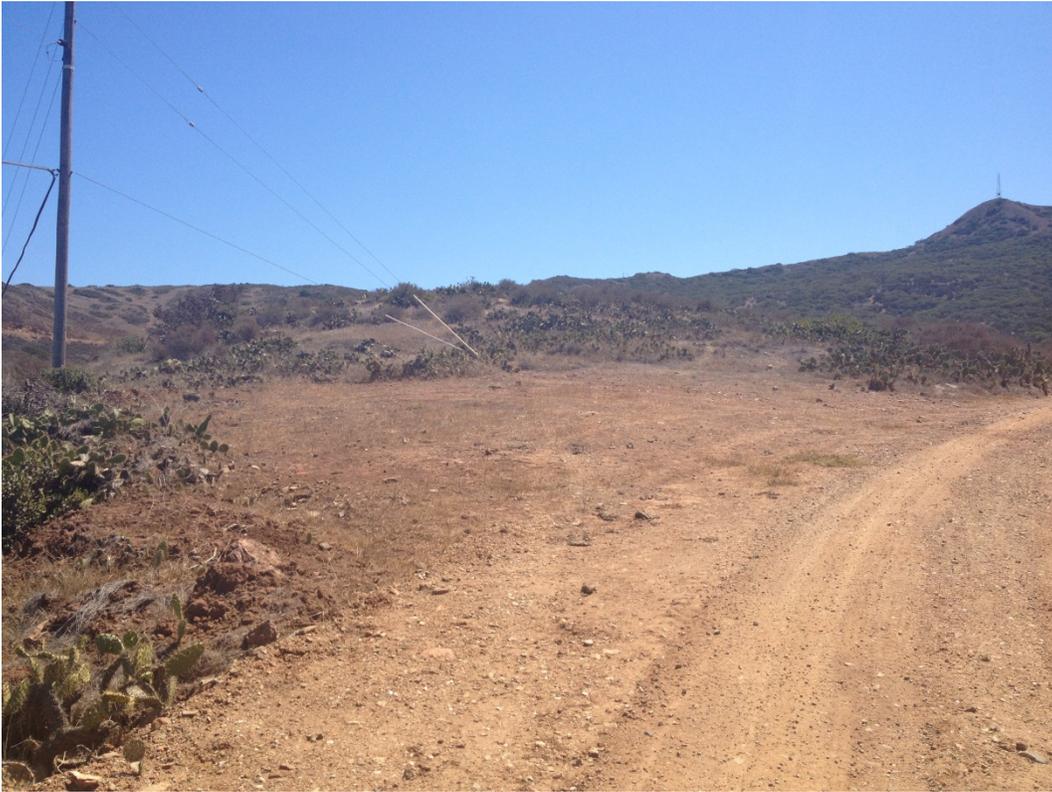
Upper laydown area, facing southeast.

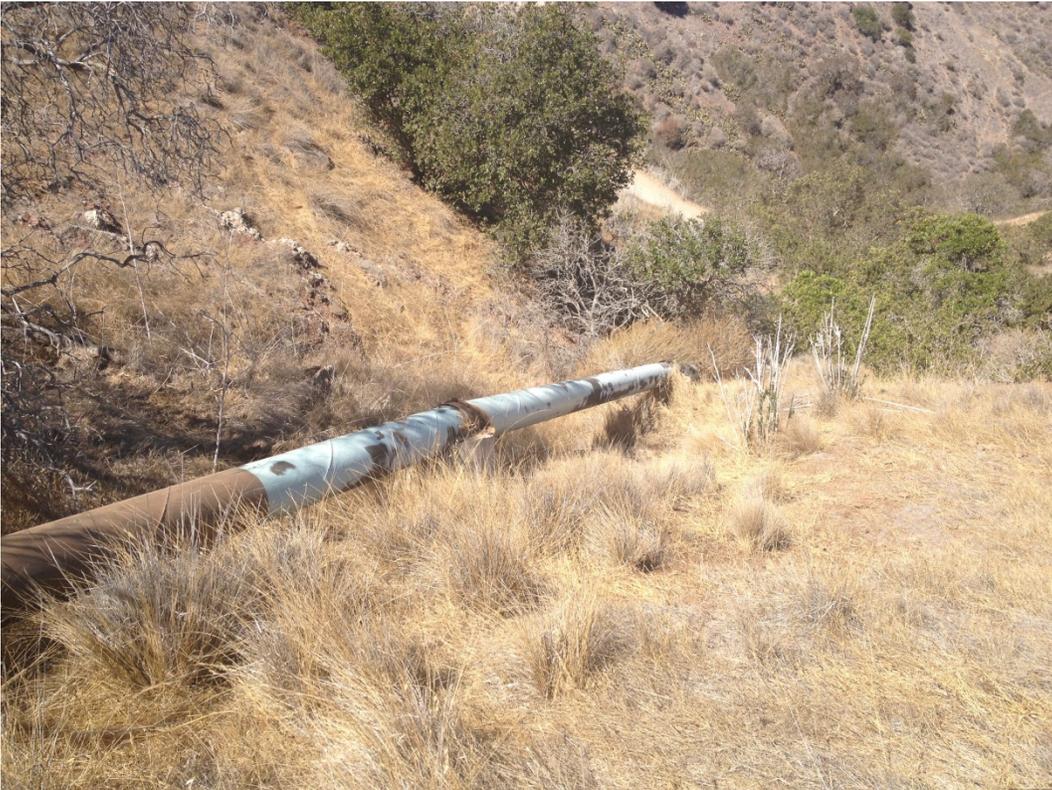
About 400 feet (ft) of above-ground pipeline associated with the MGT is also in need of repair. The pipeline descends the steep slope to the north of the tank before going underground beneath the access road to the USC marine lab. Vegetation around the pipeline includes toyon (*Heteromeles arbutifolia*) and native and nonnative grasses. Trimming of the toyon will likely be required in order to access some of the pipe supports in need of repair.

Above ground pipeline descending into toyon scrub, facing north.

- Due to the potential need for tree trimming, pipeline repair should be performed outside the primary bird nesting season (February 15 through August 31) to minimize or avoid impacts to nesting birds. If tree trimming occurs during the breeding season, a survey should be performed immediately prior to construction to ensure that nesting birds will not be adversely affected.
