# Florence-Firestone Blue Line First/Last Mile Memorandum

Florence-Firestone TOD Specific Plan  
County of Los Angeles

Department of Regional Planning

September 2020

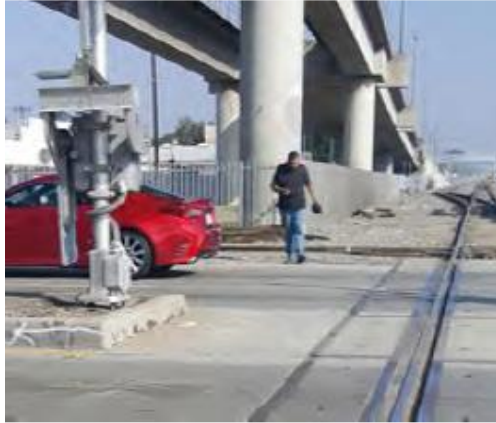
**Pedestrian Crossings:** People were observed crossing arterials and collectors where there is no crosswalk. In some areas it is necessary to cross the rail tracks in order to get to the sidewalk.

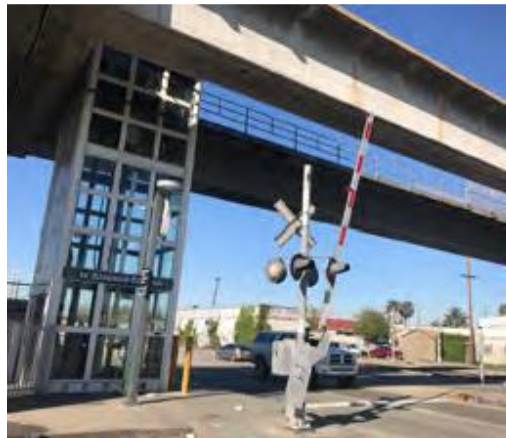
**Station Access:** Access to the station is narrow and difficult, with only three entries/exits. Bicyclists use the sidewalk because there are no bicycle lanes. This makes it difficult to navigate shared space with people on foot.

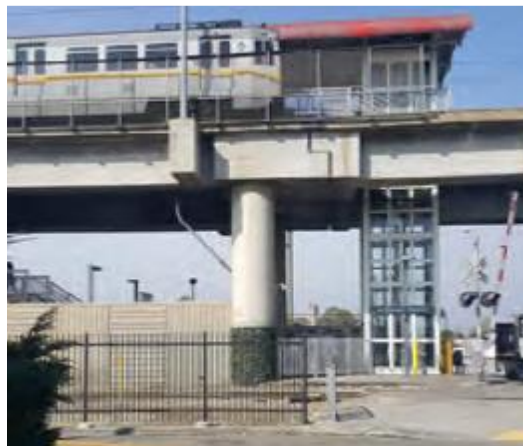
**Wayfinding:** The station area lacks wayfinding signage for pedestrians, bicyclists, and transit users.

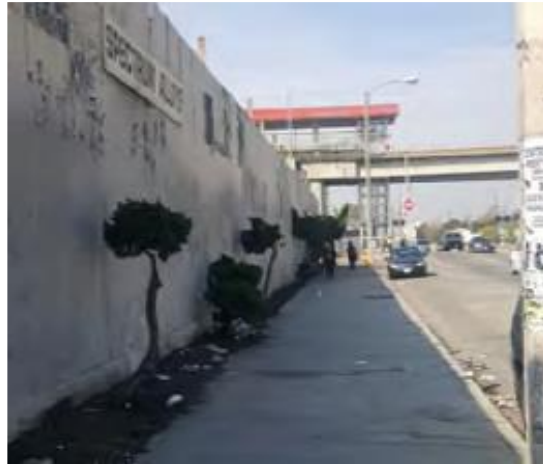
**Pedestrian-Scale Lighting:** Many streets lack pedestrian-scale lighting, or street lighting is obscured by tree canopy.

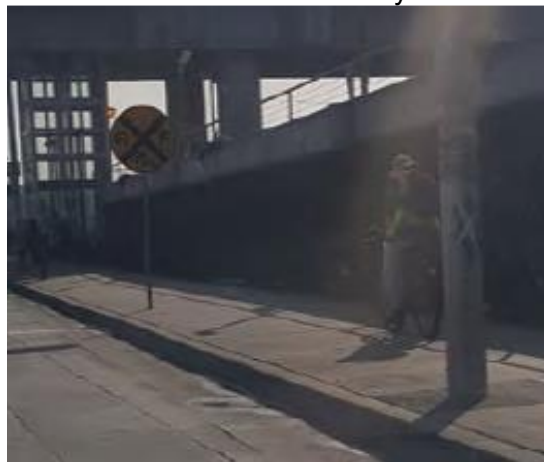
**Bicycle Facilities:** The station area lacks continuous bicycle lanes.

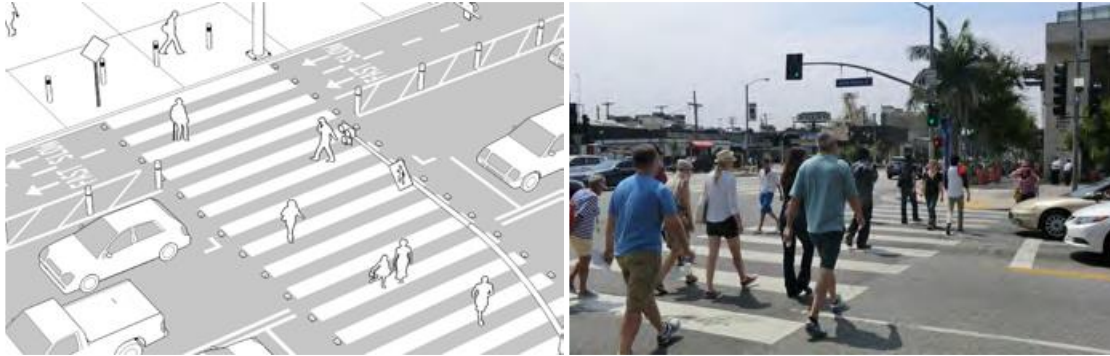
**Pedestrian Crossings:** Improve pedestrian crossings at major intersections, including at rail crossings, with sufficient countdown timers, improved crosswalks, and ADA-compliant curb ramps.

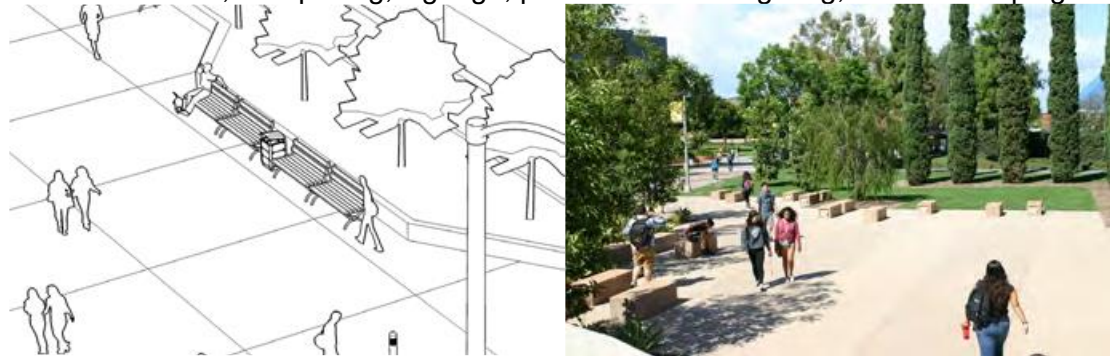
**Add New Station Access:** Improve the informal pedestrian path leading to the station underneath the tracks, with paving, signage, pedestrian-scale lighting, and landscaping.

Existing conditions around the station were scored on a scale of one to five to evaluate safety, accessibility, transfers, and aesthetics, with an overall score calculated by averaging the category scores. The Slauson Station and surrounding area received an overall score of 1.7 out of 5 based on observations from walk audits. Slauson Station's score was below average in comparison to all stations on the A Line. Safety and accessibility received scores of 1.77 and 1.71, respectively. Many streets lacked crosswalks, bike lanes, and pedestrian lighting, including areas around schools. In terms of accessibility, discontinuous sidewalks, street vendors, and other physical barriers impede pedestrian access to the station. Many sidewalks lack curb ramps and truncated domes. In addition, many residents access the station using an informal, unpaved path under the train tracks.

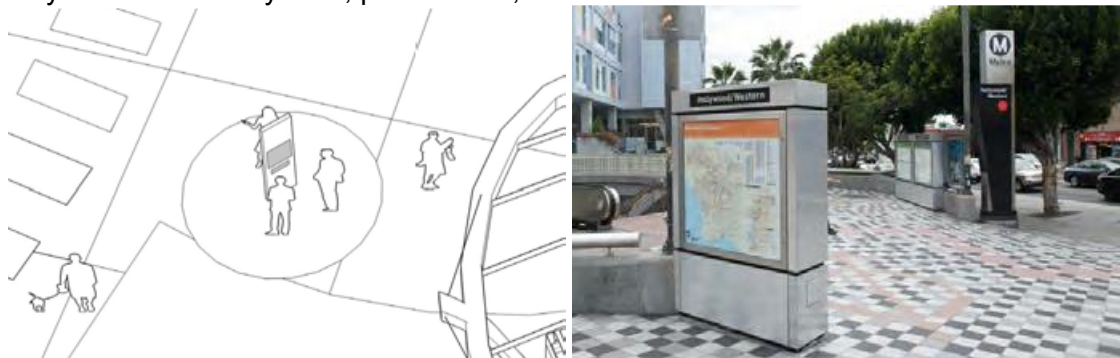
**Wayfinding & Transit Signage:** Install wayfinding signage and transit information along the Pathway Network for bicyclists, pedestrians, and transit users.

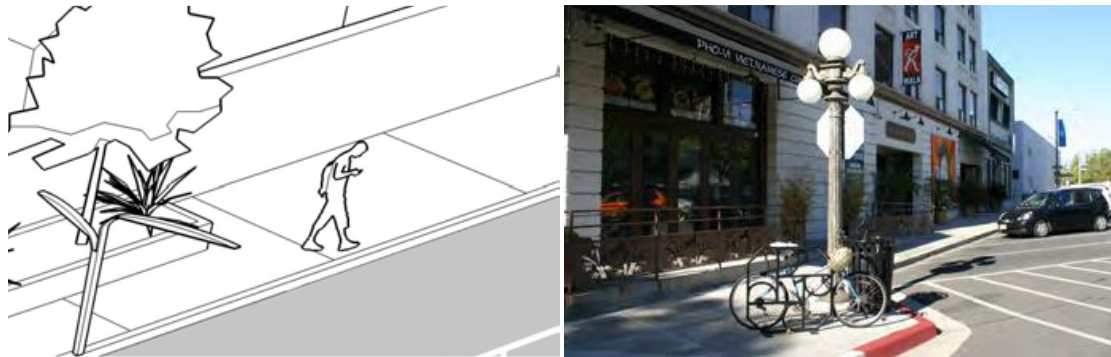
**Pedestrian-Scale Lighting:** Install pedestrian-scale lighting along the Pathway Network, especially at street crossings.

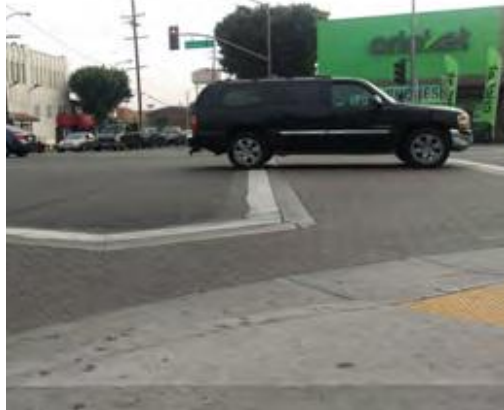
**Vehicle Speed:** Many vehicles were observed speeding on arterials and collectors, which creates an unsafe and uncomfortable environment for pedestrians and cyclists.

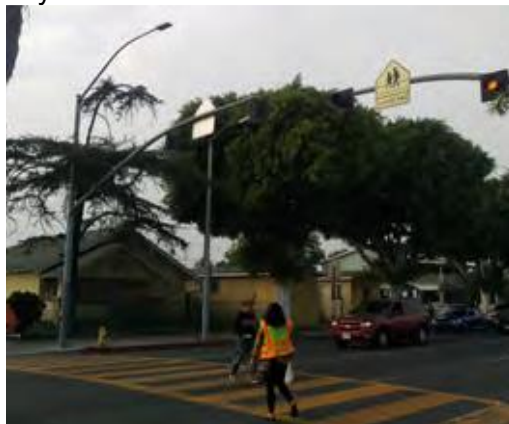
**School Crossings:** Poor crosswalk conditions, high vehicle traffic speeds, and blind corners were observed near elementary schools.

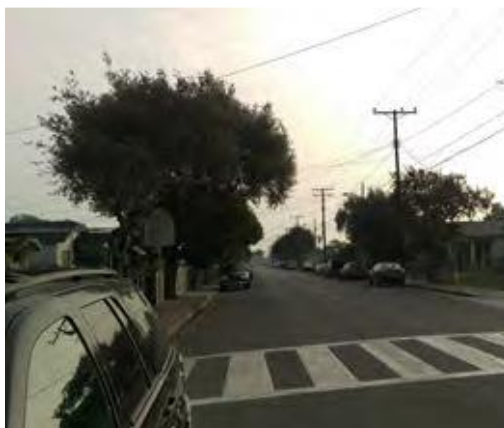
**Pedestrian-Scale Lighting:** Many streets lacked enough pedestrian-scale lighting, including at bus stops.

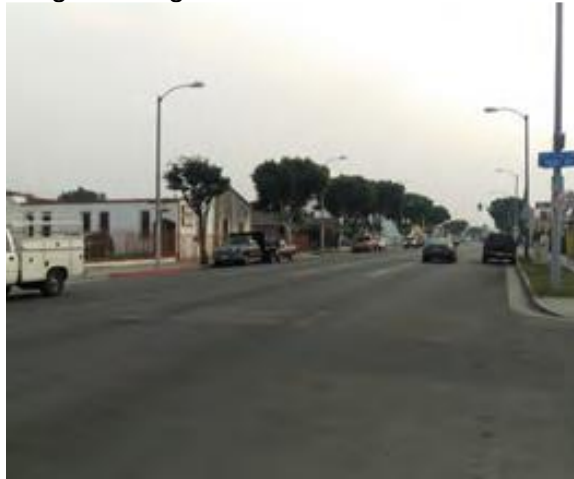
**Pedestrian Crossings:** Most of the station area had infrequent marked crosswalks, faded or insufficient markings, and long crossing distances.

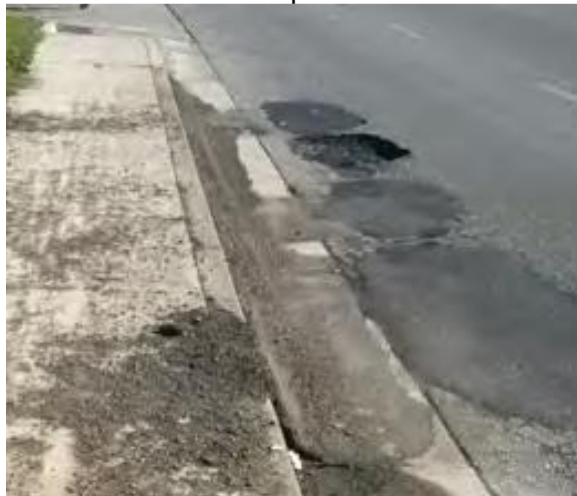
**Potholes:** Many streets in the station area had potholes.

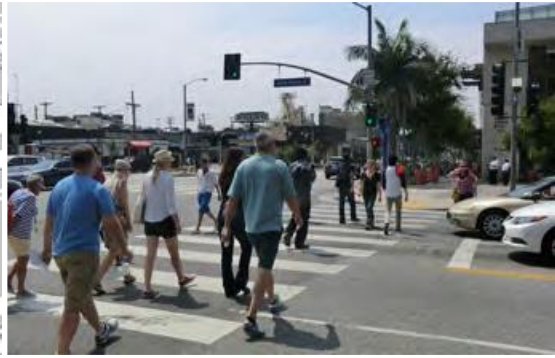
**Pedestrian Crossings:** Improve pedestrian signals and provide more visible crossing treatments at intersections along Florence Avenue, along with traffic calming measures, especially near train crossings

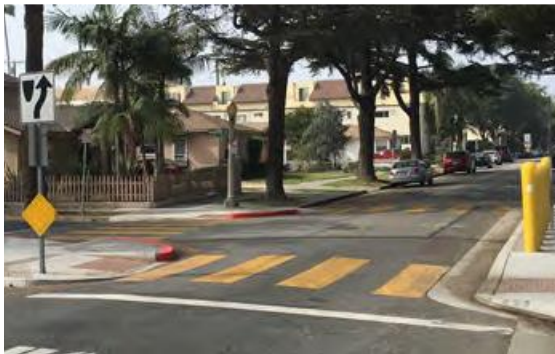
**School Area Treatments:** Add speed bumps and enhanced crosswalks around the school on Bell Avenue.

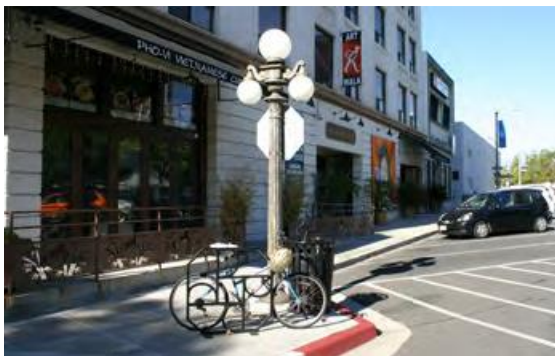
**Lighting & Wayfinding:** Add lighting and wayfinding signage through the park and along Pathway Network arterials and collectors.

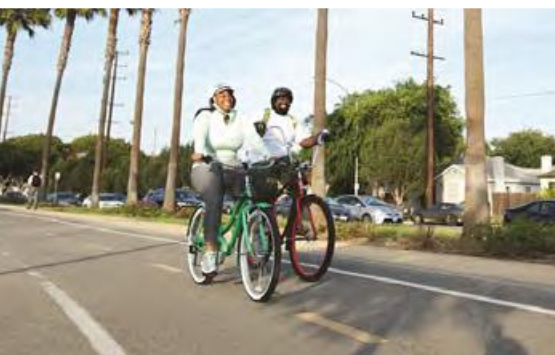
**Enhanced Bicycle Facilities:** Add enhanced bicycle facilities on Pathway Network arterials and collectors.

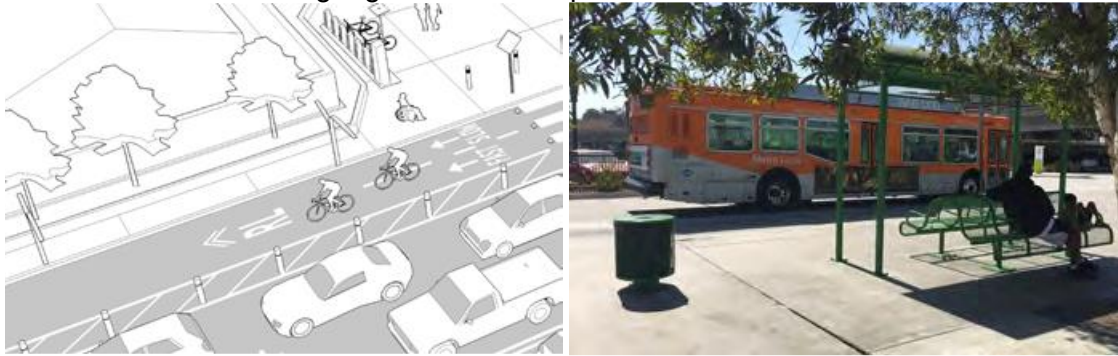
**Bus Stop Amenities:** Provide shelters, lighting, and comfortable seating at all bus stops; improve transit information signage at all bus stops.

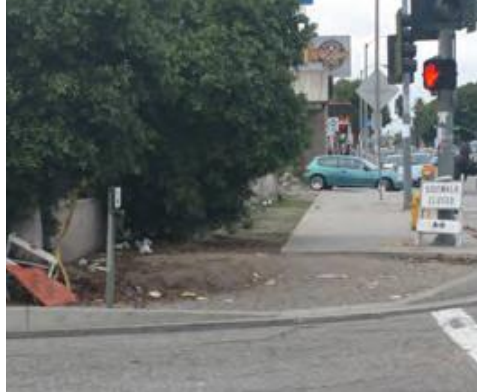
**Pedestrian Crossings:** The station area lacked sufficient crosswalks and some crossings did not provide enough time on the signal countdown, such as Firestone Blvd and Graham Ave. The intersections at Firestone/ Compton and Firestone/ Graham seemed confusing for pedestrians.

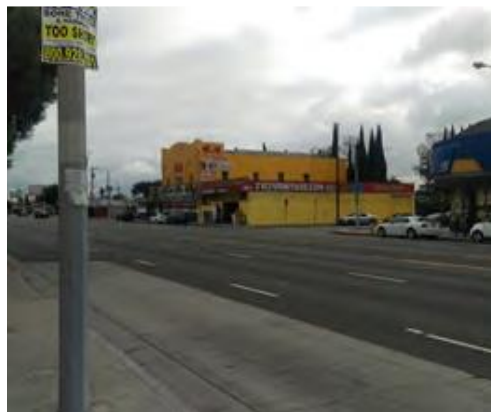
**Vehicle Speed:** High vehicle speed was observed on many streets, and especially on Firestone Boulevard.

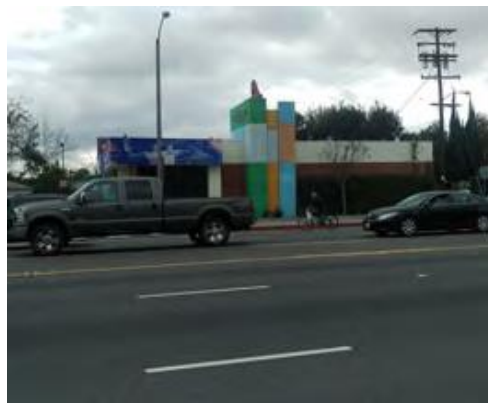
**Bicycle Infrastructure:** Many cyclists were observed using the sidewalk. Bicycle facilities were scarce and discontinuous.

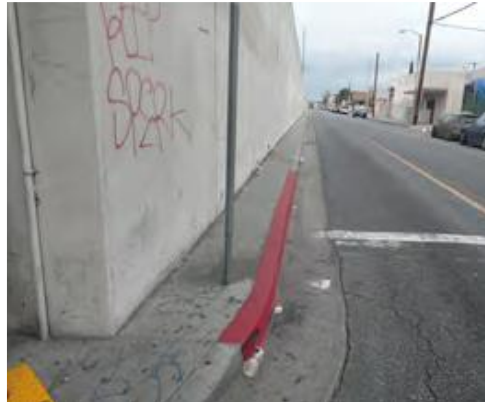
**Sidewalk Accessibility:** Many sidewalks in the station area lacked curb ramps and truncated domes, and were not wide enough to accommodate pedestrians with wheelchairs, mobility devices, or strollers.

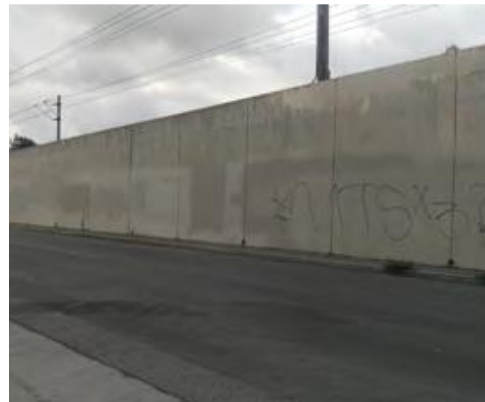
**Street Lighting:** The station area lacked sufficient street lighting, especially beneath the train overpass and along many of the streets with industrial uses surrounding the station.

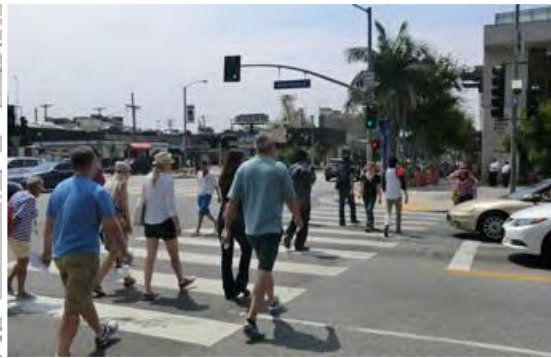
**Pedestrian Crossings:** Improve pedestrian crossings at major intersections, including at rail crossings, with sufficient countdown time, improved crosswalks, and ADA-compliant curb ramps.

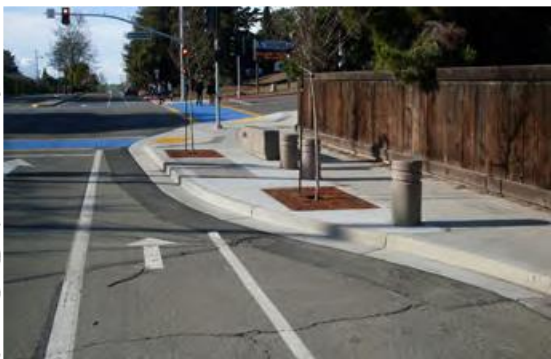
**Traffic Calming:** Install traffic calming elements and consider road diets along streets with high vehicle speeds.

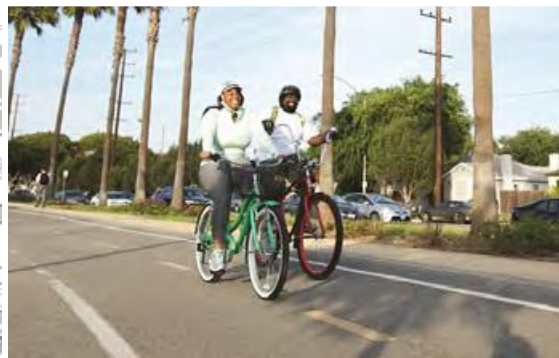
**Enhanced Bicycle Facilities:** Install enhanced bicycle facilities on Pathway Network arterials and collectors.

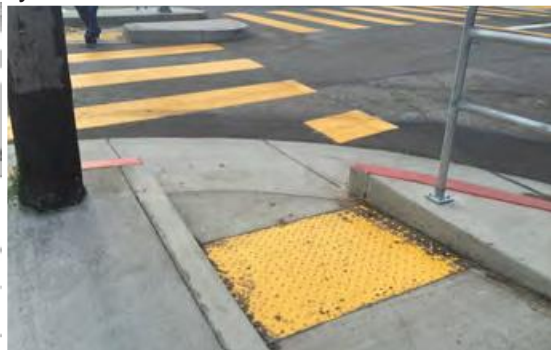
**Sidewalks & Curb Ramps:** Widen sidewalks along the Pathway Network and provide crosswalks and ADA-compliant curb ramps along the Pathway Network.

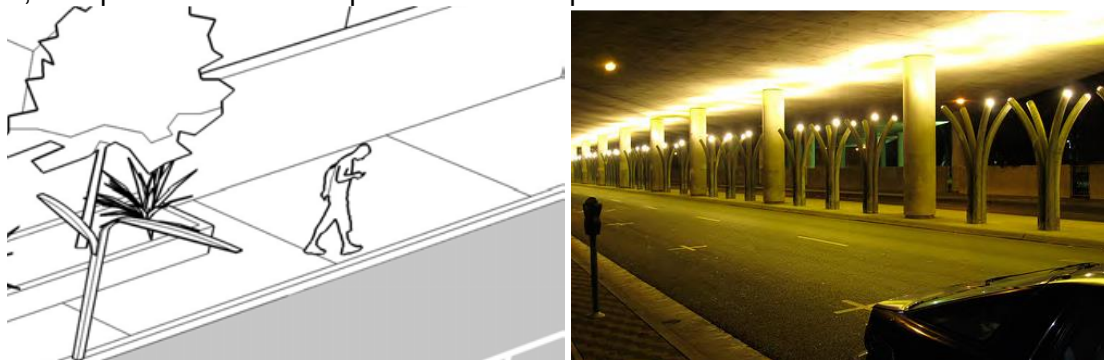
**Pedestrian Lighting:** Install pedestrian-scale lighting along the Pathway Network and at the station, with particular attention paid to the underpass at the station entrance.
