Sunshine Canyon Landfill
Independent Monitor
Quarterly Site Monitoring Status Report
April 1, 2015 – June 30, 2015

City of Los Angeles Department of City Planning

County of Los Angeles Department of Regional Planning

UltraSystems
environmental | management | planning

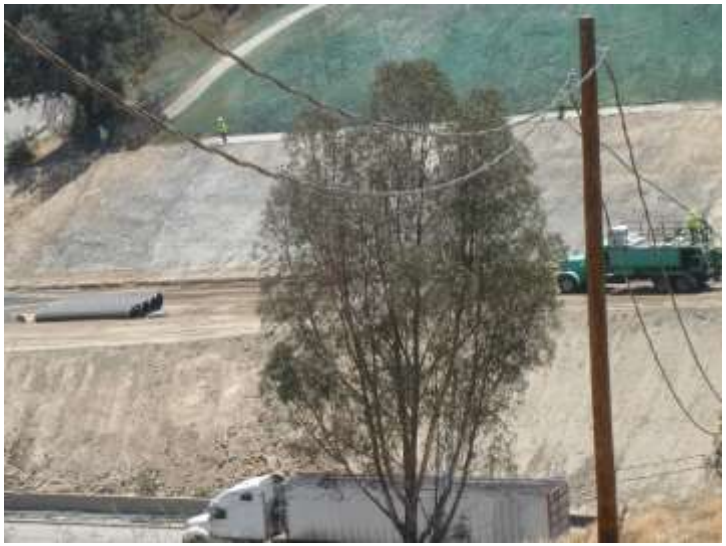
Photo 258: Access Road Realignment Area: June 24, 2015

Current Status/Comments – In early April 2015, the temporary basins and the alluvial soils under these basins were removed for the realignment of the access road. Prior to the installation of underdrains and a liner, we observed placement of compacted soil. Republic's geotechnical consultant was verifying the placement and compaction of this base material. Road construction excavation was being done simultaneously in all areas.

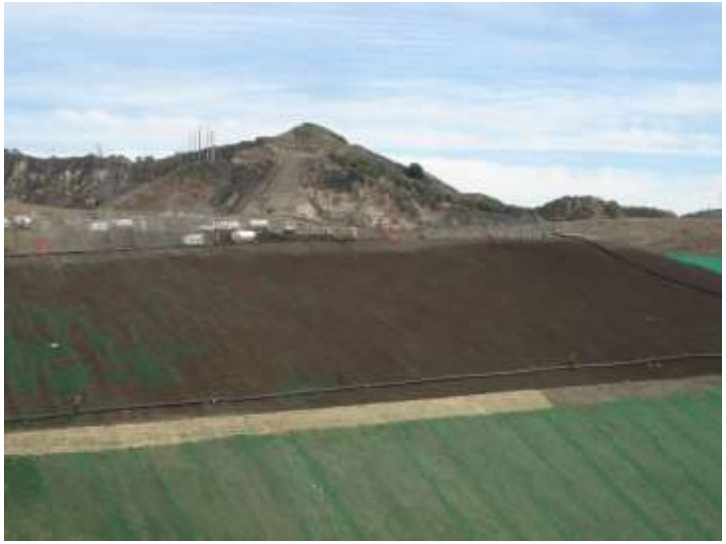
Photo 390: Site Working Area: April 9, 2015

During the April 9, 2015 site monitoring, it was observed that the working landfill face was exposed to the south when being filled causing an odor to be detected on the main access road. No odor was detected offsite. Republic staff was notified of this observation.
