**MILLS ACT EXEMPTION FROM DISQUALIFICATION ANDERSON HOUSE  
PROJECT NO. 2020-000311-(3) CASE NO. RPPL2020004010  
(THIRD SUPERVISORIAL DISTRICT) (3-VOTES)**

This Historic Structures Report (HSR) was completed by Architectural Resources Group (ARG) at the request and of Beatrice Faverjon, owner of the Anderson House at 19974 Sischo Drive in Topanga Canyon, Los Angeles County. The purpose of the HSR is to document the subject building's history, significance, and existing conditions, and to appropriately guide its rehabilitation and maintenance. This HSR is associated with a Mills Act Property Tax Abatement Program contract application that is being submitted for the subject building and is a required component of the application.

# Structural Evaluation Report

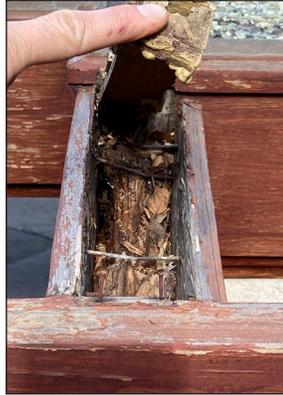
Carport roof beams pulling away from the house exterior wall (Beatrice Faverjon, 2020)

In general, the residence structural systems are intact and remain in fair condition overall, with some areas in need of repair. The carport structural system is in poor condition overall, and in need of significant repair.

The dramatic cantilevered roofs, while being a key component of Wear's design, have not fared well over time. The carport roof to the north has significant deflection and most likely loss of structural strength. The exterior deck to the south, with the wide double-cantilevered overhang, has similar structural deflection. Where framing was observed, wood joists at these locations have warped and deflected downward, and wood decay/rot was observed in some locations. The carport roof is also pulling away from the north residence wall, and a wood post has been added near the northeast corner as a secondary means of support. In other locations throughout the house, persistent roof leaks and flashing issues, as well as inappropriate alterations, have led to water damage and wood decay/rot at wood structural framing (see "Roofing and Drainage" section below for more information).

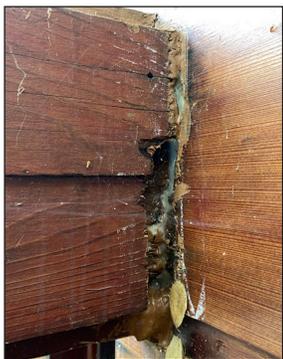
Wood post added at the northeast corner to support the carport (ARG, 2019)

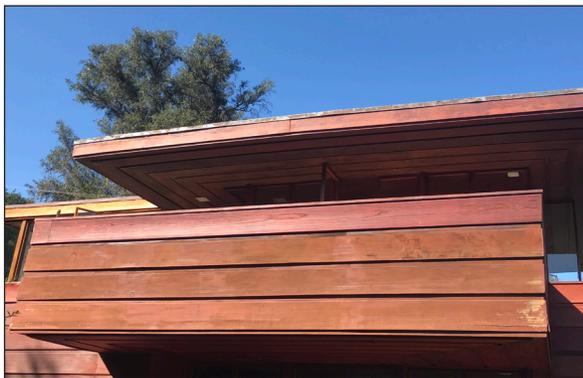
Cantilevered balcony at the south façade; note incompatible siding (ARG, 2019)

In general, the redwood siding and trim at the balconies is in poor condition throughout. Most boards throughout are bowed and cupped in shape, leading to water intrusion and leaks to the interior. At several locations, original old growth siding has been previously replaced with new growth redwood or stained pine siding. These boards are non-matching and have deteriorated much faster than the old growth lumber. In other areas, ARG noted wood decay/rot, and splitting of boards, in particular at corroded nail fasteners. Water stains/damage were also noted. The master bedroom balcony at the east elevation appears to have significant water and termite damage at the floor joists and railing.

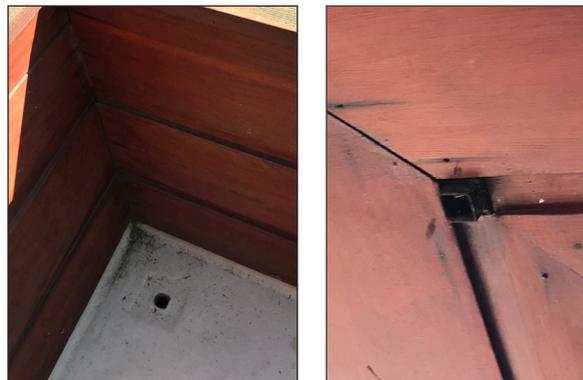
Waterproofing membrane and drain at balcony floor, and drain stub at soffit side (ARG, 2019)

The traffic coating membrane at the balconies are in poor condition. The membrane is deteriorated, with tears and perforations in several locations, allowing for water infiltration. The small drains are in tact and appear operational.

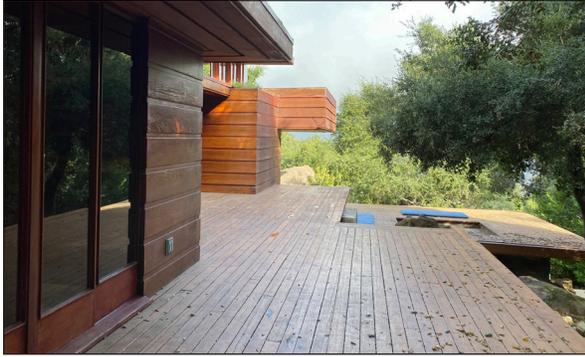
Wood deck on the south side of the house (Beatrice Faverjon, 2020)

In general, the exterior deck is in fair condition. There is noticeable structural deflection at the double cantilevered framing to the south (see “Structural Systems” section above for information). Other framing appears to be intact, with localized areas of wood rot/decay and splitting. The deck boards appear to be in good condition but will require clear coat maintenance due to the outdoor exposure to weather and UV radiation. Some boards have splits at corroded fasteners.

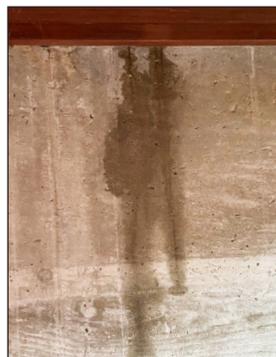
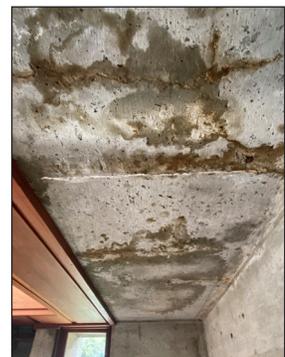
Water penetration at inside of utility shop (Beatrice Faverjon, 2020)

Currently, the utility shop roof is in poor condition. The roof surfaces are deteriorated and near the end of their useful service life. The gravel is eroded or missing in several areas, with a desiccated and cracked asphalt/tar layer visible. The concrete portion of the roof is leaking, with cracking and stains visible at the interior ceiling below.

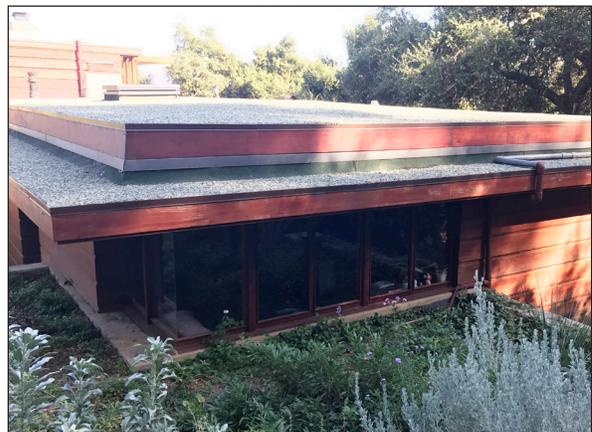
Flat roof with gravel surface at the residence; note sheet metal flashing at eave (ARG, 2019)

In general, the asphalt/gravel roofing systems are in poor condition overall. The house roof appears to have been re-surfaced (date unknown); however, conditions have deteriorated and there are leaks. Roof drainage appears to be a concern. Based on the drip stains visible at the redwood siding, there is roof water overflow near the northeast corner. Leaks were reported by the owner at the south wall of the master bathroom, where the wall and roof flashings were reconfigured in 1993 to enlarge the bathroom. Leaks were also reported at the north wall of the master bedroom, at the custom skylight. The skylight could not be observed from the roof side; additional survey is needed.

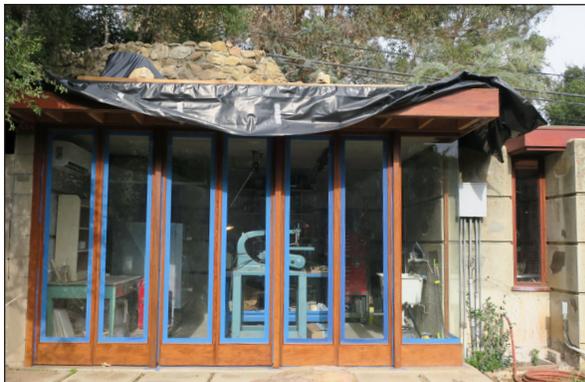
New doors (left) and original window (right) at utility shop (ARG, 2019)

The original window and door openings at the utility shop are few, including a fully glazed redwood entrance door and sidelight at the east elevation; and a single casement window at the south elevation near the east end. During construction of the 2019 addition, the west side of the south elevation was enclosed with floor-to ceiling glazed redwood doors for the pottery studio. The doors were based on the design of those in the residence dining room. All windows and doors are similar in construction to the residence (see above). The original windows and doors are in fair condition, with some signs of wear. The new doors are in good condition.

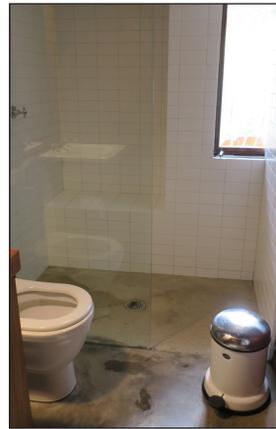
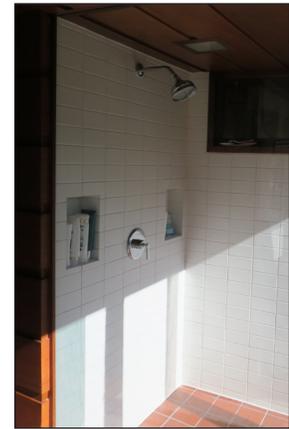
Non-original tile in the bathrooms (ARG, 2019)

with ceramic tile. The 1993 tile was replaced by the current owner with new tile. The bathroom retains its original redwood channel ceiling. The bathroom in the one-story portion of the residence also has a walk-in shower with non-original tile. Fixtures in most bathrooms are replacements.

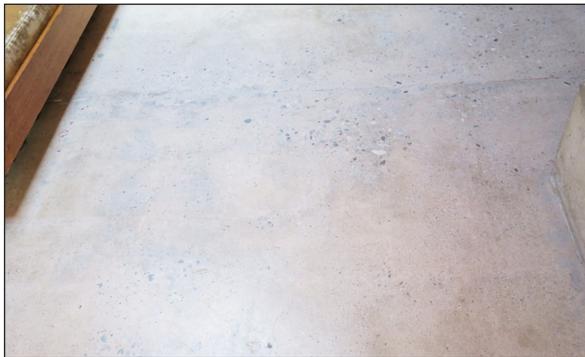
Refinished concrete floor in the west portion of the house where the owner removed non-historic tile (ARG, 2019)

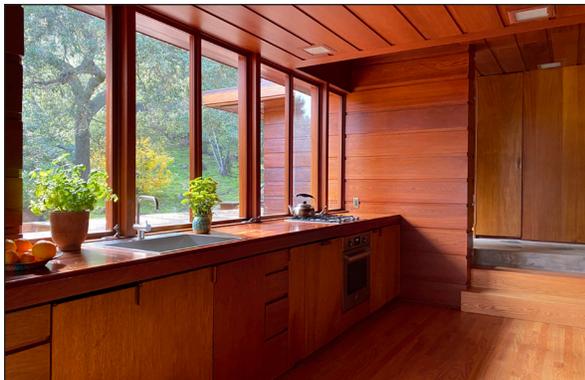
Restored redwood walls, ceilings, and cabinets in the kitchen (Beatrice Faverjon, 2020)

Apart from the bathrooms, the remainder of the interior finishes remain largely intact and original. Water leaks have damaged some areas of redwood paneling at walls and ceilings. Paneling was removed in the kitchen and dining room temporarily due to damage. Some redwood wall and ceiling paneling was painted white at one time, but the current owner has stripped the paint and restored the original finishes. The master bedroom redwood paneling has also been finished with a lacquer instead of a clear satin finish. Also between 2017-19, the owner restored all of the interior floors, including refinishing wood strip flooring, removing non-original tile at concrete floors, and grinding and sealing concrete floors. Other wall and ceiling finishes are in need of cleaning and refinishing due to deterioration from age and use, including the living room, original dining room, master bedroom and bathroom.

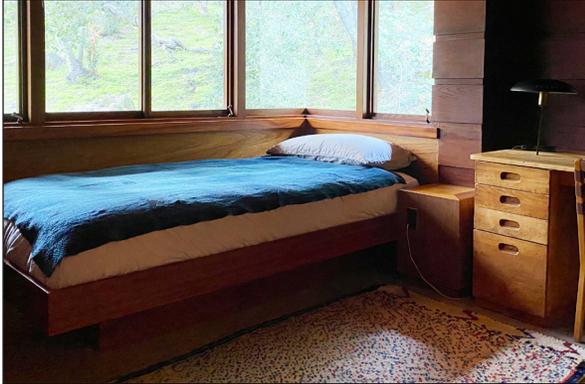
Recreated built-in furniture in the southwest bedroom (Beatrice Faverjon, 2020)

Some original millwork is missing, including a table at the original dining room and built-ins at the smaller bedrooms in the west portion of the house. Between 2017-19, the current owner added new built-in bed platforms and desks where the original built-ins had been removed, but some work still remains.

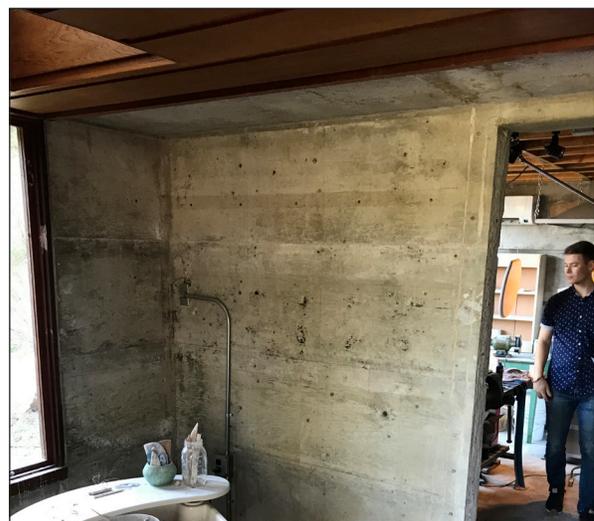
Simple raw finishes in the utility shop (ARG, 2019)

In general, the interior finishes and millwork within the shop remain in fair condition. The shop is actively used as a pottery studio, and surfaces are heavily soiled as a result. Some localized cracking and spalling was noted at the concrete finishes, and there are active leaks at the concrete roof slab. At the spall areas, there is visible corroded steel reinforcement.

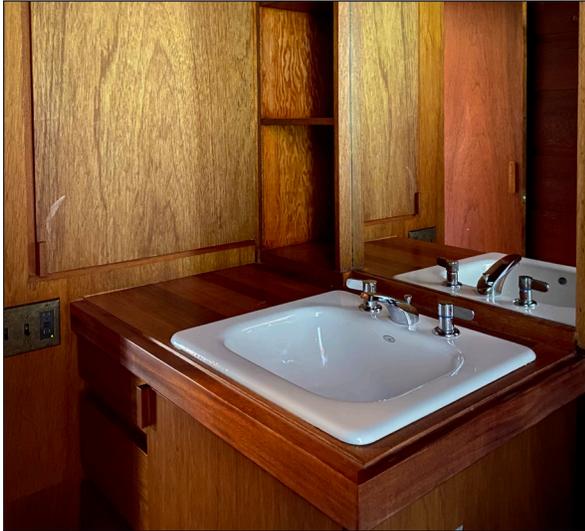
Non-original plumbing fixtures and original wood cabinet in the west bathroom (Beatrice Faverjon, 2020)

Most of the original plumbing fixtures in the bathrooms have been replaced with contemporary fixtures. There is one original toilet in the quarter bathroom adjacent to the entrance hall. Other plumbing upgrades have occurred between 2017-19. The system is reportedly in good condition, but will require maintenance. The owner is also interested in replacing non-original plumbing fixtures with period-appropriate fixtures.

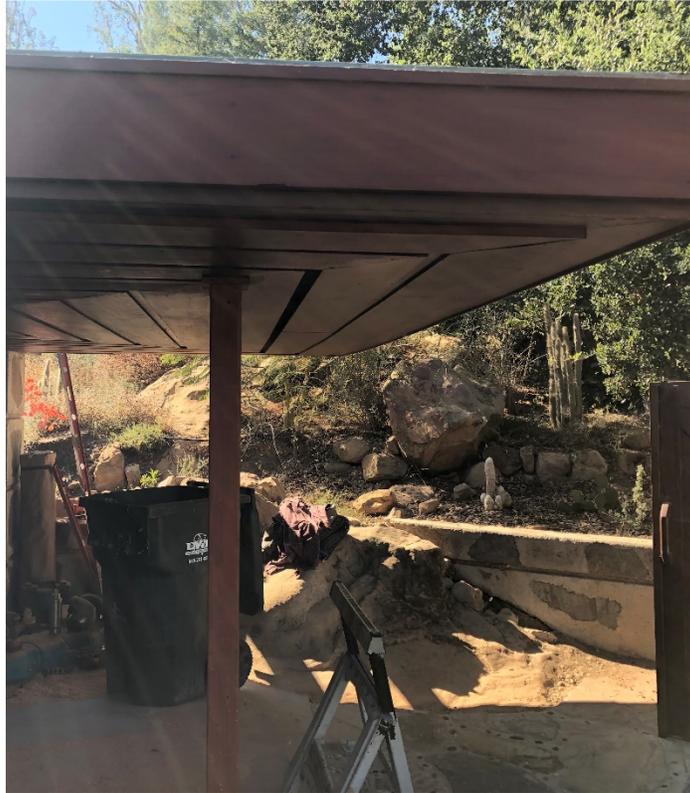
Figure 3: Temporary column to support carport.

- The carport has significant deflection at the cantilevered end. A temporary column has been placed to shore the structure. (figure 2) Additionally, water/termite damage has been observed at the carport structure. (figure 3)
- The roof balcony at the master bedroom shows significant water damage to the wood structure. (figure 4)
- The deck near the jacuzzi appears to be significantly deflecting at the double cantilever.
