**Chiquita Canyon Landfill  
Independent Monitor  
Quarterly Site Monitoring Status Report  
July 1, 2022 through September 30, 2022**

**County of Los Angeles Department of Regional Planning**

October 7, 2022

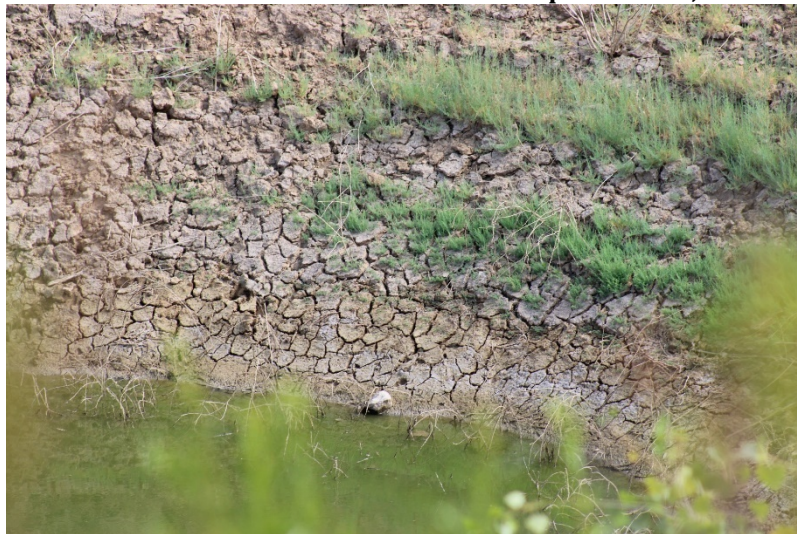
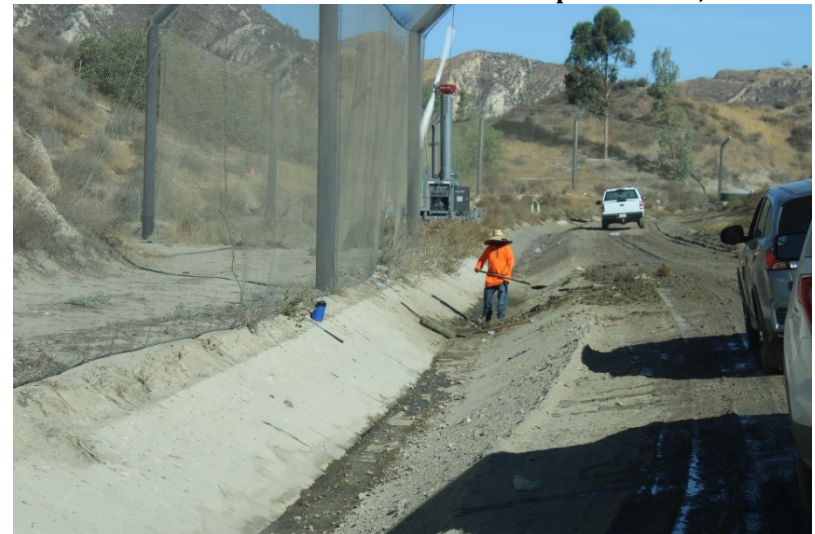
**Photo 198: Northeast Sediment Basin: September 13, 2022**

**Photo 199: Northeast Sediment Basin: September 13, 2022**

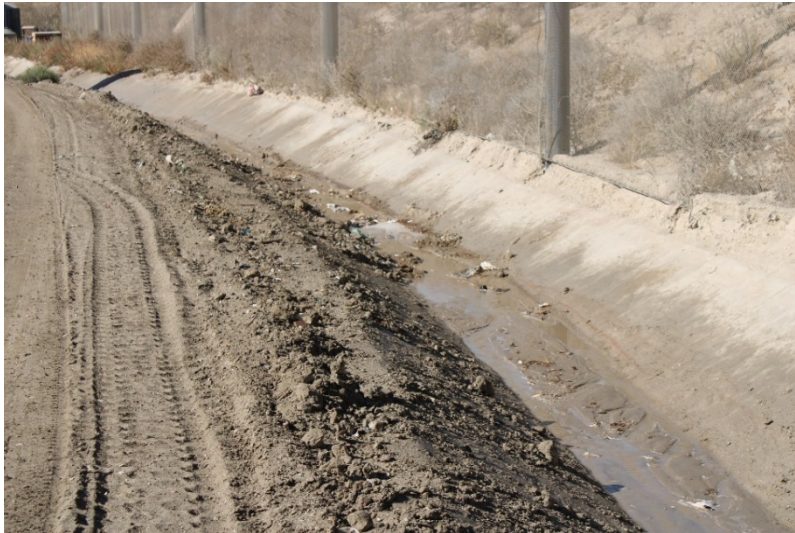
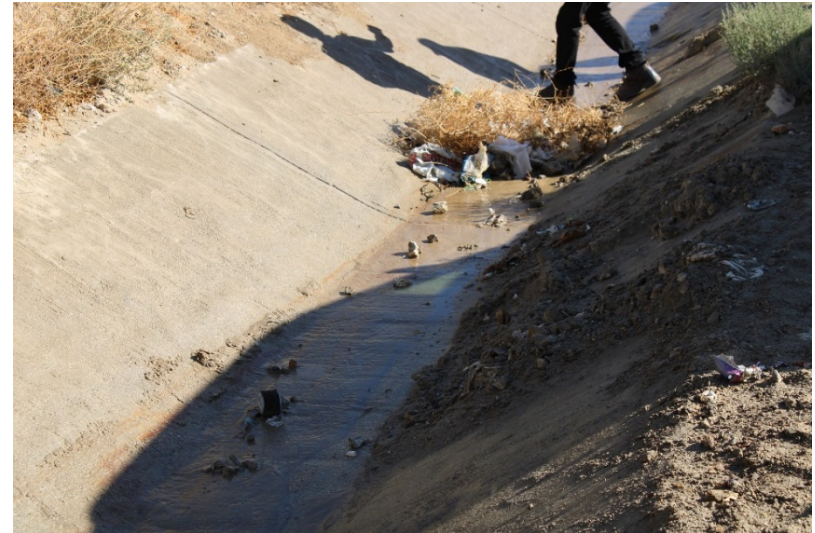
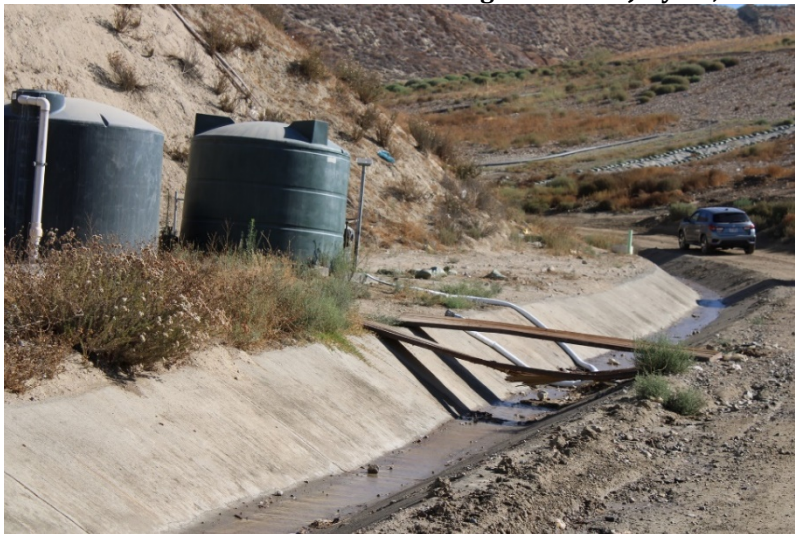
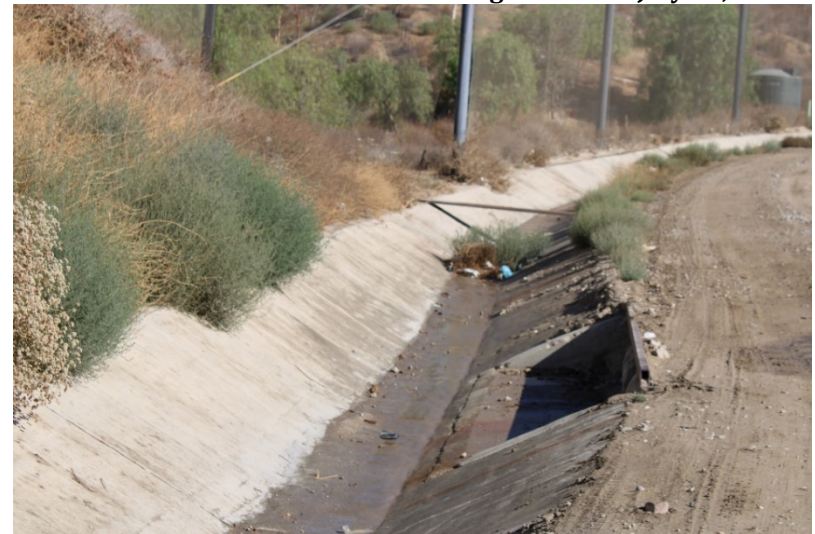
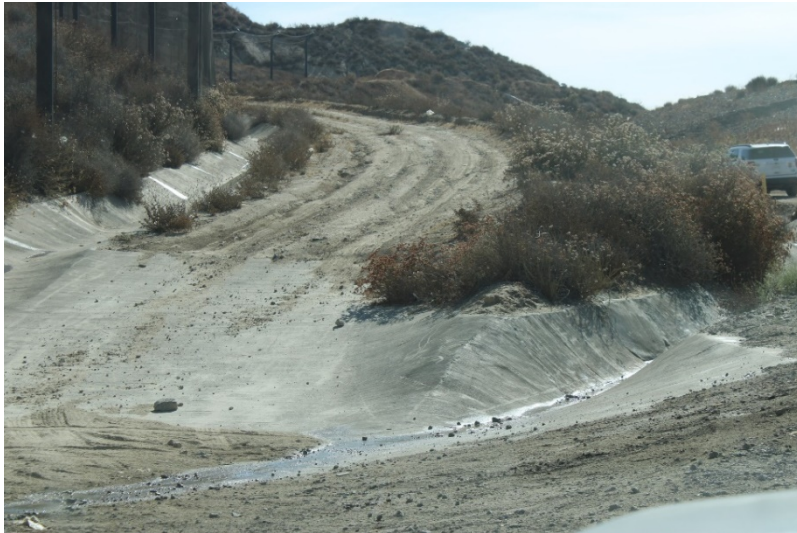
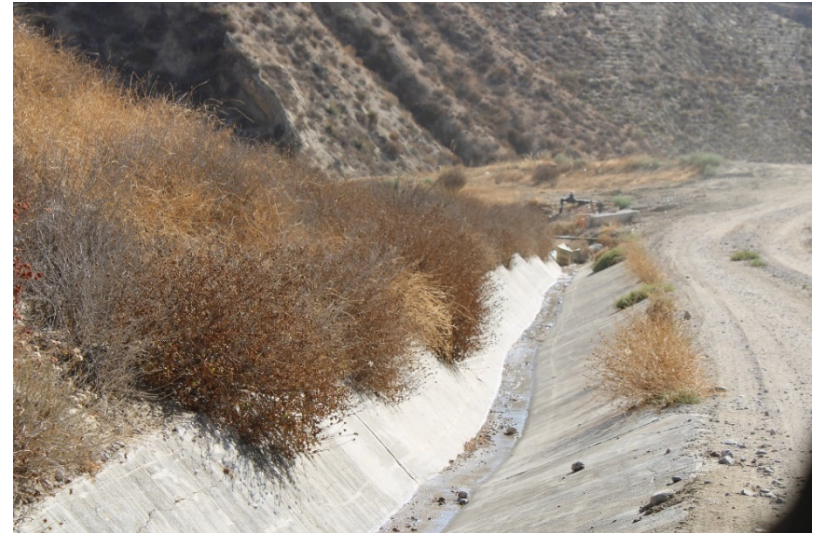
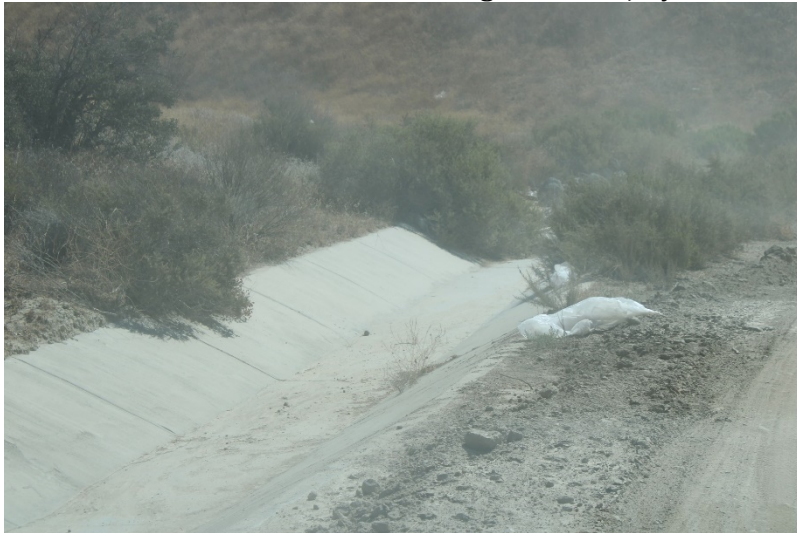
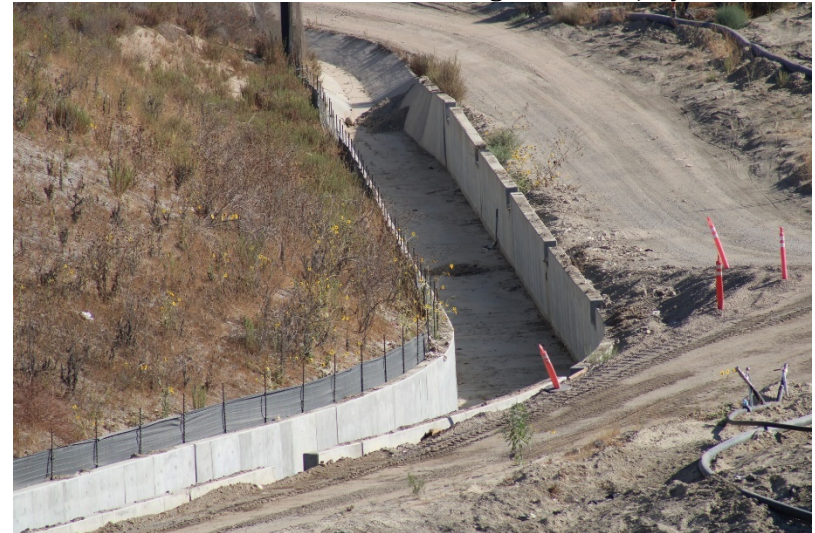
**Photo 200: Landfill Perimeter Drainage Channel: July 21, 2022**

**Photo 201: Landfill Perimeter Drainage Channel: July 21, 2022**

**Photo 202: Landfill Perimeter Drainage Channel: July 21, 2022**

**Photo 203: Landfill Perimeter Drainage Channel: July 21, 2022**

**Photo 204: Landfill Perimeter Drainage Channel: July 21, 2022**

**Photo 205: Landfill Perimeter Drainage Channel: July 21, 2022**

**Photo 206: Landfill Perimeter Drainage Channel: July 21, 2022**

**Photo 207: Landfill Perimeter Drainage Channel: July 21, 2022**

- The FivePoint tilled area was observed. The dirt area was a large parcel.
- The westside drainage channel was being cleared of sediment, brush, and debris.

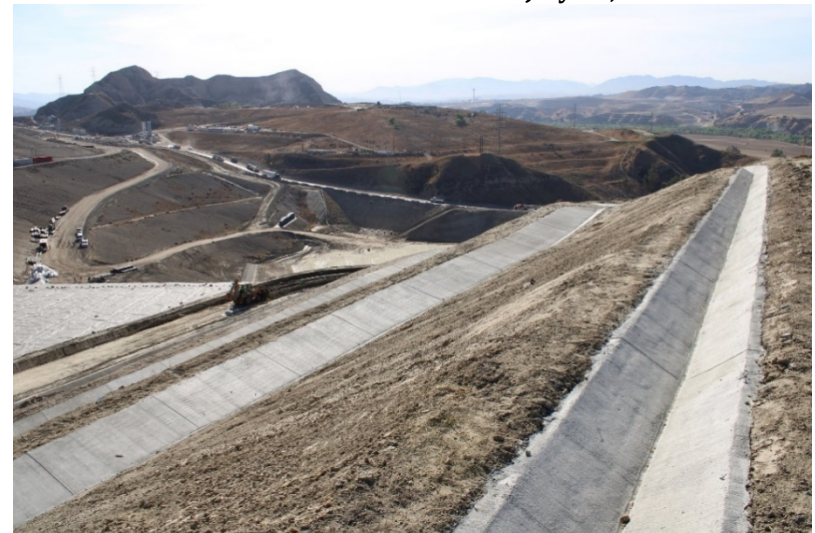
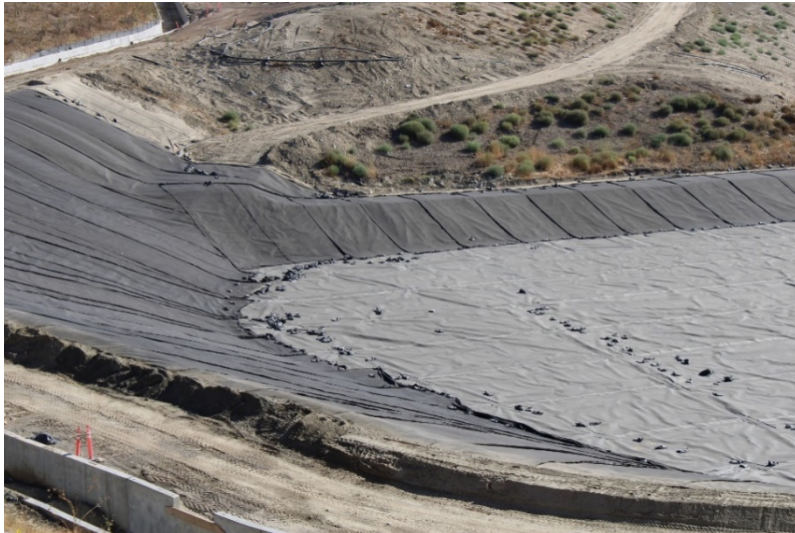
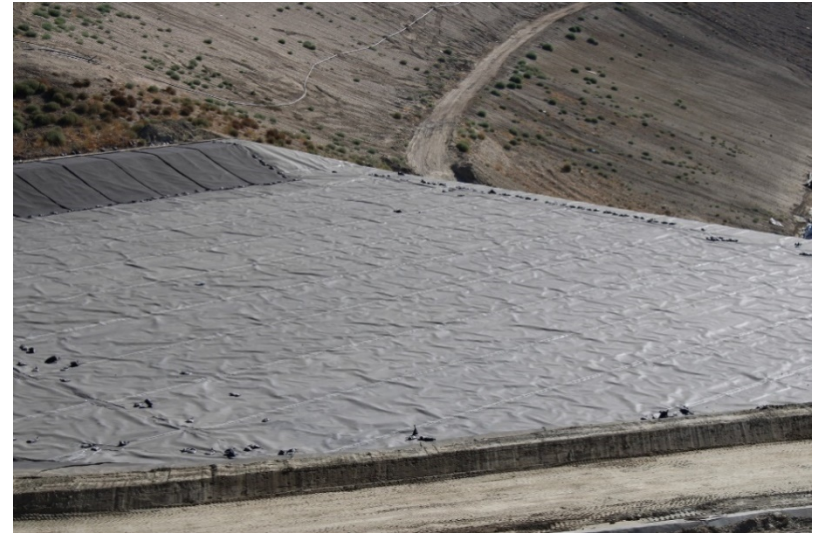
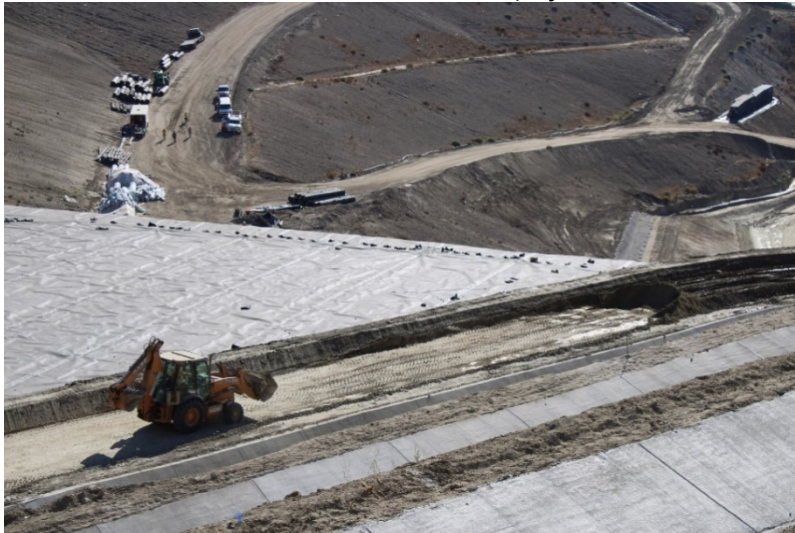
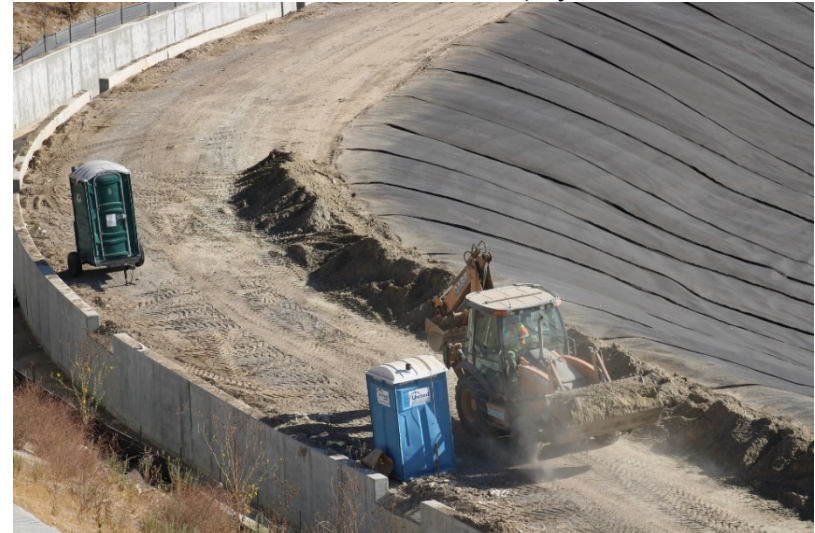
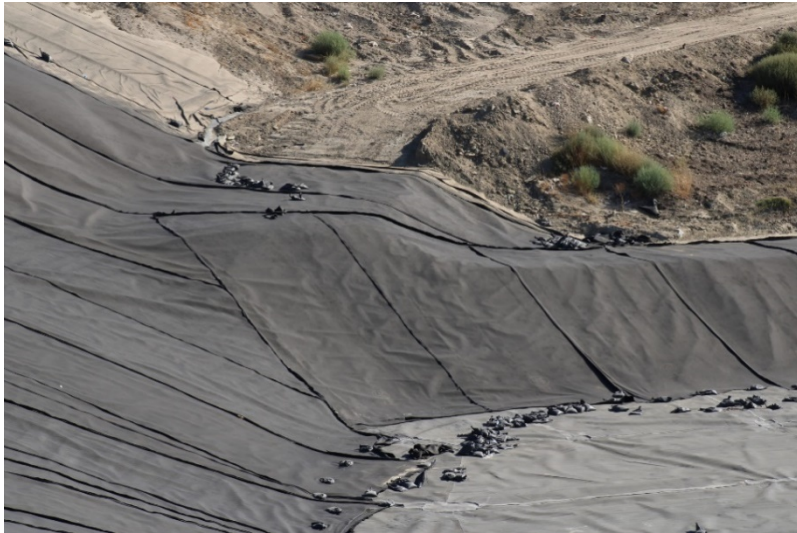
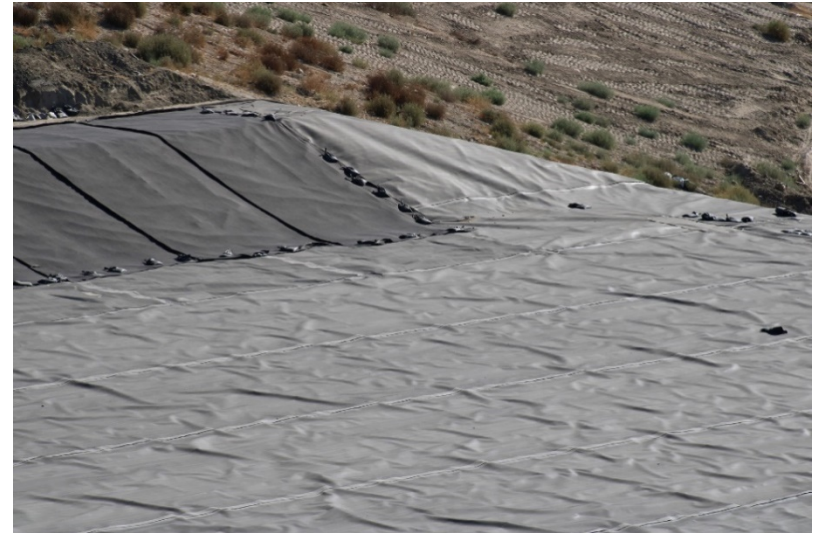
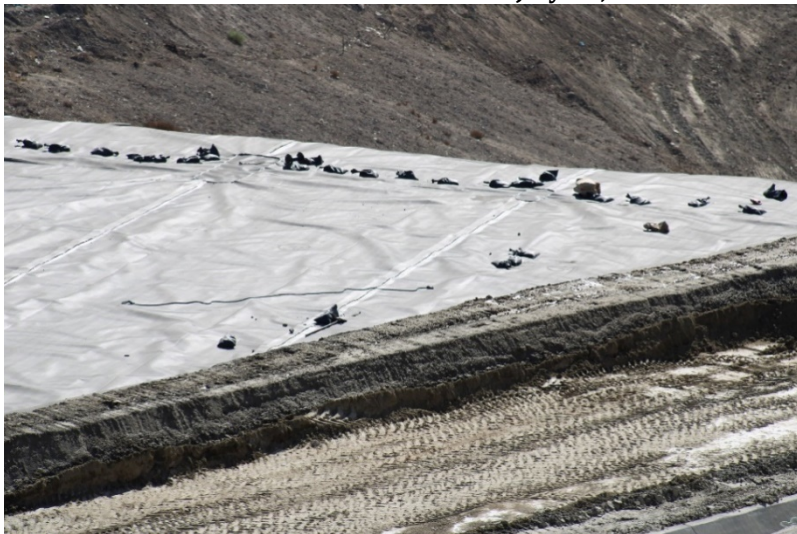
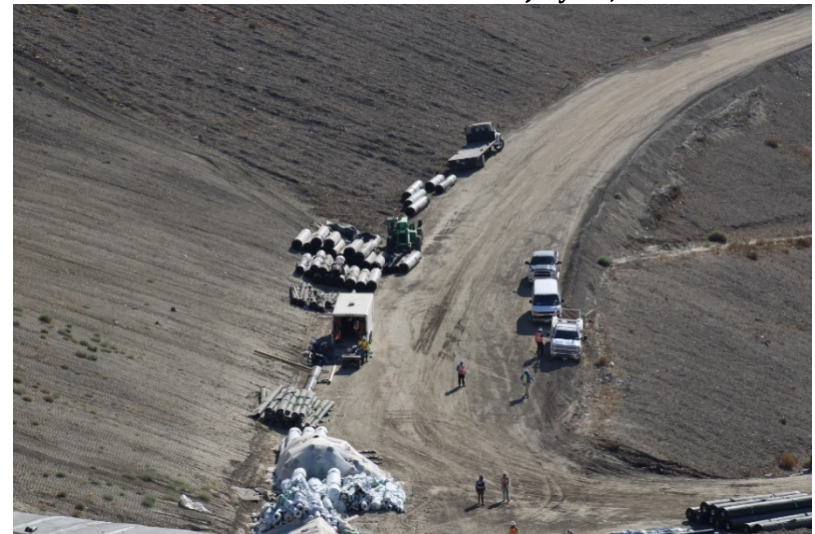
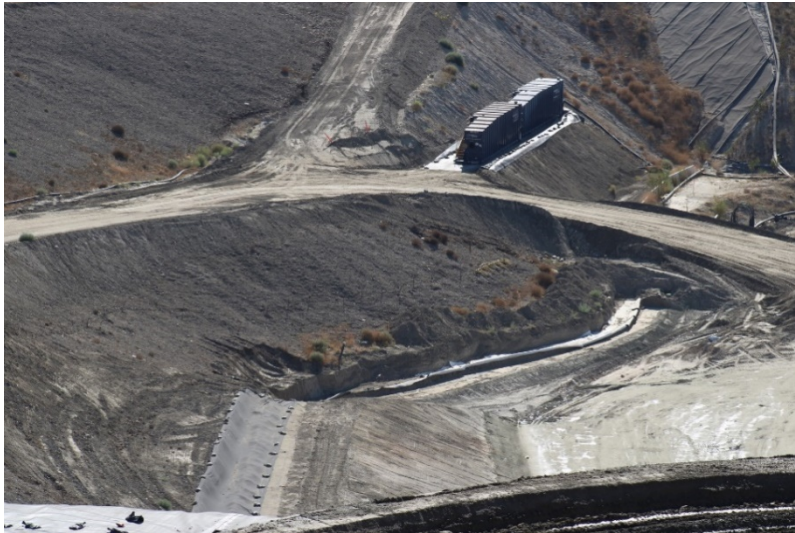
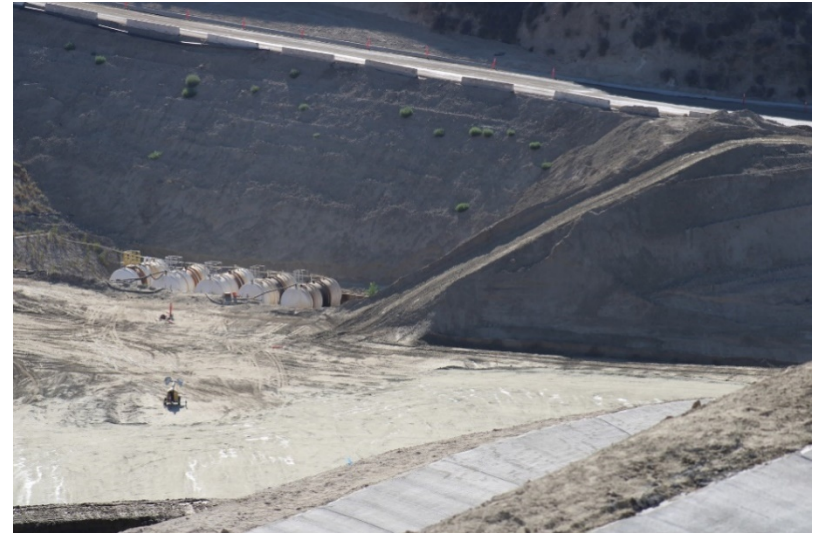
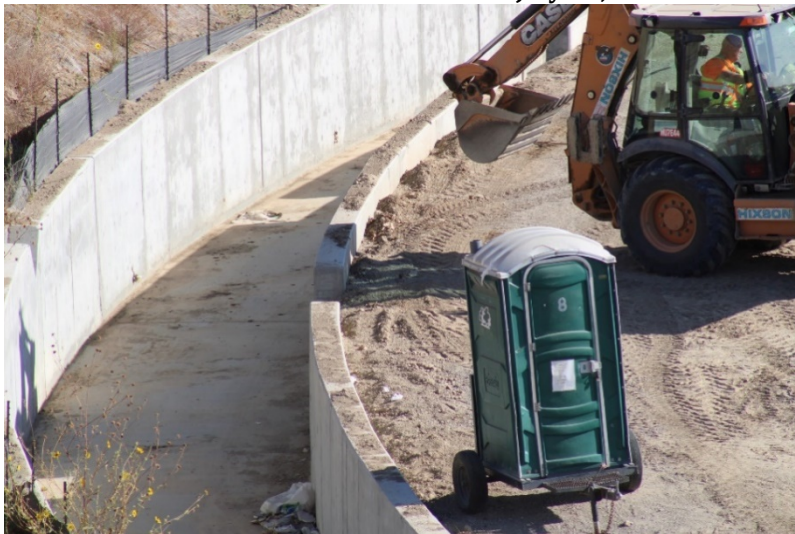
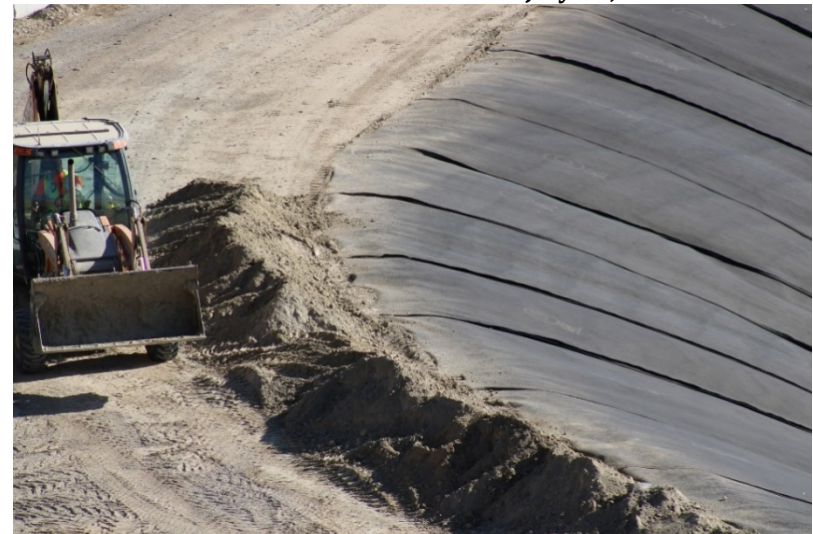
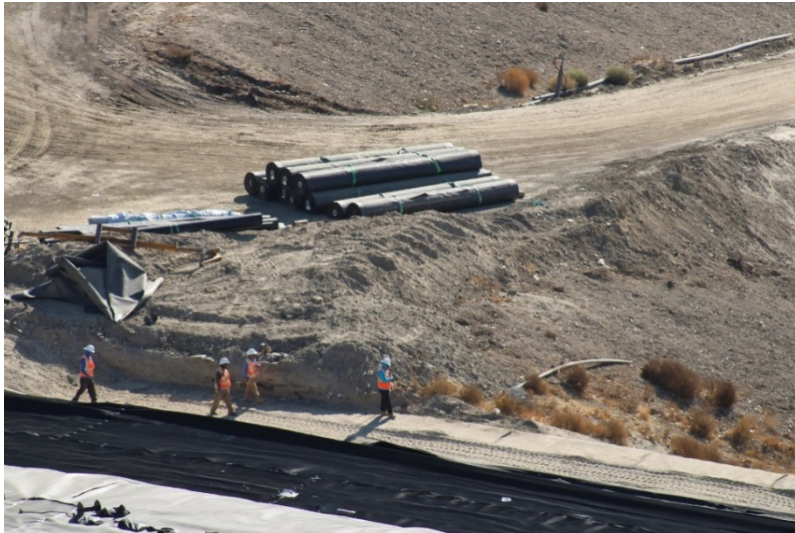
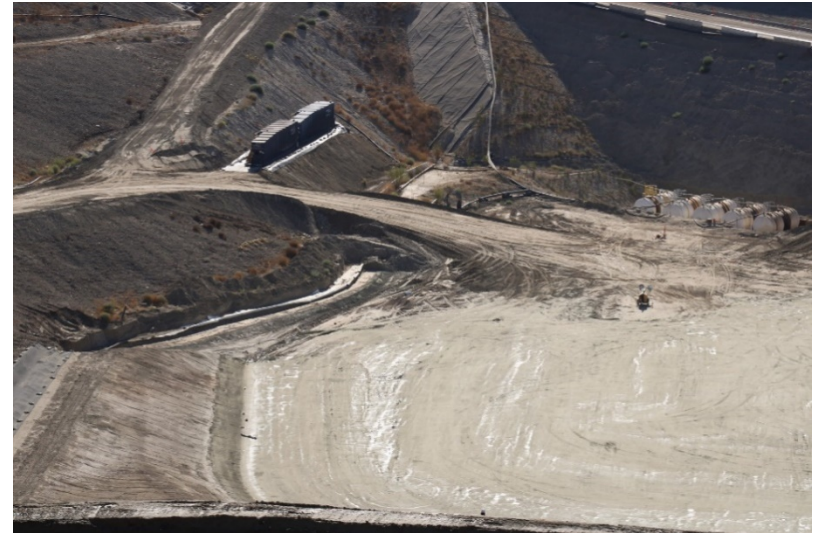
**Photo 382: Cell 8 Construction: July 21, 2022**

- The Cell 8A construction included an expansion to the existing catch basin.
- The Cell 8A development was observed from the western ridgeline. The liner system was being installed in the cell's floor and lower side areas. The perimeter access road (now dirt) was constructed above the final liner height.
