**RECLAMATION PLAN
LEBATA BIG ROCK CREEK
AGGREGATE SURFACE MINE AND PROCESSING FACILITIES**

**Memorandum from Mari Quillman to Lou Merzario, dated August 21,
2014, Re: *Comments Regarding the Establishment of Creosote Bush
Scrub on Revegetation Sites***

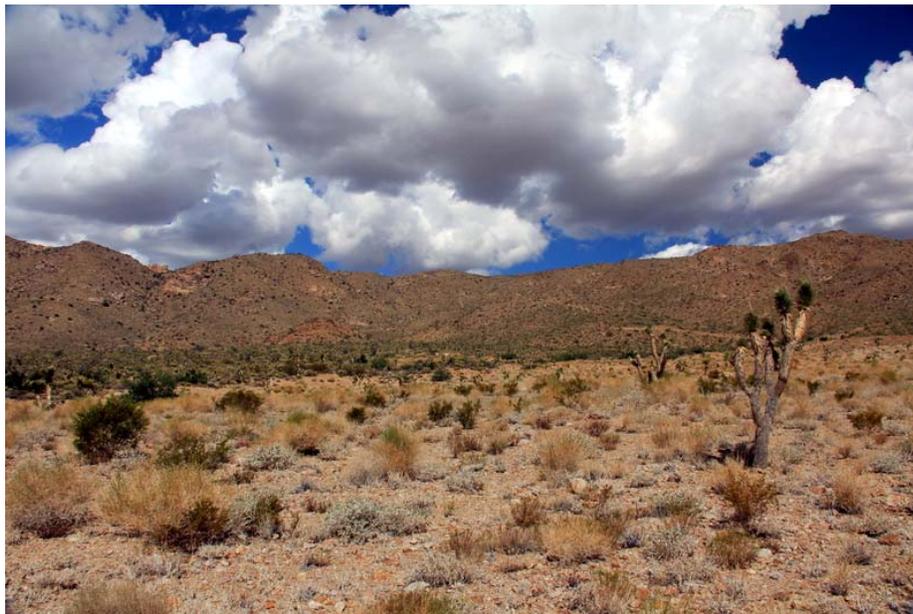
Photograph 1 – Overview of the Phase I revegetation site at the Morning Star Mine

A site visit was conducted at the revegetation site on August 21, 2014 to look at the progress and to qualitatively reevaluate the status of Joshua Trees and creosote bush. The Joshua trees continue to survive and many have flowered and produced seed during the 2014 season. In addition, recruitment of Joshua Tree “pups” was also noted. The creosote bush seed that was included in the seed mix germinated very well and new plants continue to germinate. The plants ranged from a few inches to approximately three feet tall. Creosote bush was a common species throughout much of the revegetation site. Photograph 1 shows a broad view of a portion of the revegetation site and the dark green plants in the photograph are the creosote bushes. Photograph 2 shows a closer view of one of the creosote bushes on the revegetation site with a cellphone at the base to demonstrate the size of the shrub. The revegetation site was seeded in December 2008 and January 2009, which was about 5.5 years ago. The growth and density of the creosote bush shrubs in approximately five years shows that creosote bush can be successfully grown on revegetation sites.

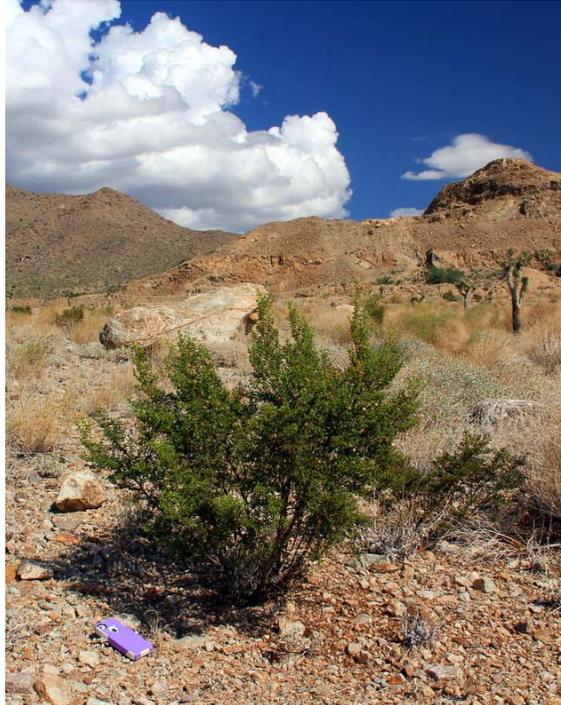
Photograph 2 – Creosote bush shrub on the Phase I Revegetation Area
